STRUCTURAL REPORT FOR ERF 5245 THE ORCHARDS.

Background: A single-storey house at 5245, The Orchards Ext 56 in the City of Tshwane built year 2019 showed some structural defects on the walls and roof. An investigation was then requested to determine the cause and possible remedial works to these defects. In this report are the findings and recommended remedial works found after the two site inspections dated (23 June and 02 July 2022).

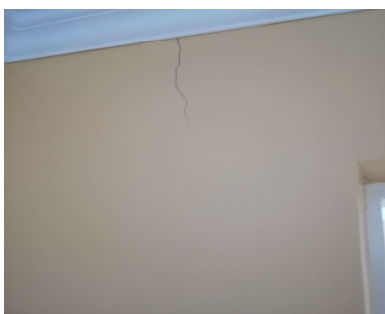
The walls were found with cracks at different points throughout the house both inside and outside. These cracks included both structural and plaster cracks. The plaster cracks were mostly found on the outer part of the external walls, while structural cracks were found both inside and outside the building (structure). The structural cracks are visible on the garage wall, Bedroom 1 door to the bathroom, kitchen, door to main bedroom and door to the garage. There were further horizontal cracks in the garage at ground slab and brickwork interface. This horizontal crack between these two interfaces is also visible on the external face of the wall running around the house.

The cause of the structural cracks above door or window opening is the lack of articulation joints to allow some movement due to the settlement and heaving figures mentioned in our Geotechnical findings further down this report.

Fig 1 Lounge

Walls: An introduction of articulation joints be done on some internal and external door openings including all doors with visible cracks running from the door opening. All other structural wall cracks can be fixed by chipping off the plaster and expose masonry units, then place expanded (1030R-A) or equivalent before plastering. The expanded mesh should extend a minimum of 200mm on either sides of the crack. The garage horizontal crack is an interface crack between concrete and brickwork should be exposed and sealed with crack sealer.

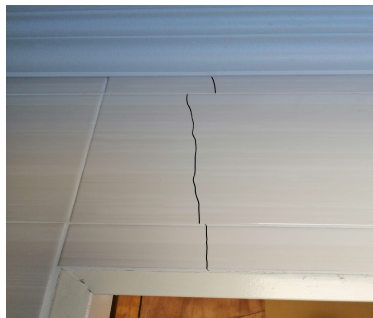
Fig 2-From inside Bathroom

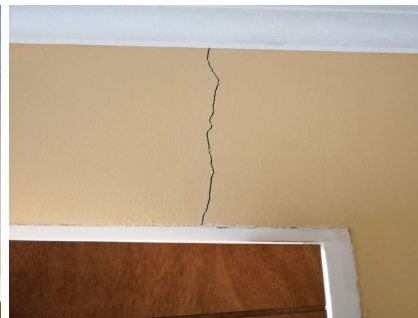
Fig 3-Door to Bathroom

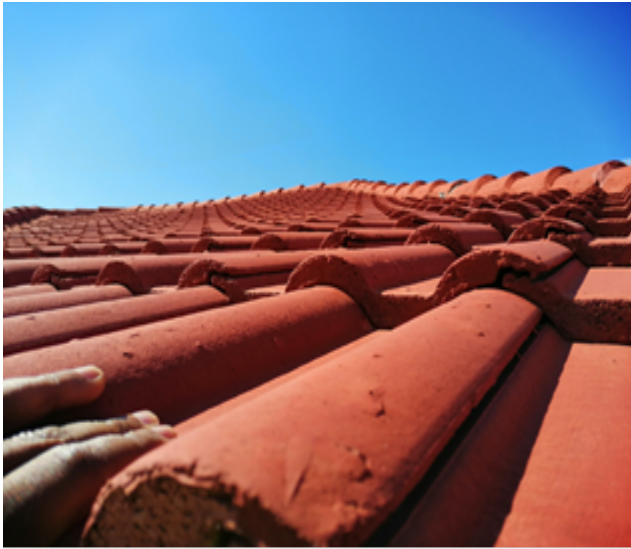
The roof can be seen from the road as uneven, with some areas of the roof already sagging in (caving in). The unevenness is due to lack of support and overstressed trusses that have already buckled under load. The buckling of the support structure (roof trusses) has also caused the wall (beamfilling) to develop cracks from the wall plate level. This is visible in certain areas on the cobble running around the structure.

Fig 4- Roof sagging

Roof: It is recommended that **the whole roof be stripped** and redone by a roof specialist and should be prefabricated, and who will also ensure that the necessary bracing and connections are done properly. The existing roof tiles can be reused after fixing the timber structure. Ensure that all tiles are checked for any defects prior to reinstalling.

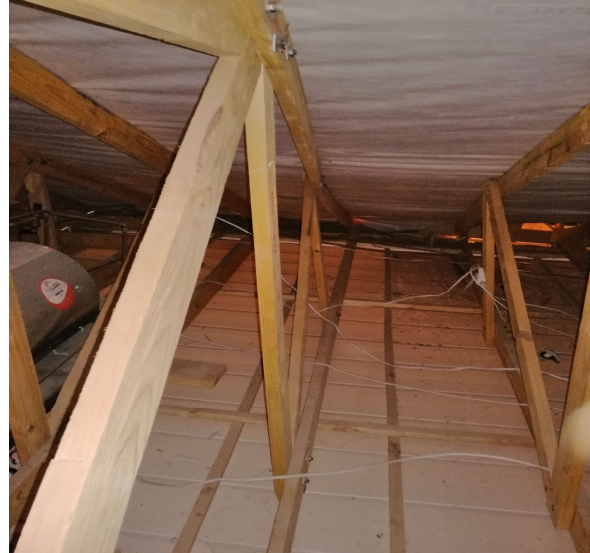
Fig 5 – Buckled Trusses

A further inspection was done to assess the support structure (trusses) by going through the trap door and walking to the affected areas of the roof. It was found that the trusses spanning over the dining room and kitchen had failed and can collapse any minute. These trusses spanning about 9.6m are overstressed and have already buckled out of plane. The connections at certain areas of the trusses have pulled out with just a few nails still holding it up. A truss was also seen with a free (loose) end close to the trap door opening. The roof over the garage and bedroom also spans in the same direction as the adjacent dining room span. Even though the spans a shorter it is also affected and will have to be redone by a qualified roof fabricator and installer.

The maximum clear span of a six-bay Howe Truss is 8m as stated in the NHBC standards. An option of creating a midspan support girder will be ideal and splitting the span in two which allows for a standard 6 bay Howe truss to be used, thus keeping the members sizes smaller or a specific truss design from a roof specialist.

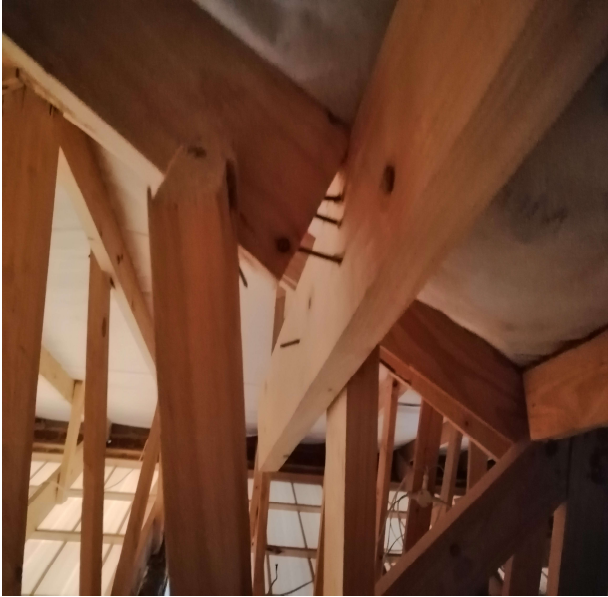
Fig 6- Loose connection

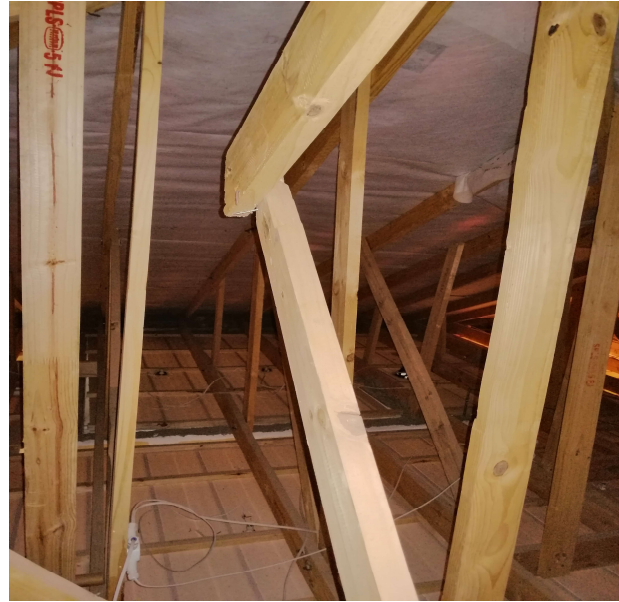
Fig 7 Truncated truss

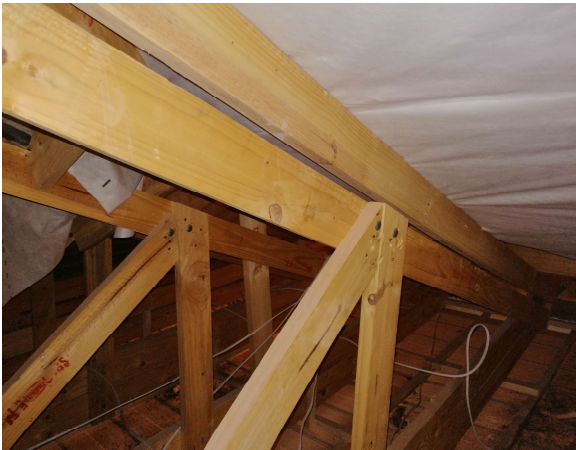
There were signs that this issue with the roof had been picked up earlier and efforts to remedy or improve the truss section had been made. This is evident from the additional timber section that have been added to the truss. The additional sections are visible on the bottom cord of the last bay and visible on the top-cord from support wall to the apex. However, these "additional timber sections" were not properly connected to the existing truss making them redundant.

Fig 8- Attempted fix

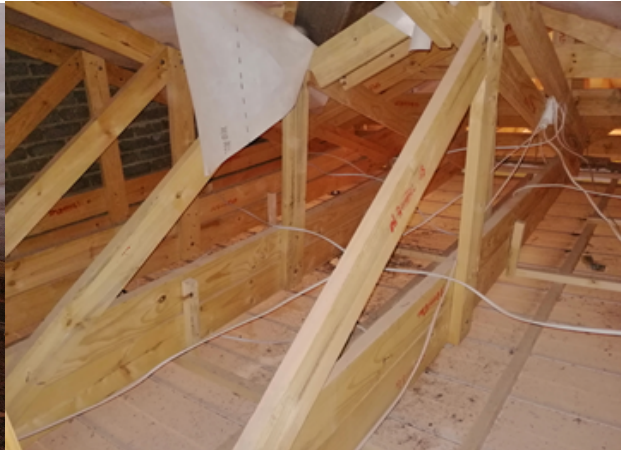
Fig 9- Stiffened bottom sections

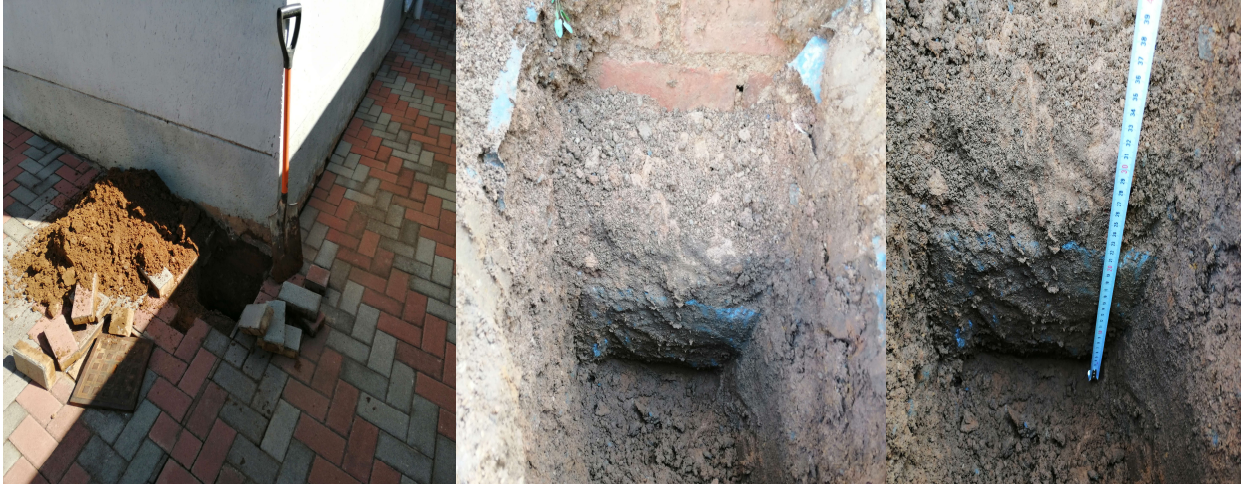
Two excavations were done from the outside to determine the type and size of the footing. It was discovered that the house is on approximately 600x300mm deep footing. This footing sits about 300mm from the finished paving level and we couldn't determine if the footing was reinforced or not.

Fig 10- Exposing foundation Fig 11- Exposed footing Fig 12- Footing thickness

Due to the above-mentioned highlights from the Geotechnical report, it is clear that although a reinforced strip foundation is an option, the preferred foundation was the Reinforced foundation raft to accommodate settlements determined in the design parameters.
