Professional Engineering Services for:
House Van Niekerk, Erf 7421 - Swellendam

Forensic Investigation and Structural Engineering
remedial solutions

Investigation and Recommendation Report

January 2023 (Rev 01)

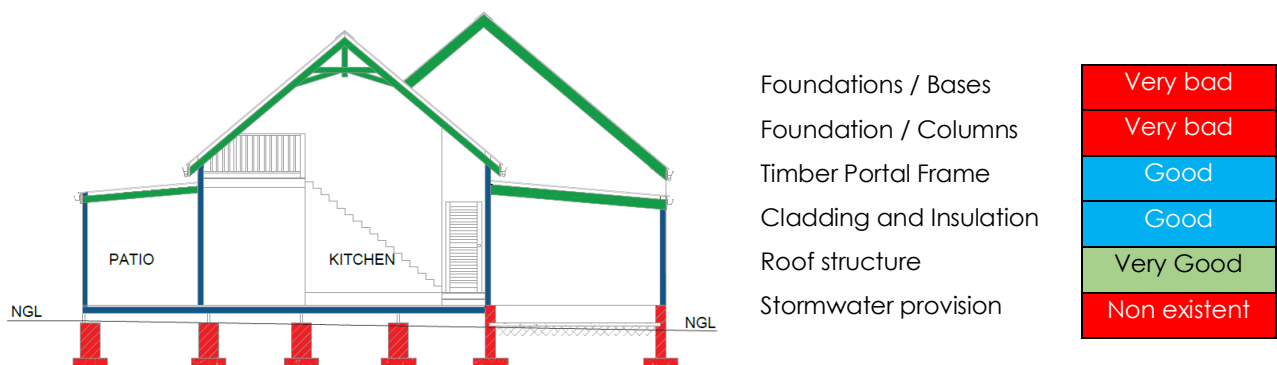
Figure 2: Condition Assessment

The structural condition assessment of the building portrays a very high risk towards the structural integrity of especially the foundations of the building as schematically shown below and further detailed in this section below.

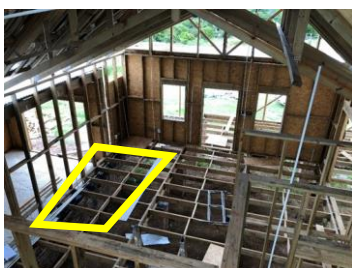
The architect's drawings indicates that the two bathrooms and the kitchen to have concrete surface beds, however, only a concrete surface for the garage was constructed on compacted fill. A large percentage area of the wooden floor deck is not fully supported onto the foundation columns which results in oscillation occurrence when walking on the surface and during high-speed winds imposing on the vertical elevations of the building.

No concrete floor in kitchen

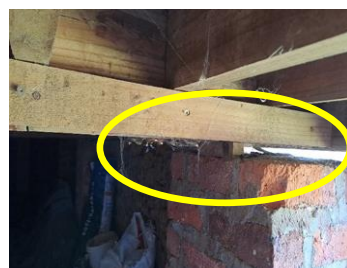
Timber deck not supported

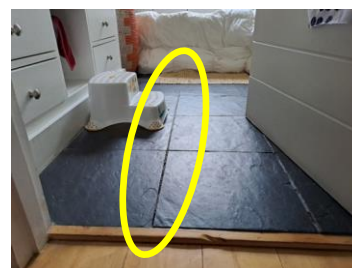
The tile flooring in the bathrooms is laid on a layer of screed which elements are both cracking up from the oscillation movement of the structure further caused by inadequate and uneven horizontal, vertical and lateral supports to the structure as shown in the photos below.

Cracked tiles in bathroom – on screed
