STRUCTURAL ASSESSMENT OF HOUSE LE ROUX, ERF 10716 THORNY BUSH ESTATE, POTGIETERSRUS EXT 25, MOKOPANE

STRUCTURAL INVESTIGATION REPORT REV 02

JANUARY 2024

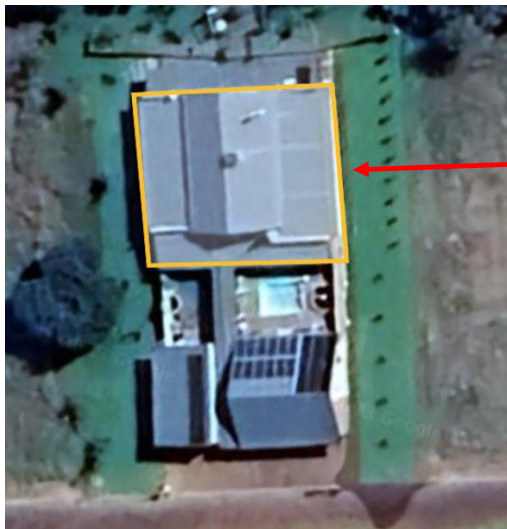
Figure 3: Aerial view of the north-westerly wing

- ❖ Foundation underpinning around the external wall of the north-western wing of the property which is relatively on a high fill platform.

Area earmarked for foundation underpinning

Detailed specifications and drawing for foundation underpinning are entailed in Appendices B and C of this report respectively.

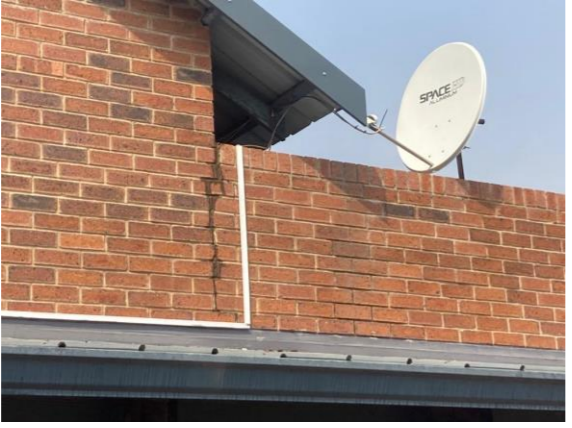
- ❖ The main bedroom has a vertical crack on the exterior wall and this crack penetrates both the inside and outside of the room, showing signs of significant foundation settlement;

<p>Photo 1: Crack outside main bedroom</p>

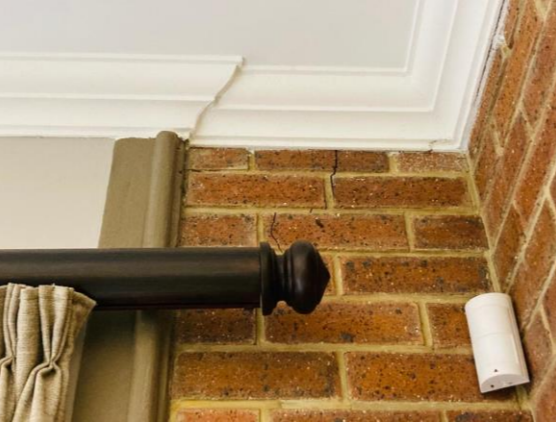
<p>Photo 2: Crack inside main bedroom (interior of photo 1)</p>

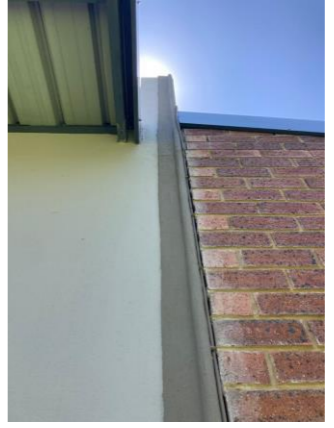
- ❖ A movement joint between walls in the south-west side of the building is not properly sealed, which can also result in long-term issues of water ingress, moisture leading to mould and affecting the building's structural integrity;

<p>Photo 3: Movement joint not properly sealed</p>
<p>Report Title: Roof Leaks Assessment Report</p>

- ❖ The vertical movement joint on the south-western elevation must be closed with a high-performance movement joint sealant.
- ❖ Hairline cracks on the interior wall should be fixed by cleaning the cracked surface, make the crack moist and applying the acrylic sealant into the crack.
- ❖ The interior walls affected by crack repairs need to be repainted to Architect specifications.

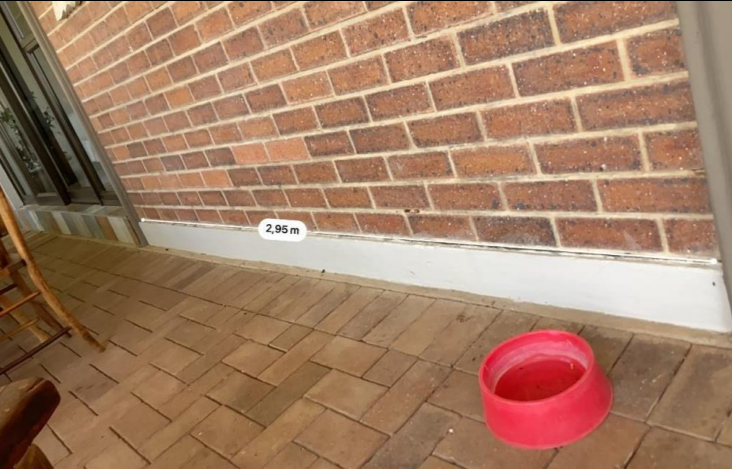
- ❖ There is a horizontal crack around the exterior wall at floor level (DPC level) in the north-western side of the courtyard. It appears the horizontal crack is due to a slight foundation settlement;

<p>Photo 4: Horizontal crack at DPC level</p>

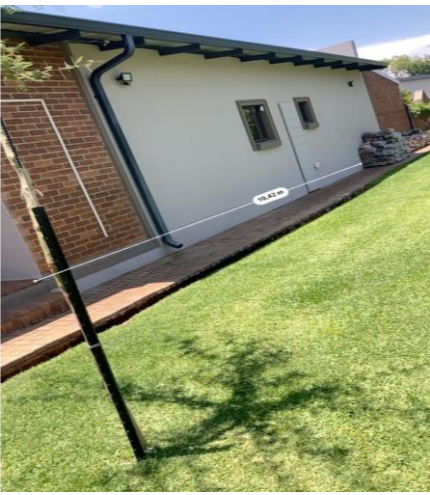
<p>Photo 5: Horizontal crack at DPC level (Repaired by the homeowner)</p>

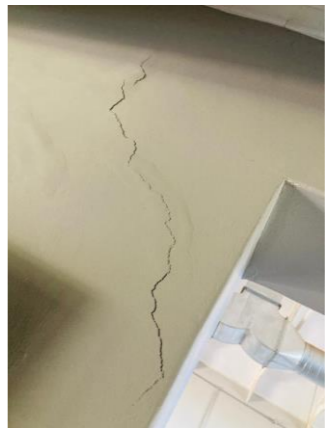
- ❖ There are vertical and diagonal shear cracks on the interior wall of the bedrooms' corridor due to differential settlement;
- ❖ There is a diagonal crack above the door of bedroom 2, and this crack is also attributed to foundation settlement;

<p>Photo 6: Crack on corridor internal wall</p>
<p>Report Sub-Title: HOUSE LE ROUX PHOTO REPORT</p>

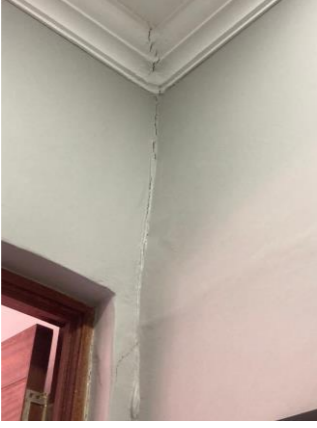
<p>Photo 7: Crack on corridor internal wall</p>

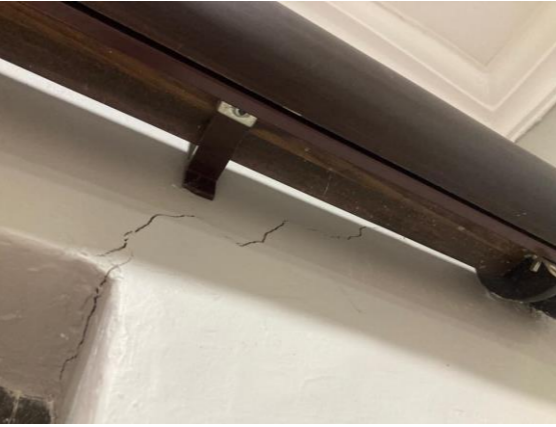
<p>Photo 8: Crack on bedroom 2 internal wall</p>

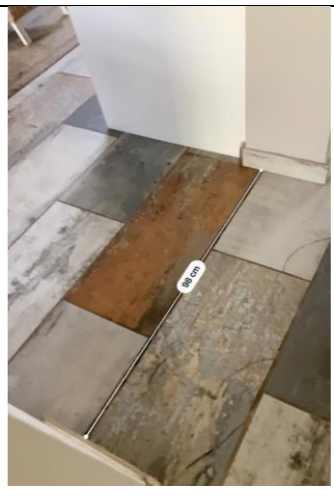
- ❖ All surface bed floors are tiled with ceramic floor tiles; and
- ❖ There was a 4m long expansion crack in bedroom 2 (wall-to-wall) and 0.98m across the corridor for bedrooms, which could be as a result of soil heave underneath the surface bed. These cracks penetrate through the ceramic tiles and seem to be up to 10mm in width, which are severe according to the NHBRC classification of floor slab damage.

<p>Photo 9: Crack on corridor surface bed</p>
<p>Revision: 02 Date: 18-01-2024</p>

The cracked surface bed in bedroom 2 and the corridor should be repaired by:

- ❖ Applying SABS approved non-shrink epoxy grout into the cracks. The grout should be able to achieve a compressive strength of 600 Kg/cm / 60MPa in three (3) days;
- ❖ The crack must be used to fill the cracks on the surface bed by first removing the tiles, cutting out the crack to create a backward-angled cut “V” about 50mm deep, cleaning out any loose material from the crack and applying the grout as specified.

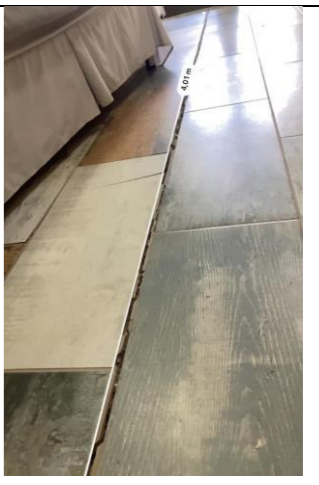
<p>Photo 10: Crack on bedroom 2 surface bed</p>

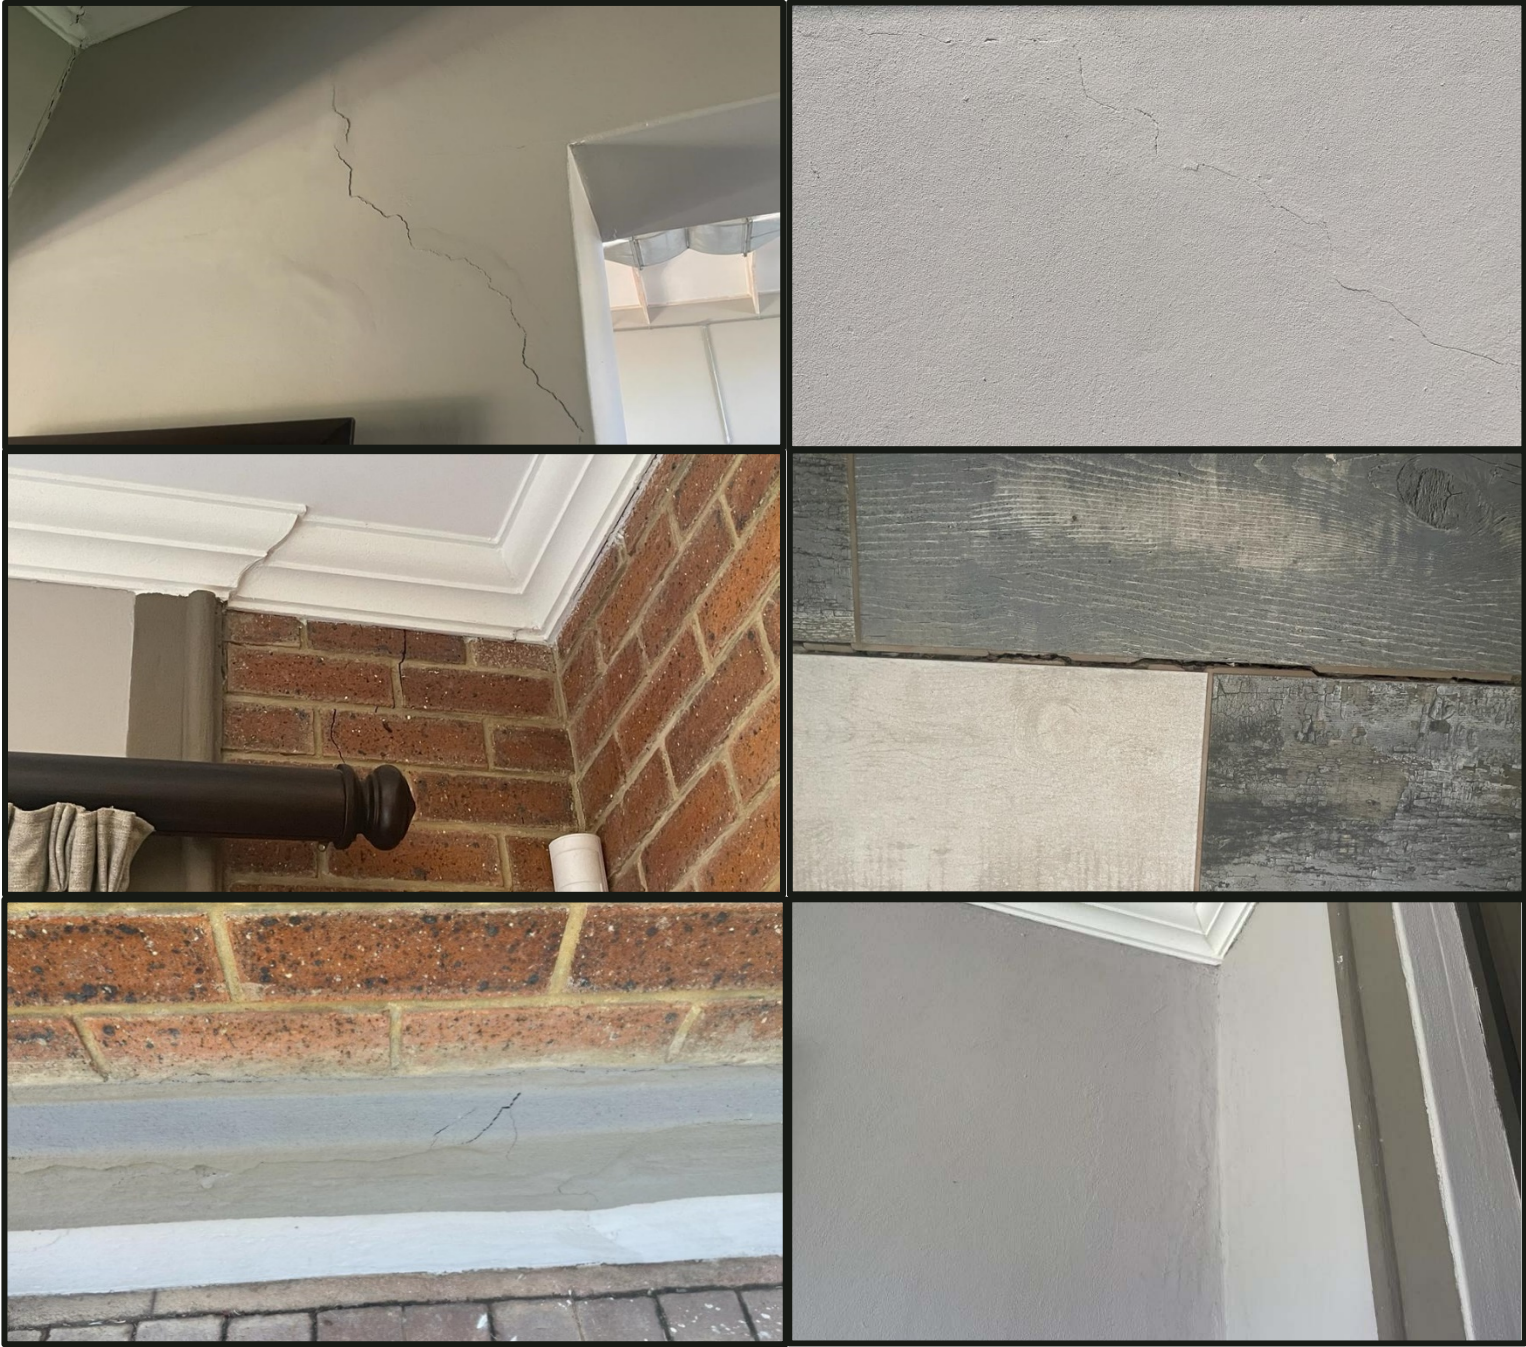
The house under assessment displayed structural distress (vertical and lateral movement) because of compression and heaving, and ultimately differential settlement. The cracks were observed on the walls around the house and on the floor as shown in Figure 8 below. It is worth noting that this site most likely experiencing compression than heaving.

Figure 6: Showing structural cracks on the investigated house.

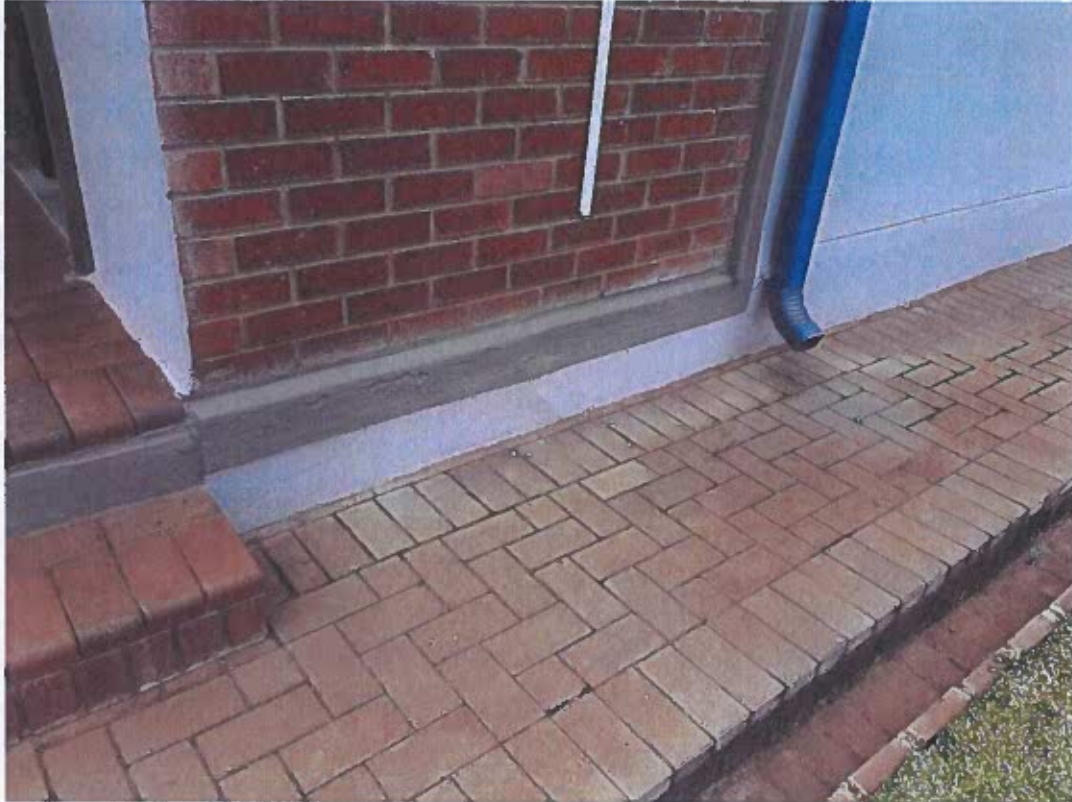
Plate1

Plate 1 shows the signs of structural defects on the repaired western foundation wall.

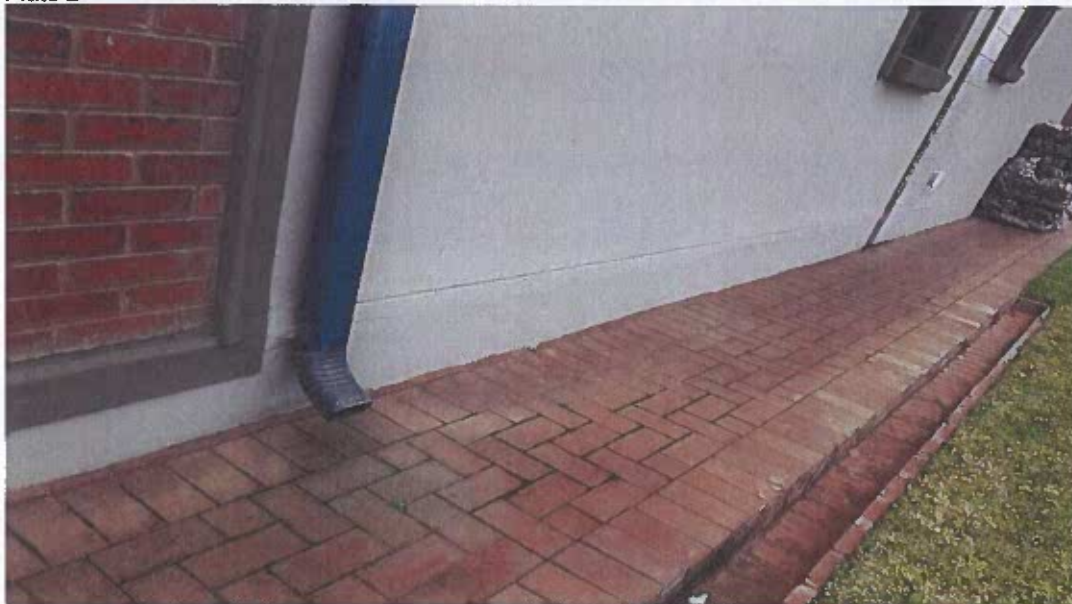
Plate 2 supplements plate 1

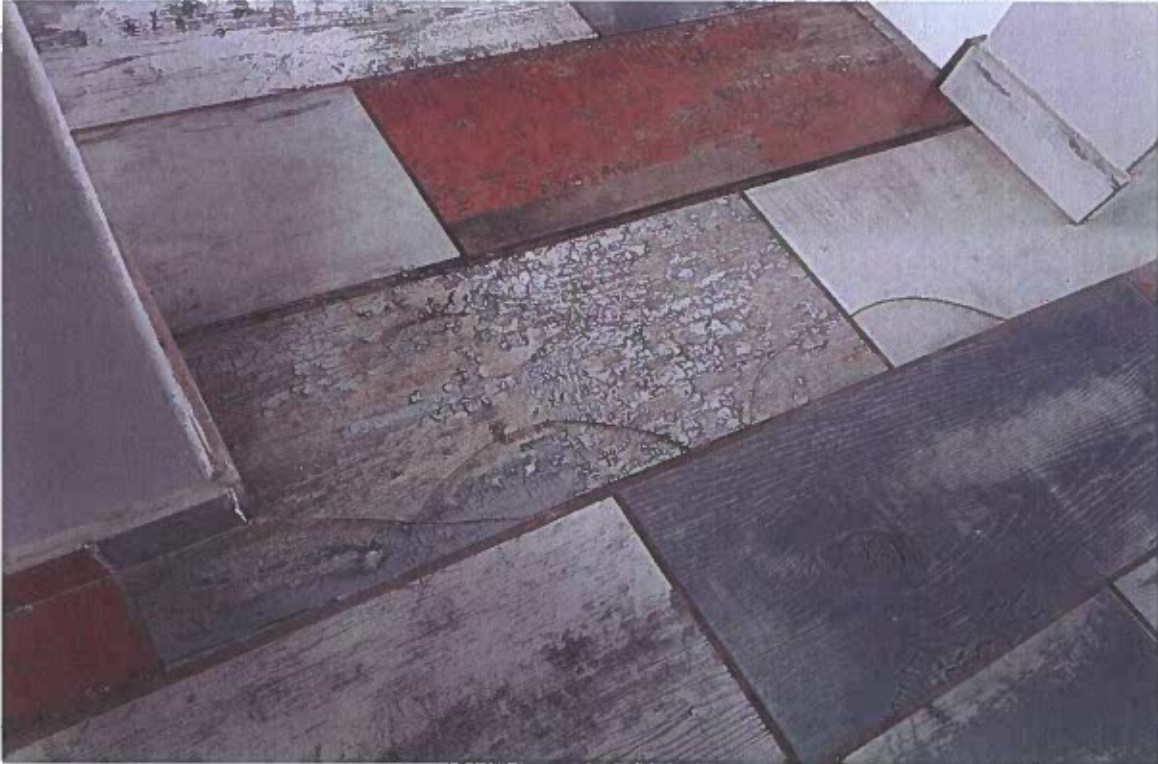
Plate 3 shows cracks on floor finish in the corrido..

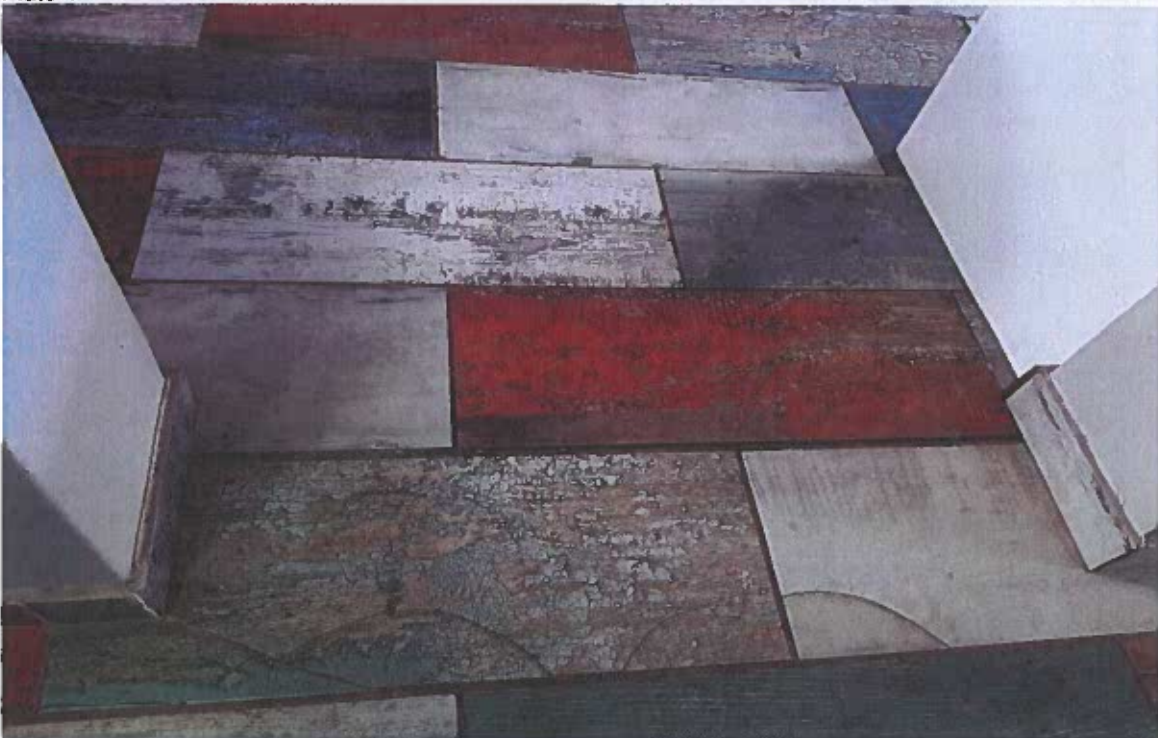
Plate 4 supplements plate 3.

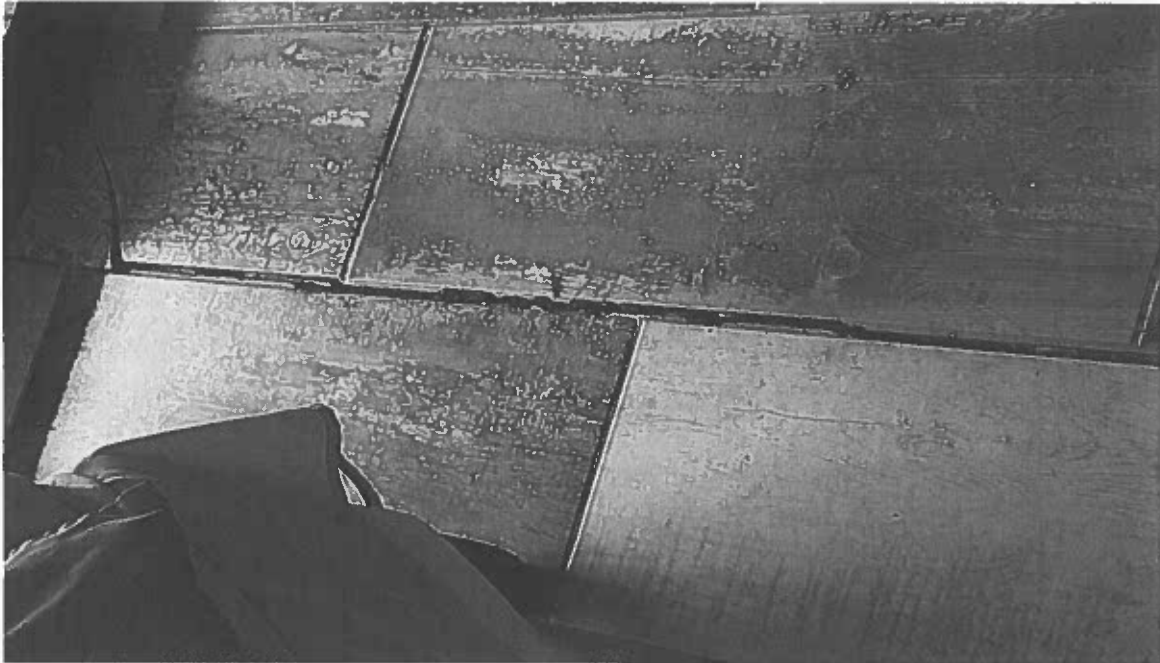
Plate 5 shows a floor crack in the western bedroom. The crack represents a shift movement to the west and is open the full length of the room.

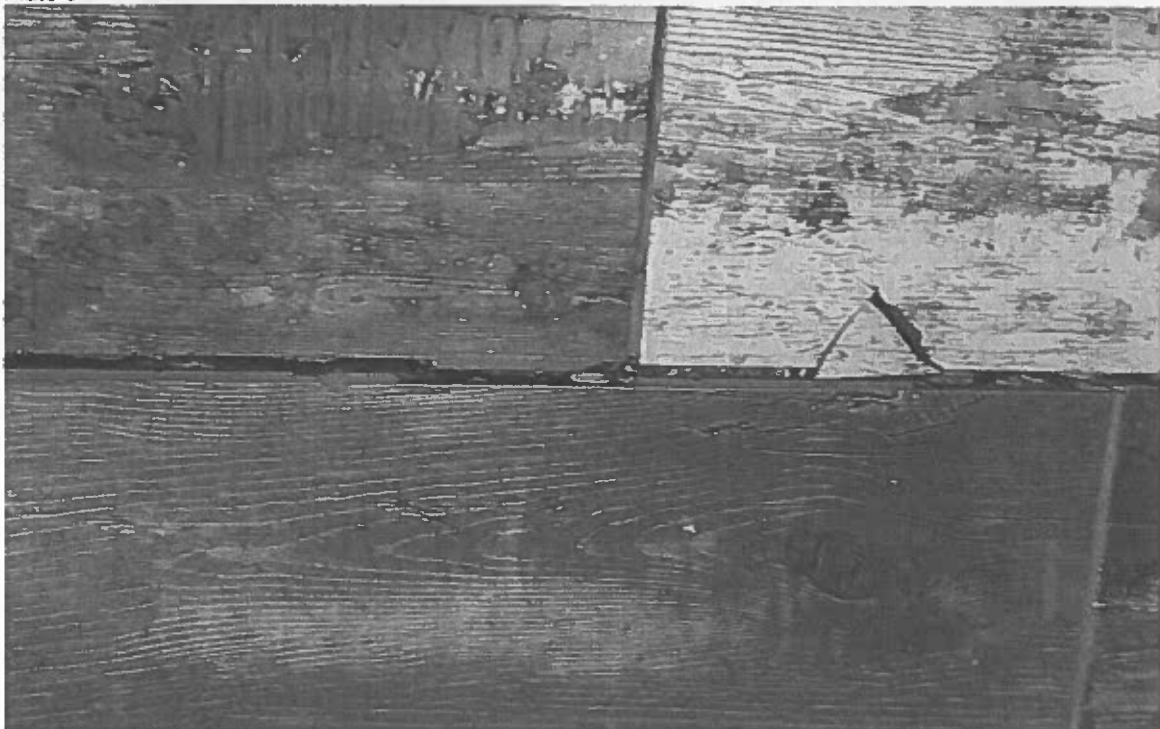
Plate 6 supplements plate 5

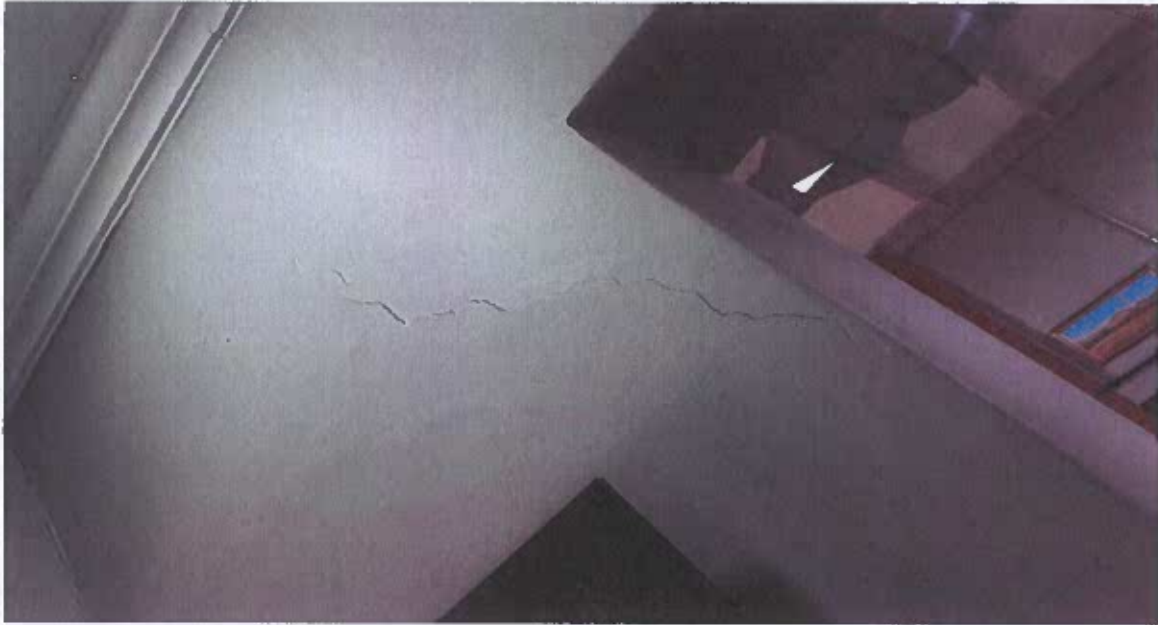
Plate 7 shows the recurrence of the repaired crack on the wall of the corrido.

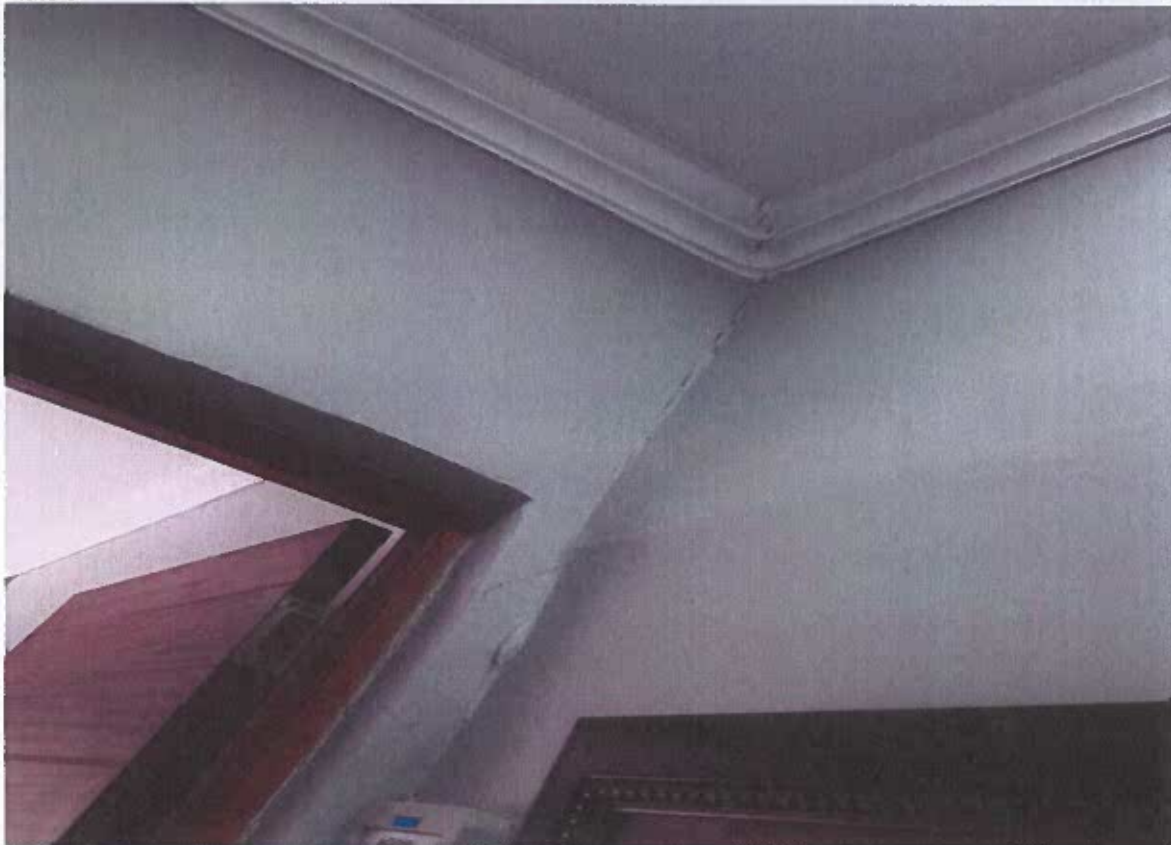
Plate 8 supplement plate 7

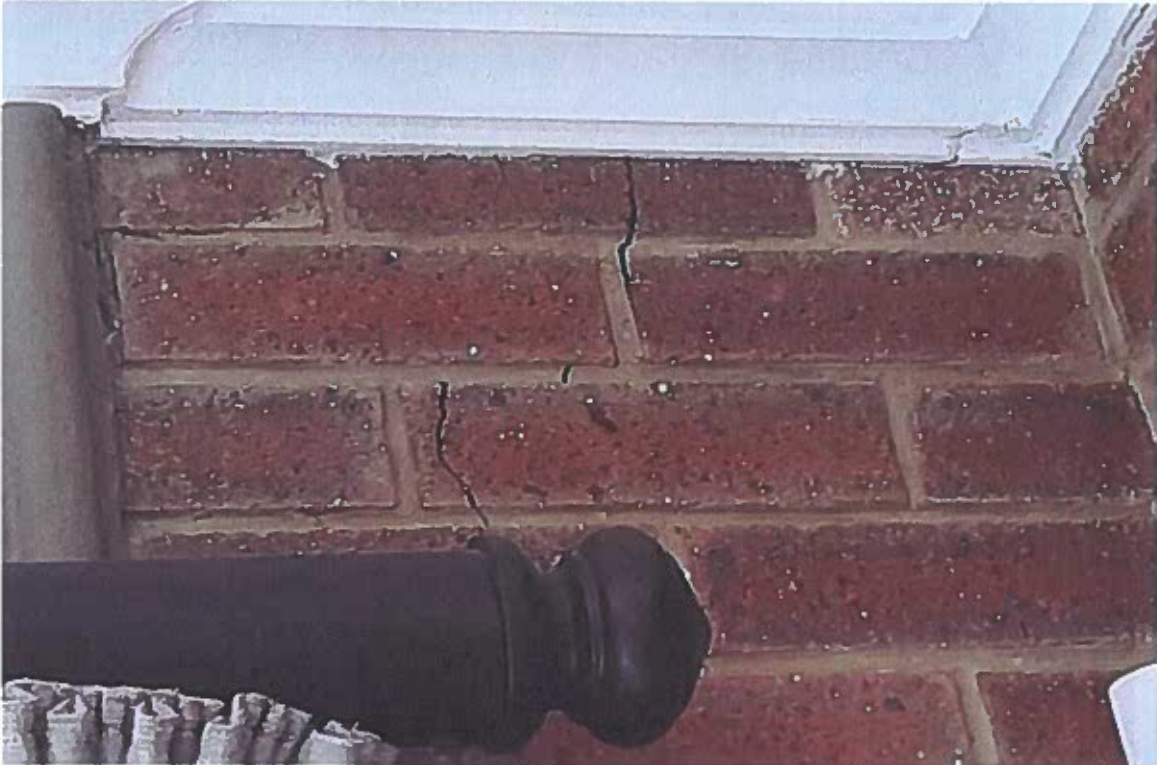
Plate 9 shows a crack on the external wall of the dining area.

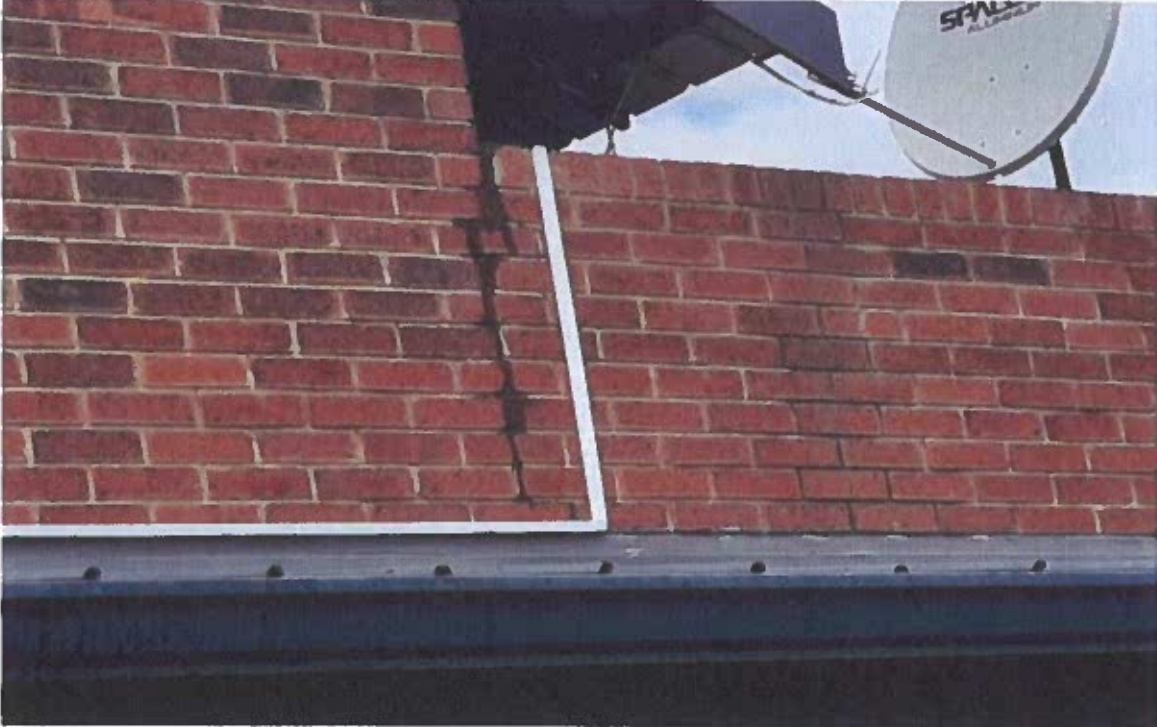
Plate 10 supplements plate 9 showing the same crack on the outside.

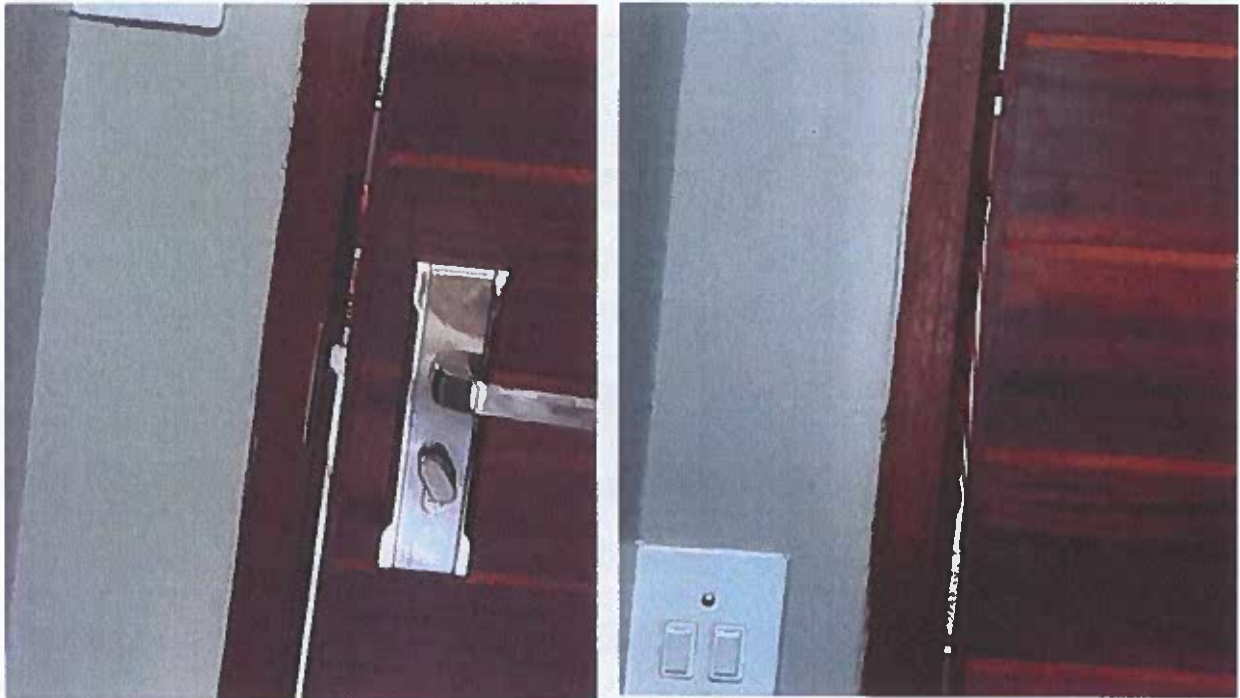
Plate 11 and 12 depict the door gap of the western bedroom attributed to the foundation movement.

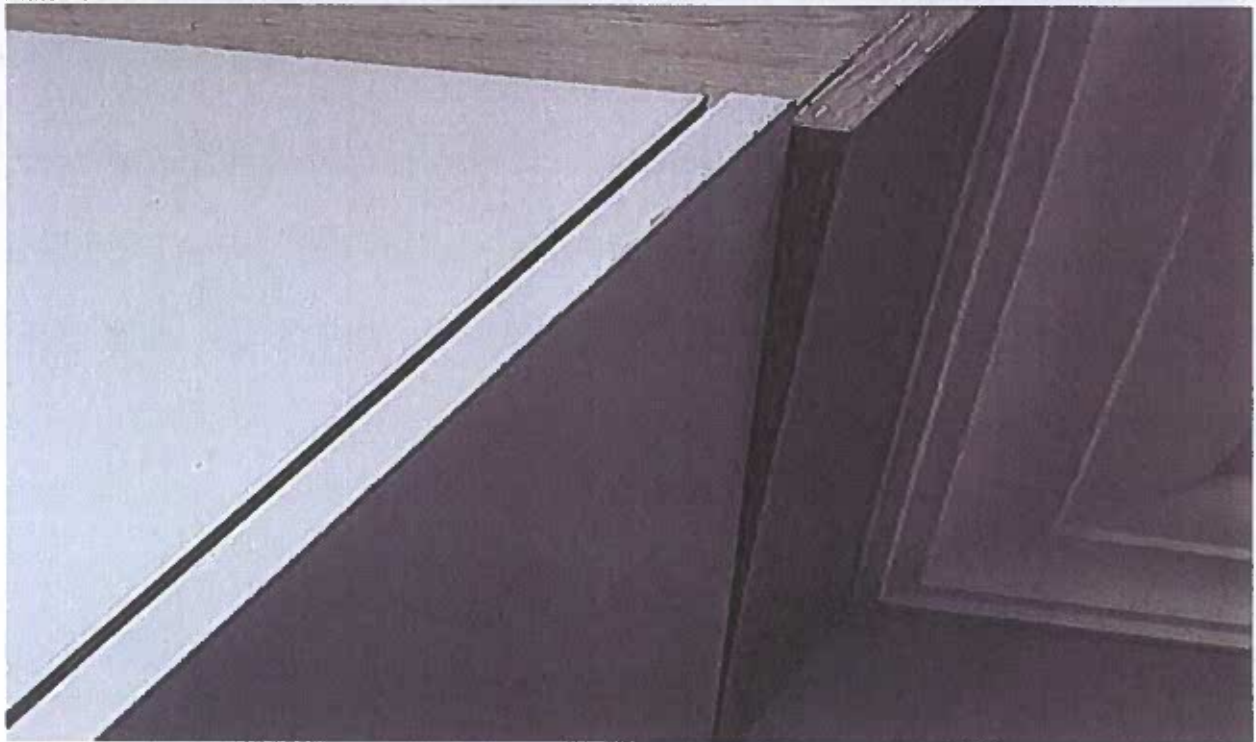
Plate 13 supplements plate 11 and 12 but showing misalignment of the build in closets attributed to the foundation movement.
