Investigation and Structural Engineering  
Remedial Concepts to Erf 18471, Mossel Bay  
House Bernard

## Report – Rev 0

26 April 2024

# GEOTECHNICAL INVESTIGATION FOR 15 SEEMEEU HOOGTE, MOSSEL BAY

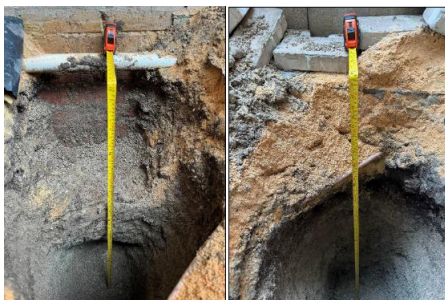
**Test Pits:**

Foundations constructed on silty material

The Dwala Group report recommends underpinning to foundations and installation of proper stormwater management systems.

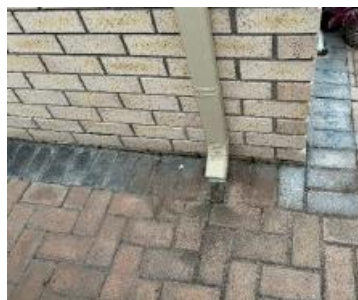
**Rainwater downpies**

Water ingress into paving

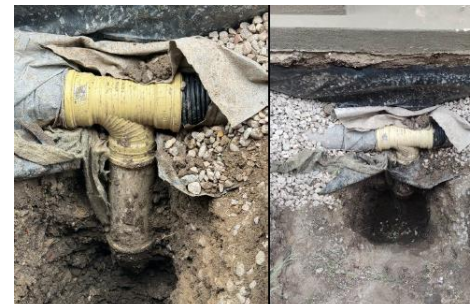
**Sub-soil drain on eastern boundary**

Non-operational sub-soil drain

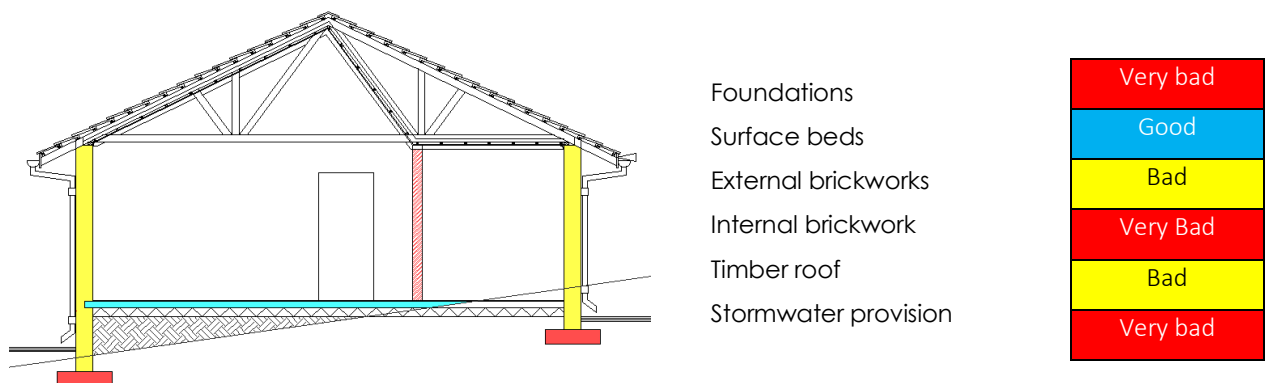
**Figure 2: Condition Assessment**

The structural condition assessment of the building portrays a very high risk of failure towards the structural integrity of almost the entire building as schematically shown below.

The condition of the external walls are not as bad as the internal walls however, large cracks are evident over door and window openings on the perimeter of the building vertical walls.

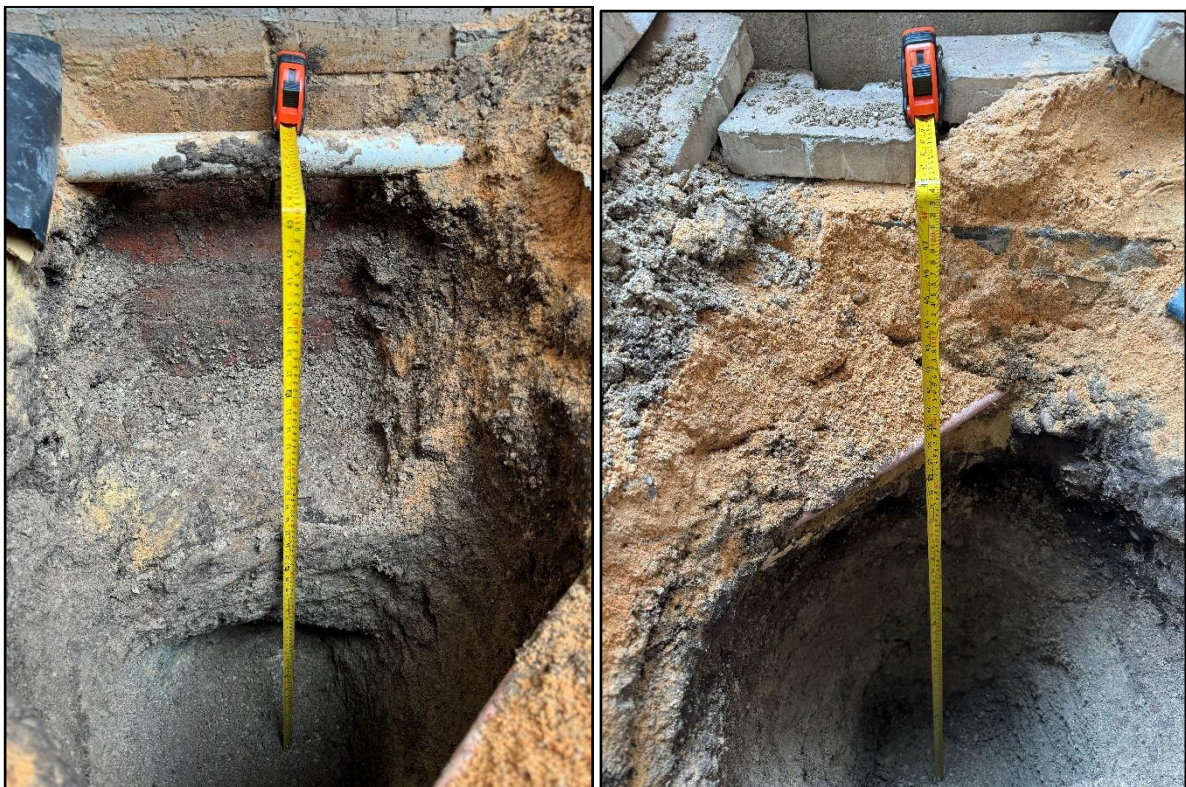
Figure 5: Showing test pit HB1.

Figure 5 below shows the excavated test pit HB1 on-site. The profile on-site consists of fill and residual siltstone horizon.

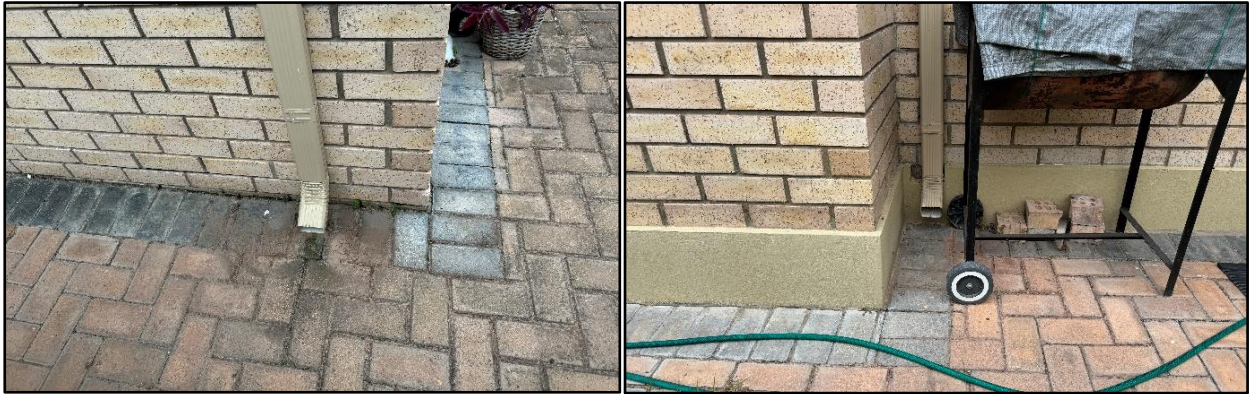
Figure 6: Showing the gutters around the investigated house.

The gutters around the house channel water **directly onto the inadequate paving and into the foundations and subsoil**. This allows for water to permeate the soil directly and infiltrate through to the foundations facilitating the movement of foundations and leading to structural damage. Figure 6 below shows the gutters around the house.

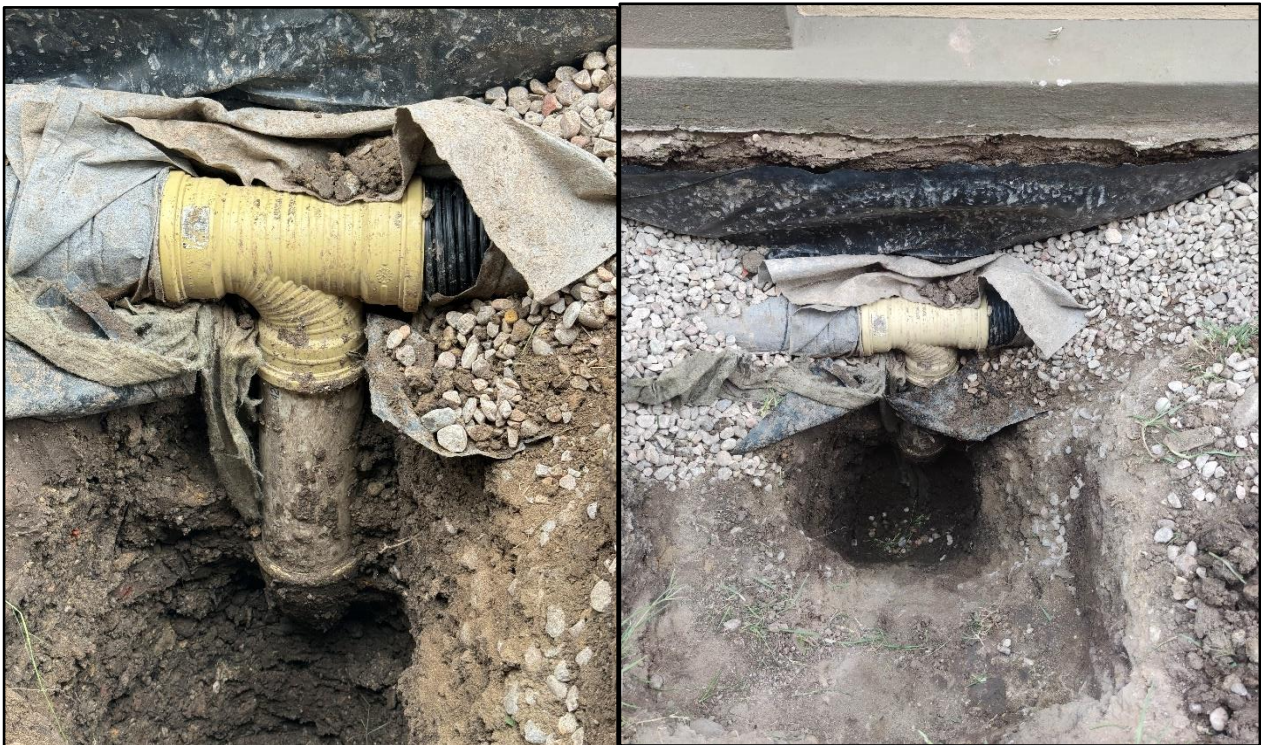
Figure 7: Showing the stormwater pipe in the garden area.

Upon exposure of the stormwater drainage pipe in the garden area, there were no visible signs of damage or leakage or disconnect. The pipe was encountered to be at a depth of 300 mm and extend to 1.0 m below the ground. Sandy clay with minor gravel and pebbles was used as backfill for the pipe. While the stormwater drainage system appears without visible damage, it should be noted that it cannot be definitively affirmed that there are no leakages during periods of heavy rainfall. Figure 7 below shows the stormwater pipe in the garden area.

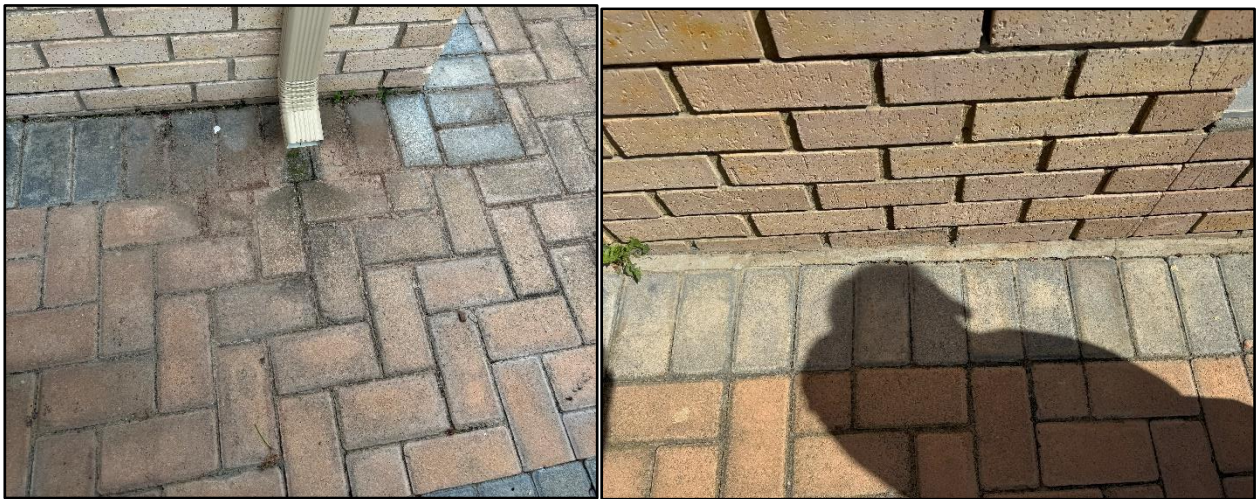
The brick pavement around the house is inadequate as there are spaces between the building walls and the brick pavement. This renders the pavement ineffective in keeping surface runoff away from the subsoils and subsequently the foundations. It allowed water to permeate through the foundations and the residual siltstone material directly, increasing the moisture content in the sub-foundation horizon. There are also signs of stagnant water on the pavers which is not drained away. Figure 8 below shows the inadequate brick paving around the investigated house.

Figure 8: Showing the inadequate brick pavement with spaces between bricks around the house.

**The inadequate brick paving around the investigated house allowed water to permeate through to the foundations and directly into the foundations and subsoil residual siltstone material. These materials absorbed the water and induced plastic deformations of the soils. The change in moisture content of the subsoil and the load of the house has triggered the compression/collapse and consequently differential settlement of the subsoil and thus caused the movement of foundations resulting in structural damage to the house.**

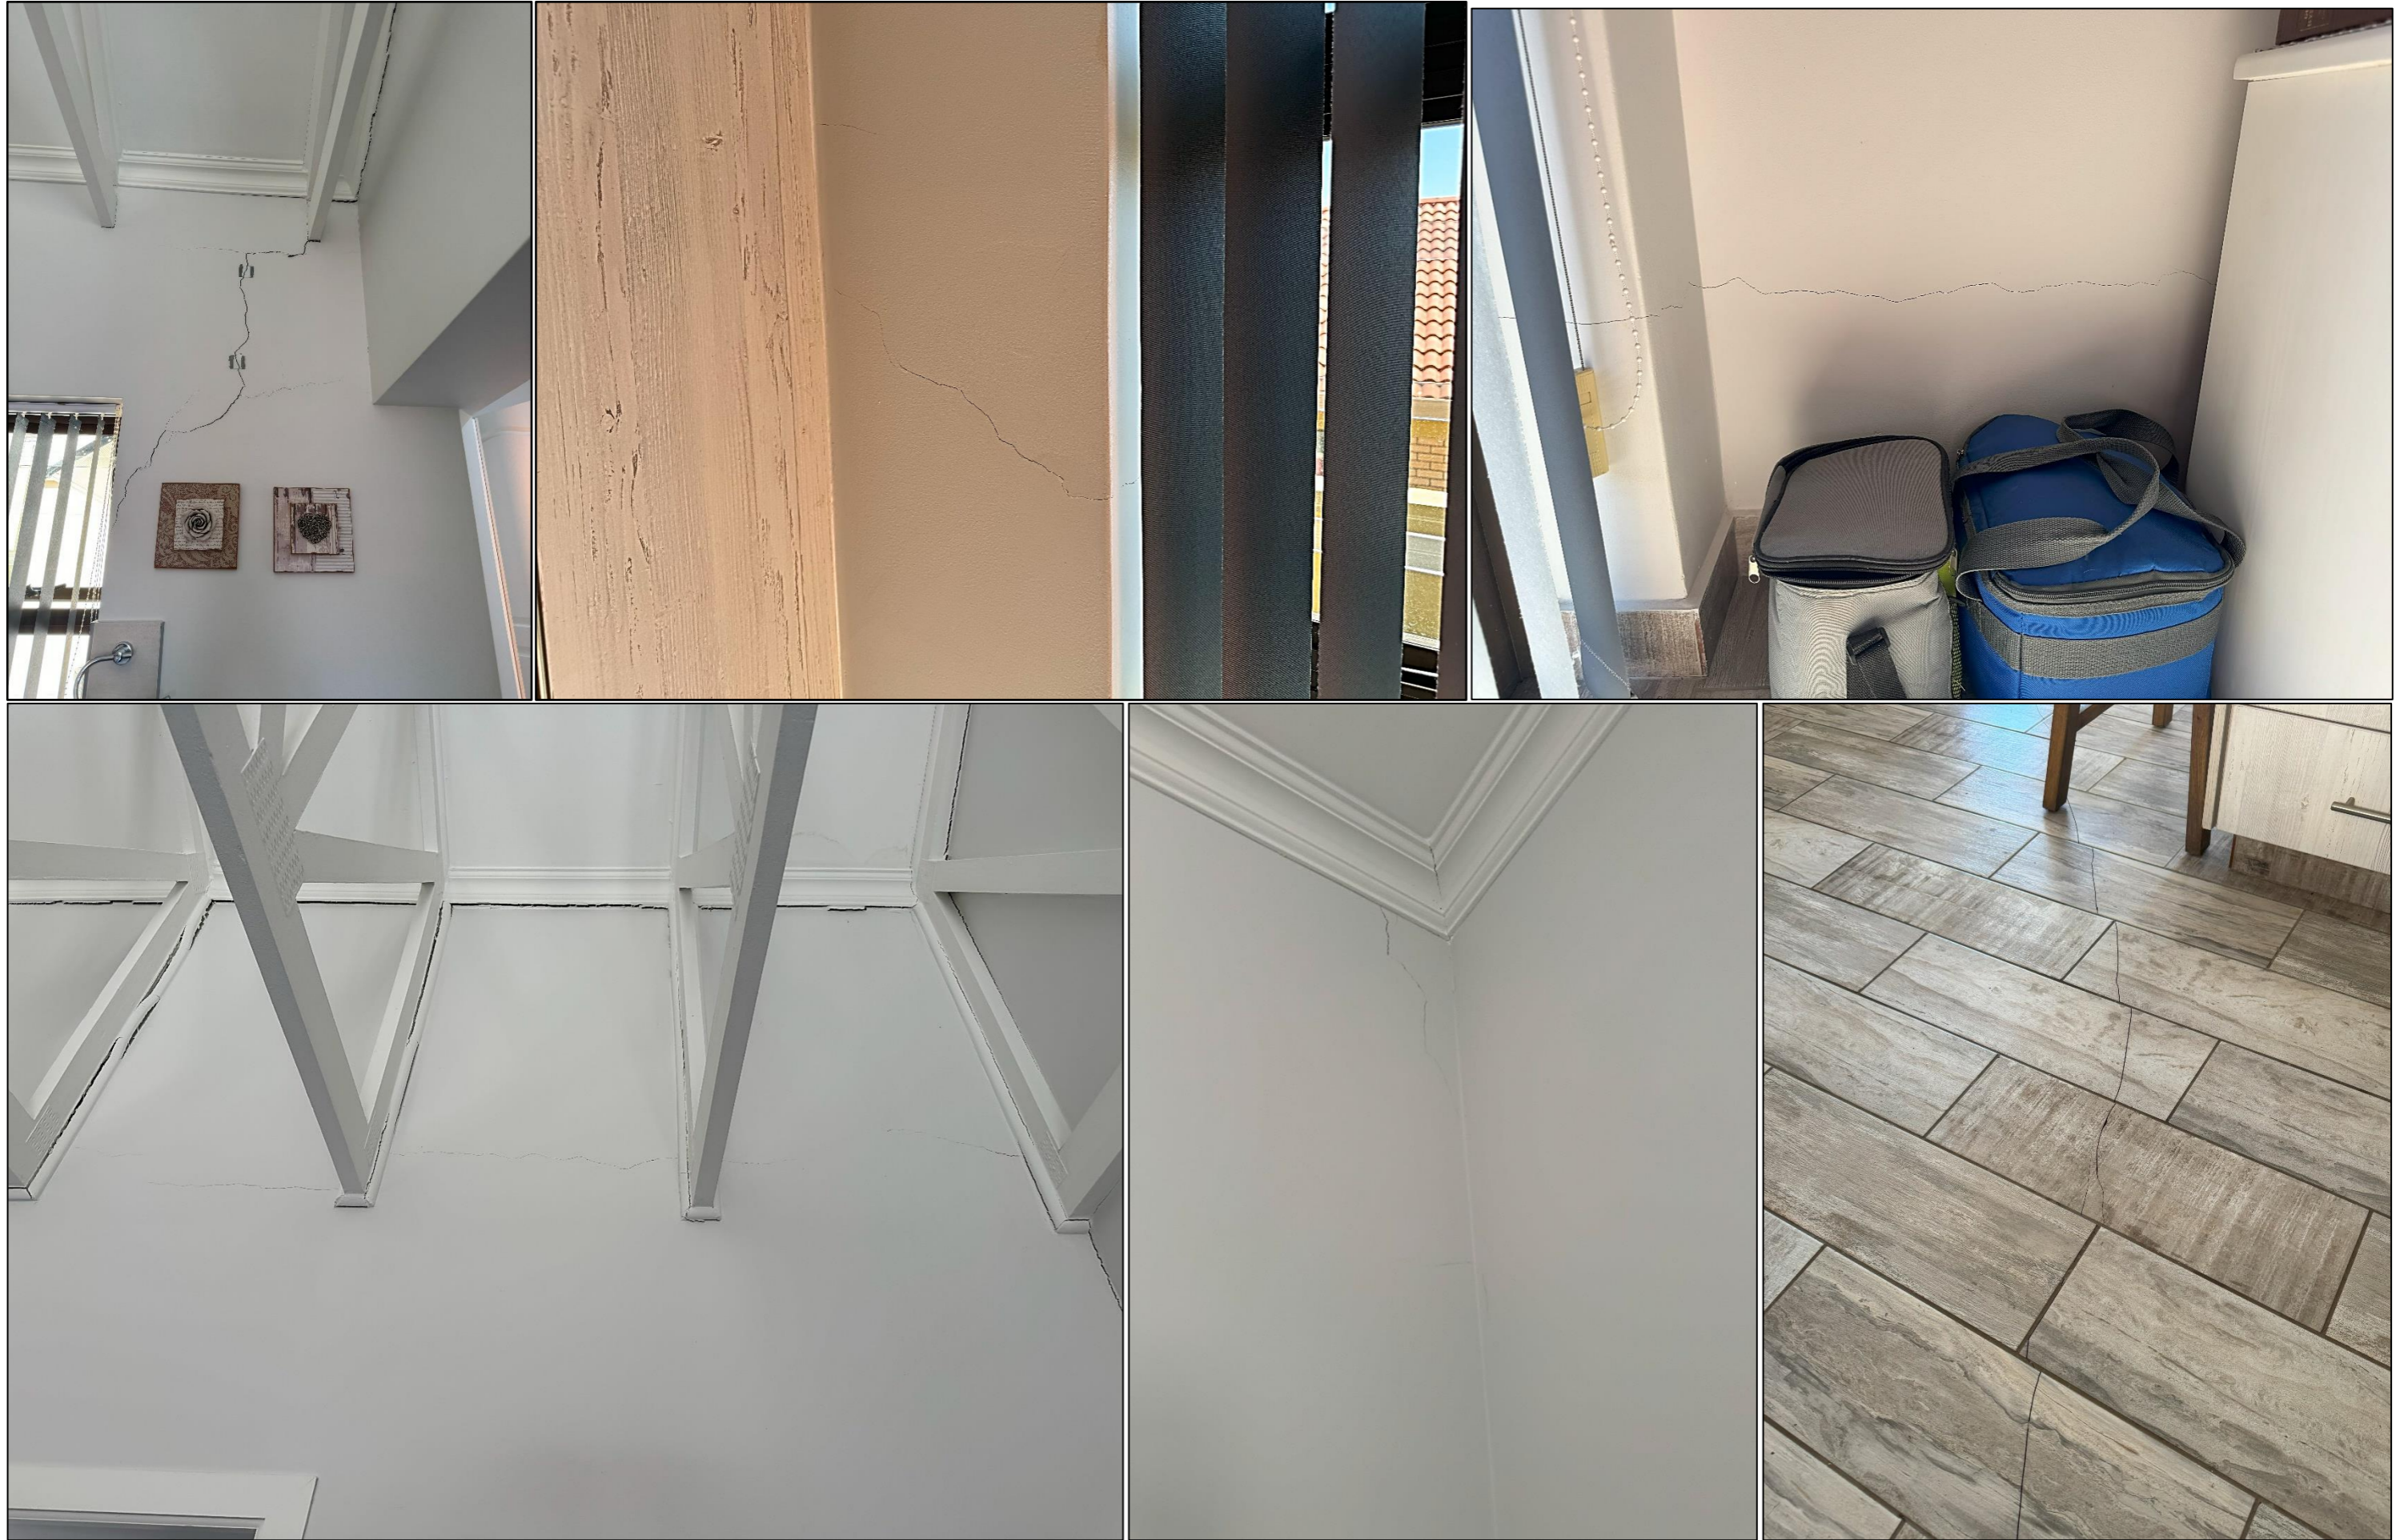
The house under assessment displayed structural distress (lateral and vertical movement) because of compression and ultimately differential settlement. Cracks were observed on the interior walls of the house extending from the ceiling, corners of the windows and doors, and on the floors and tiles inside the house as shown in Figure 9 below and on the exterior walls as shown below in Figure 10. It is worth noting that this site most likely experiencing compression that heave.

Figure 9: Showing the horizontal, diagonal, and vertical cracks on the interior walls of the investigated house.

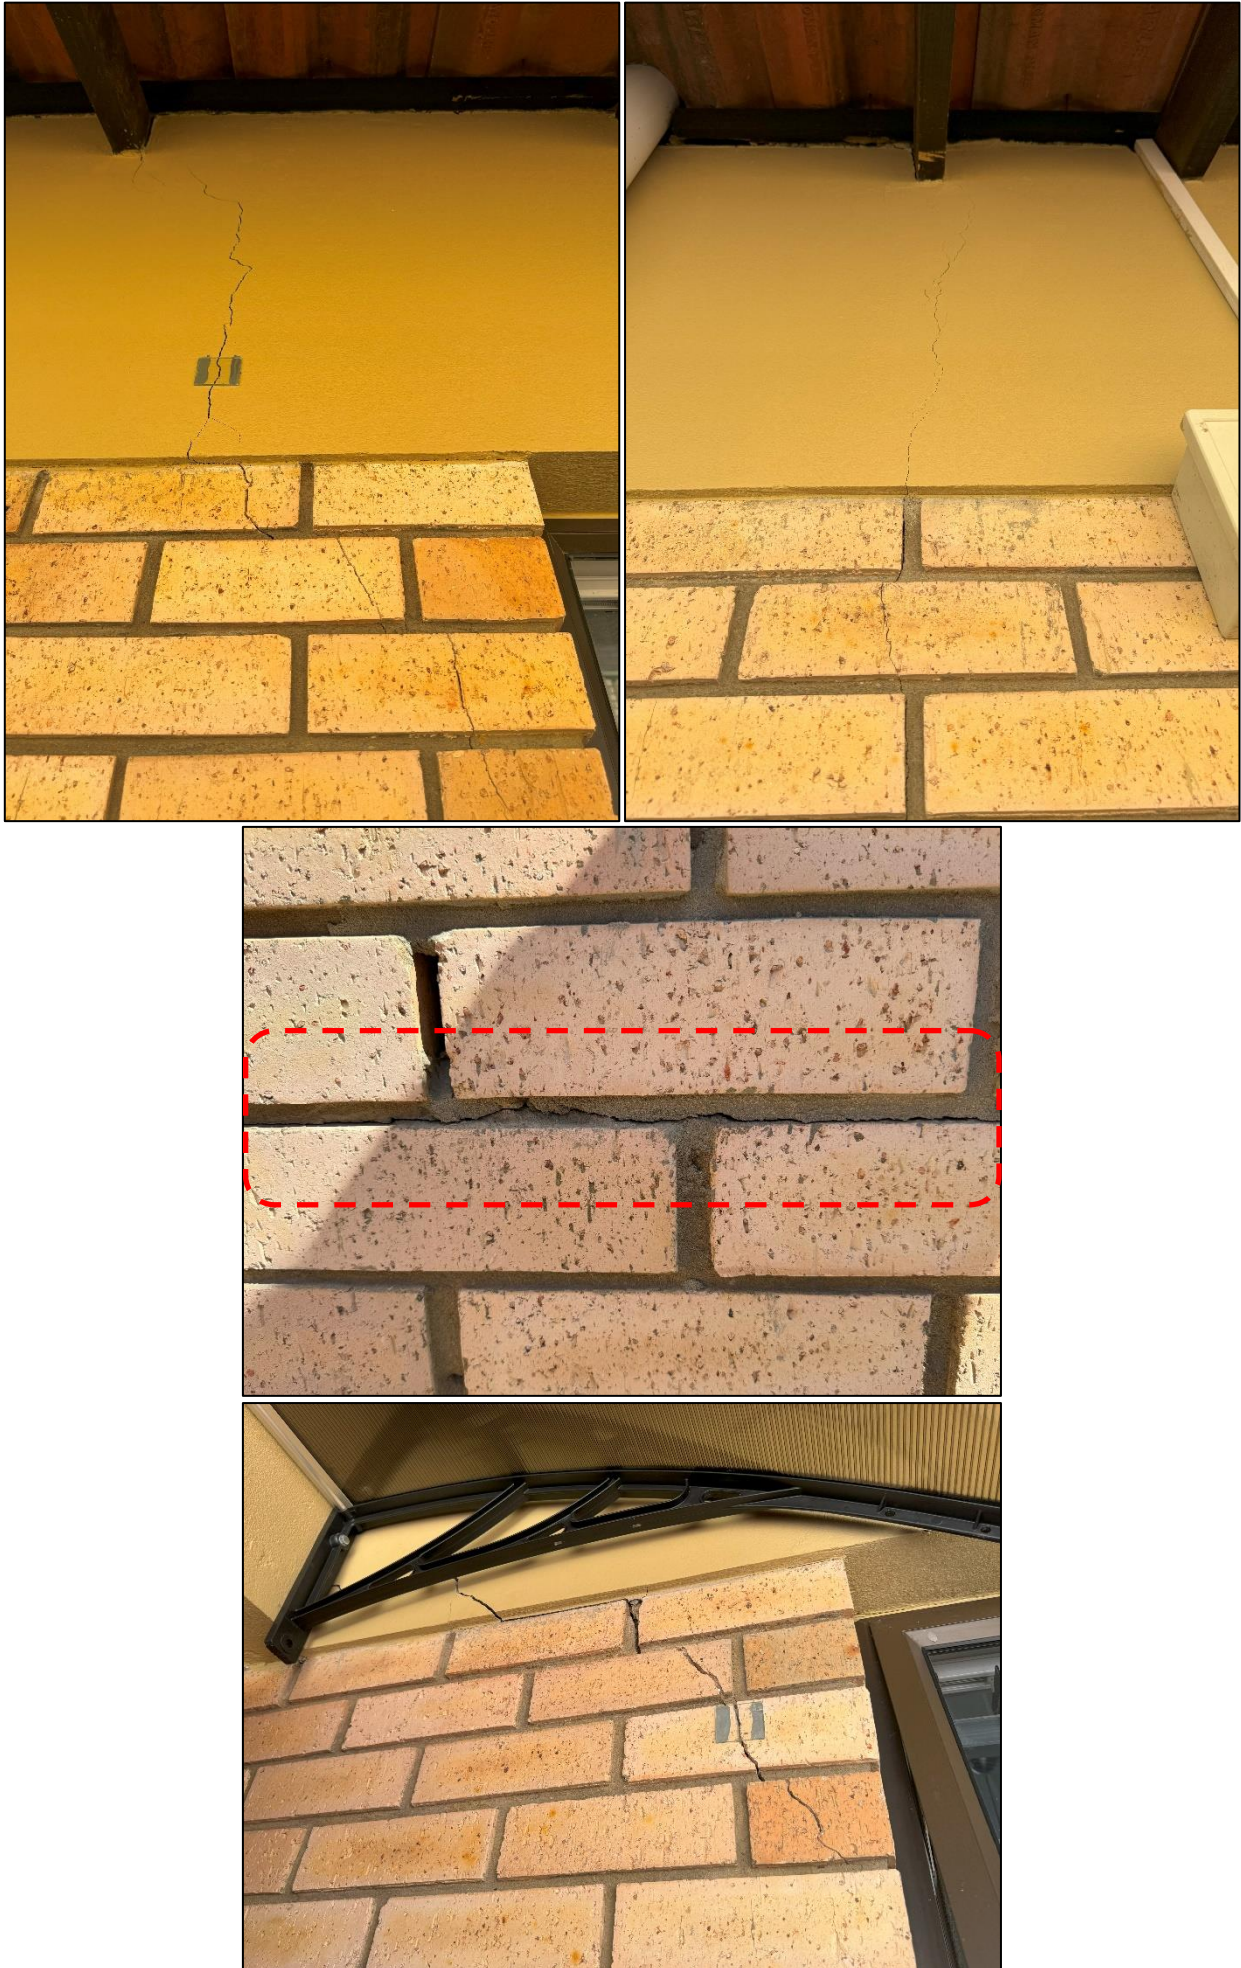
Figure 10: Showing the cracks on the exterior walls around the investigated house.

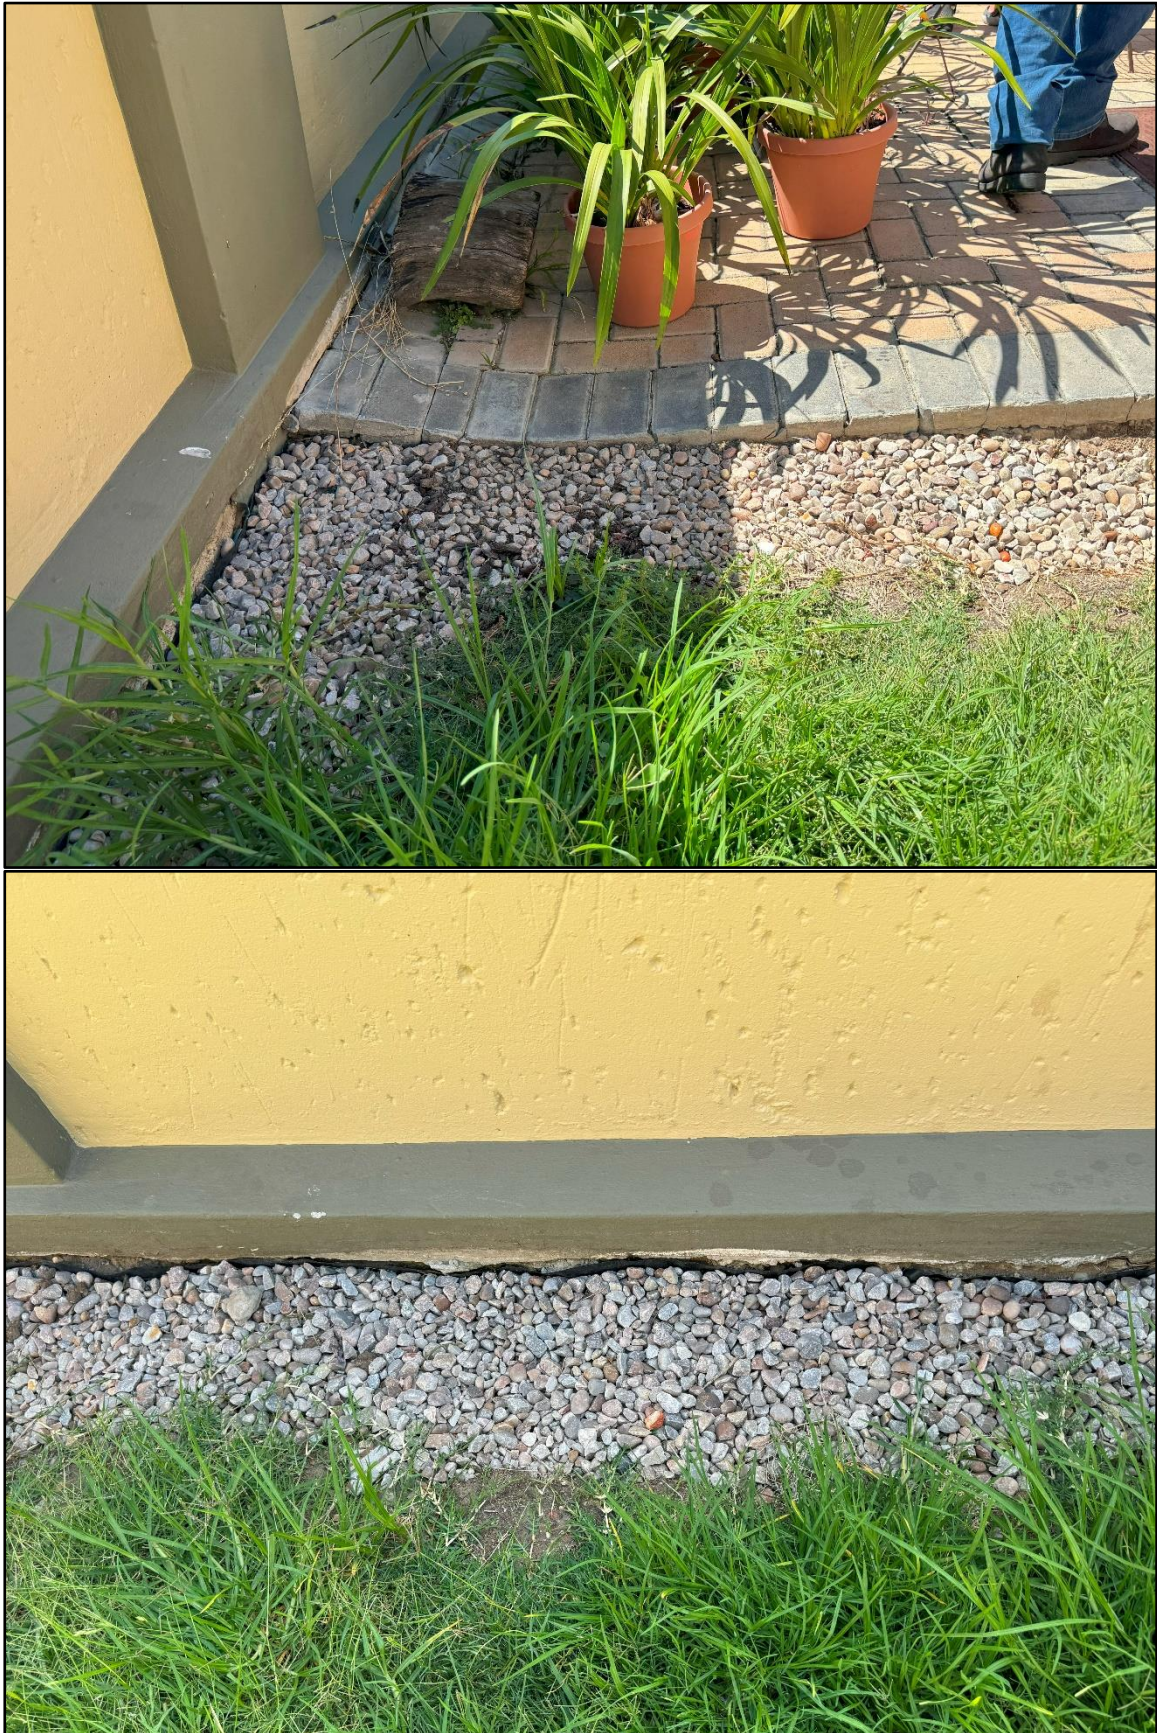
The garden area and paving on the northeast side of the house has settled and a depression of the pavement is seen as shown in Figure 11 below.

Figure 11: Showing the settlement in pavement and garden area.
