**STRUCTURAL ASSESSMENT AT HOUSE VAN DYK, 58 PRIDE OF INDIA
CRESENT IN WAVECREST OF JEFFREYS BAY**

**DETAILED FORENSIC REPORT:
STRUCTURAL ENGINEERING REV 2**

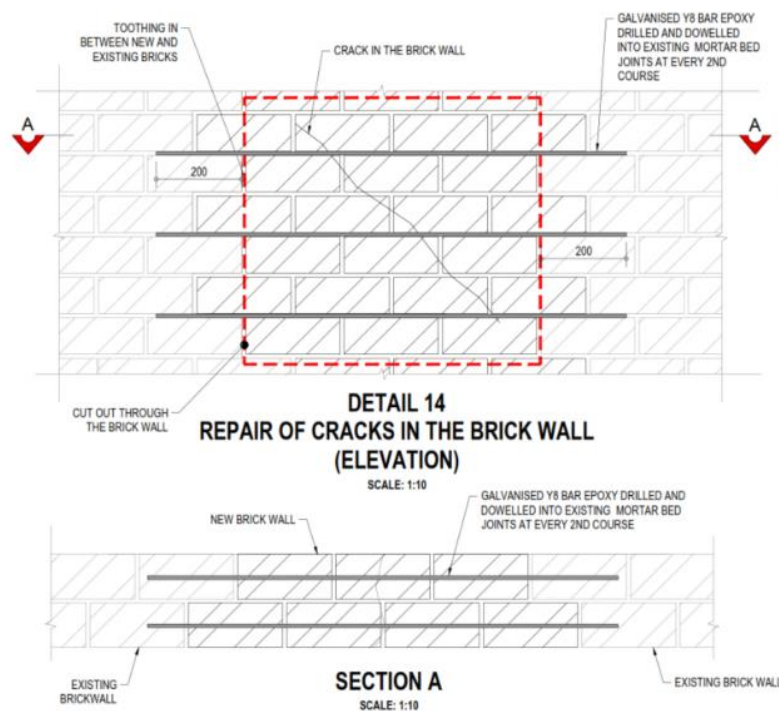
Figure 3: Typical crack repair

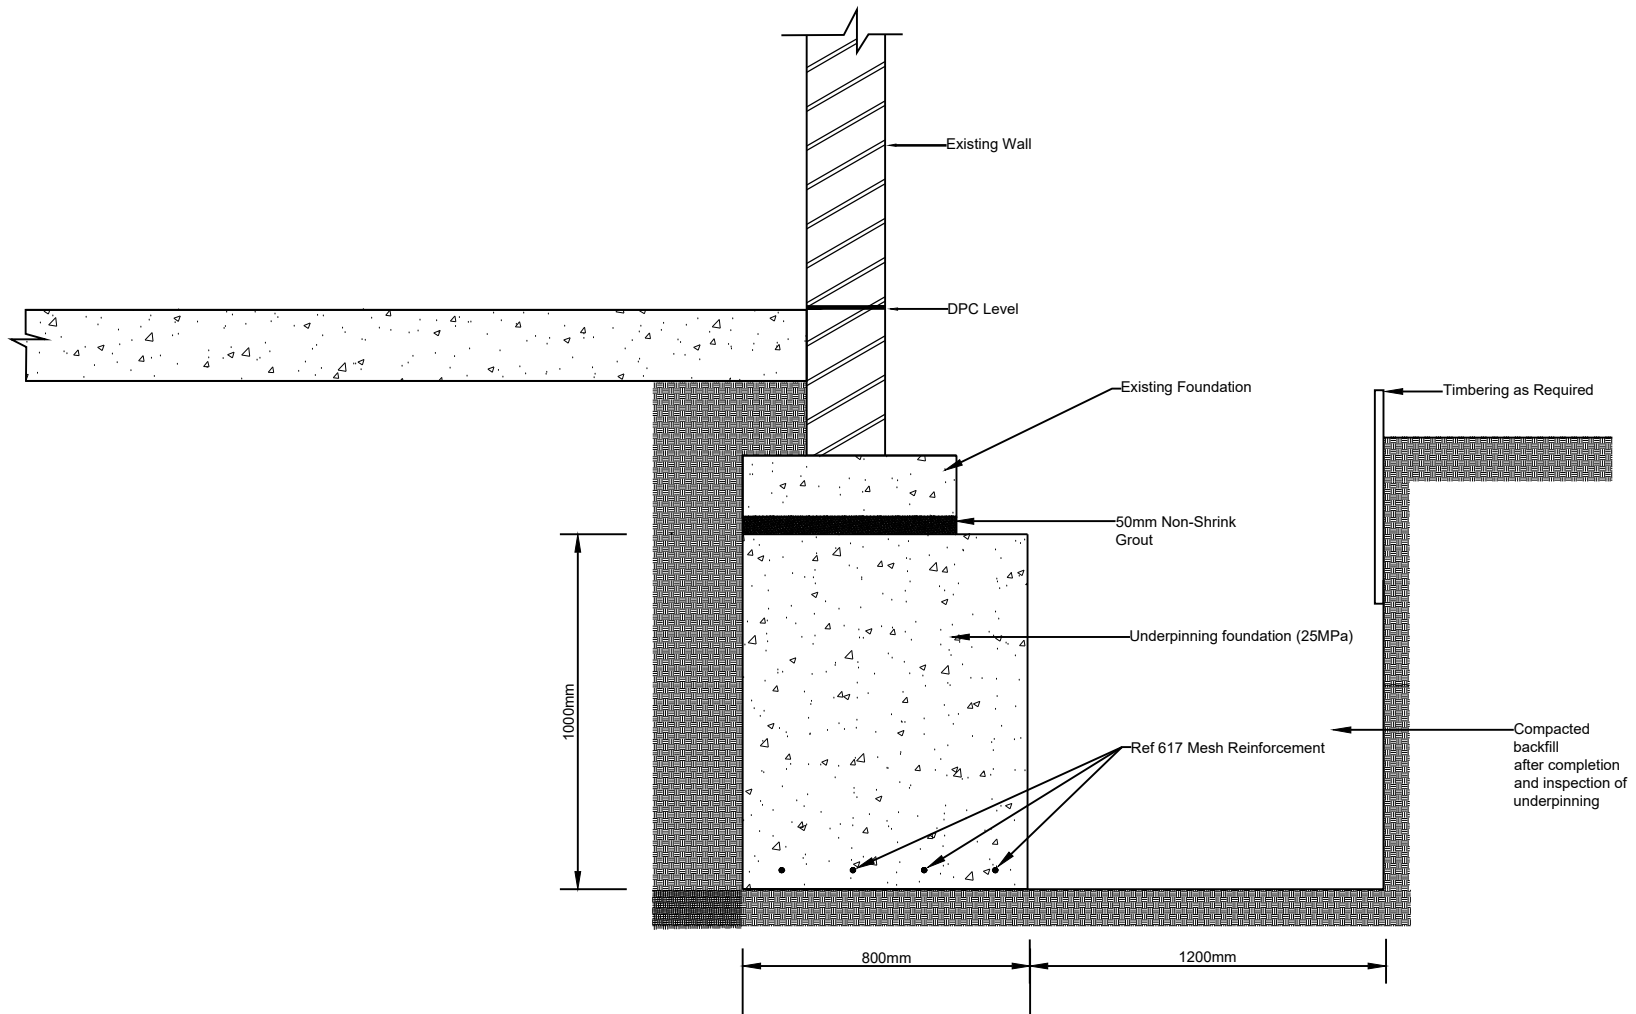
SECTION FOUNDATION UNDERPINNING (1.5m x 0.8m x 0.8m)

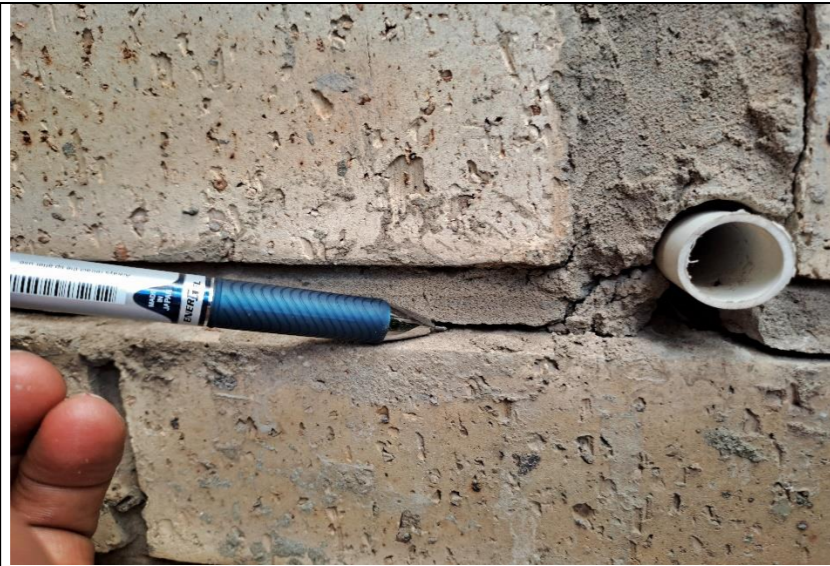
Photo 1: Horizontal crack at surface bed level

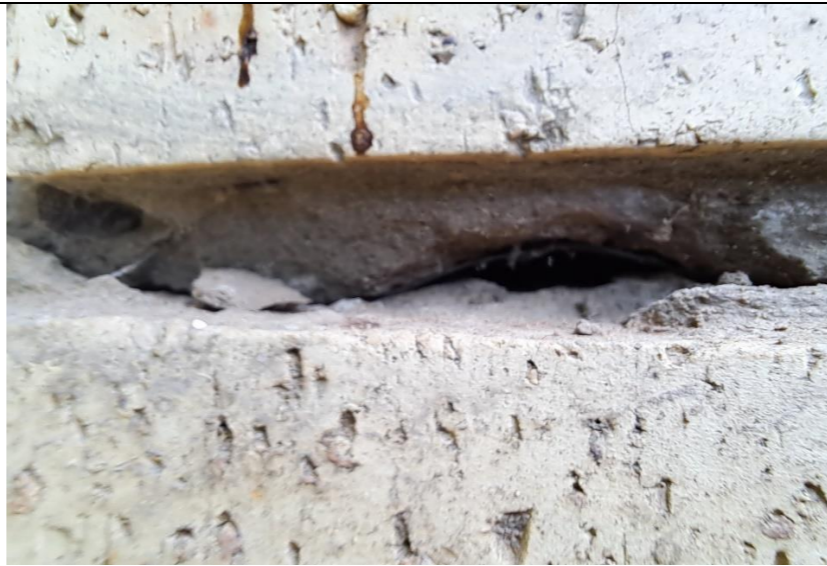
Photo 2: Bond mortar separation in-between the DPC and mortar course bed .

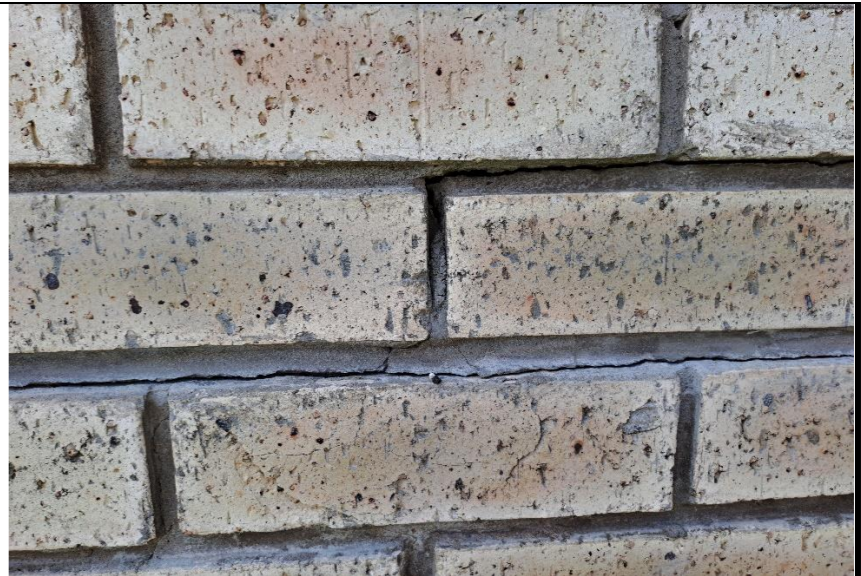
Photo 3: Horizontal crack at surface bed level

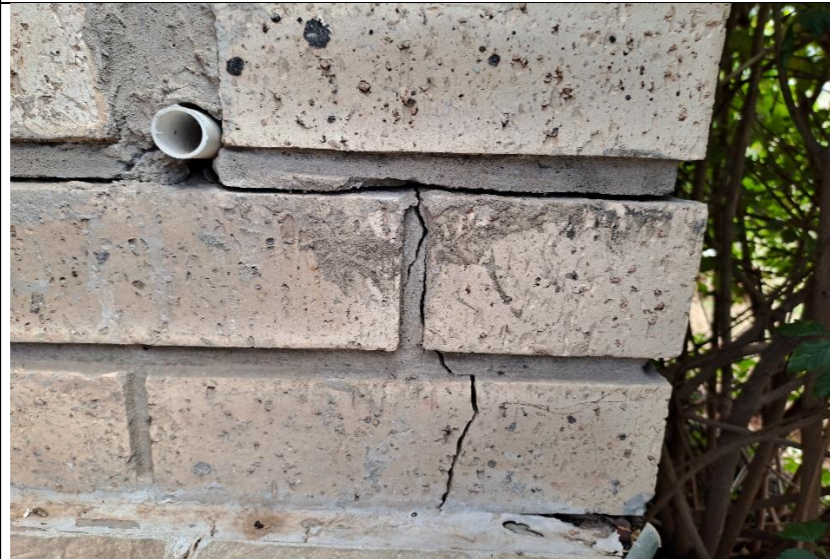
Photo 4: Horizontal crack at surface bed level .

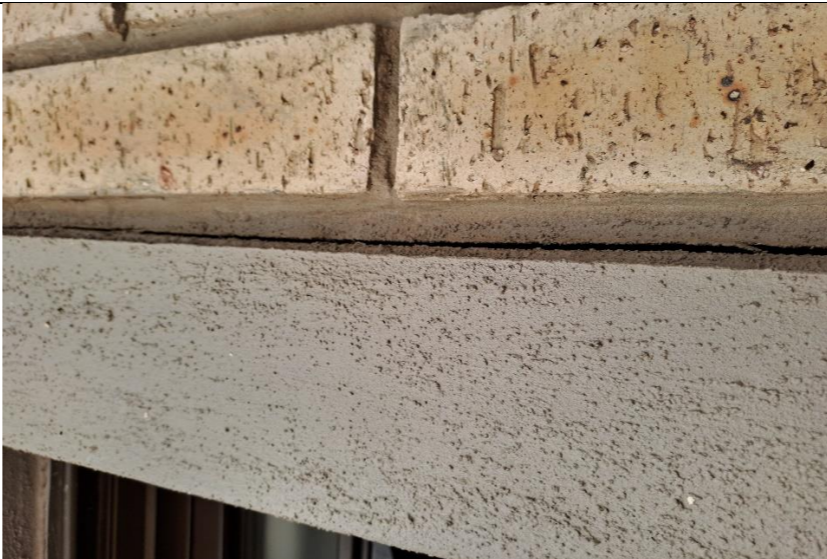
Photo 5: Horizontal crack above back entrance door.

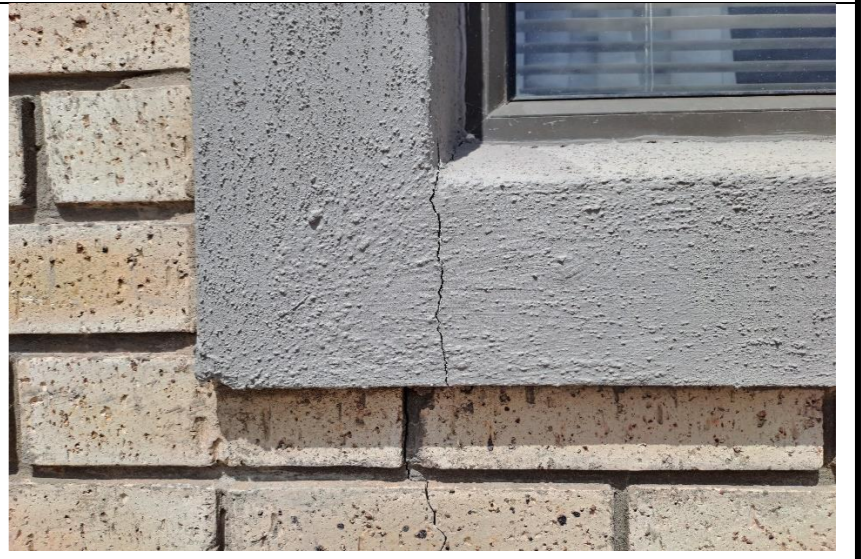
Photo 6: Crack on window seal

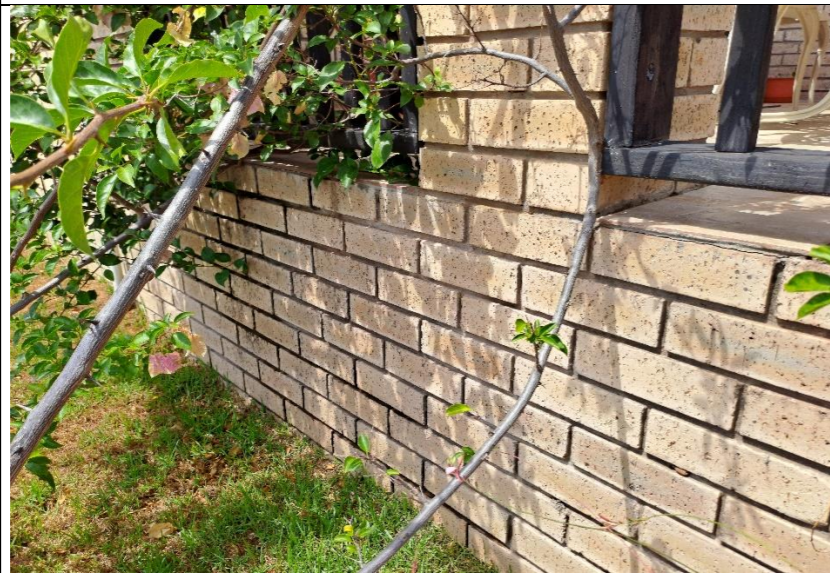
Photo 7: No aprons or stormwater around the building.

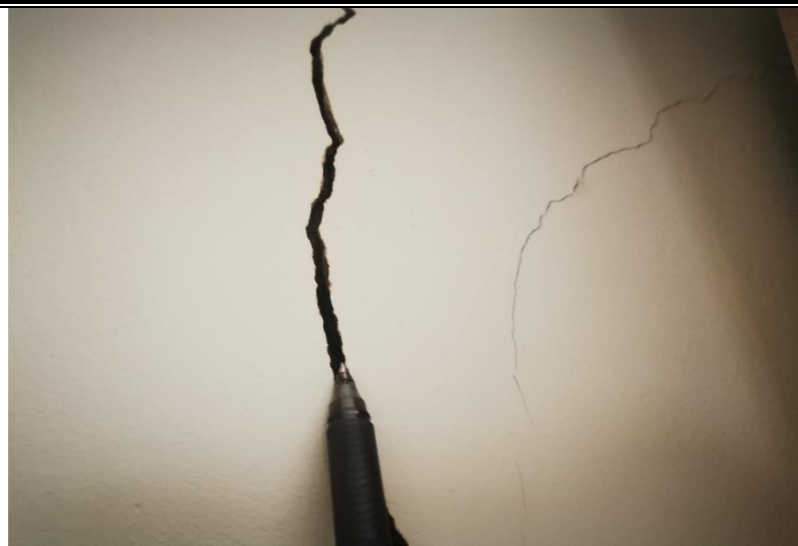
Photo 10: Major vertical-diagonal crack on the internal bedroom wall.

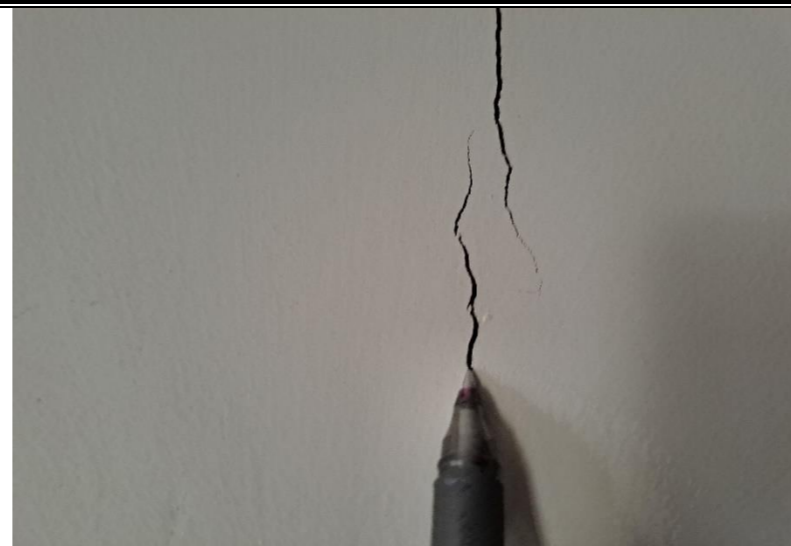
Photo 11: Vertical crack on internal wall.

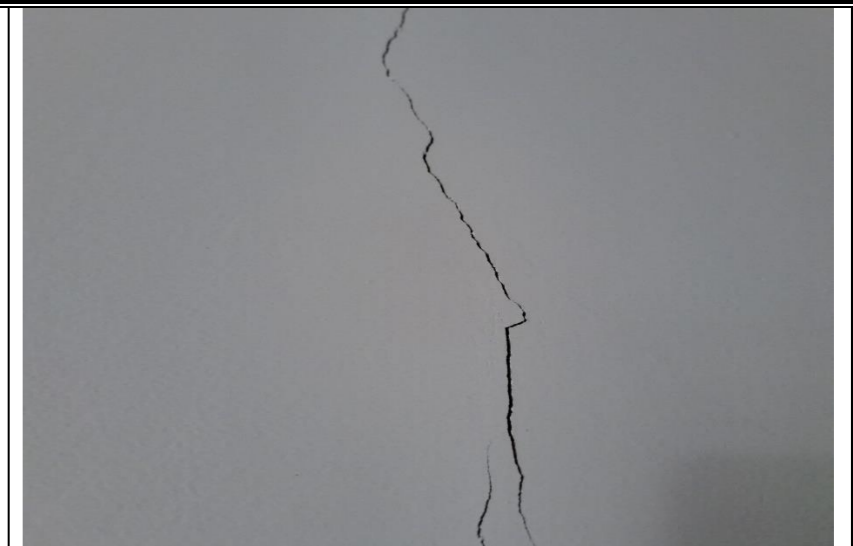
Photo 12: Vertical crack on internal wall.

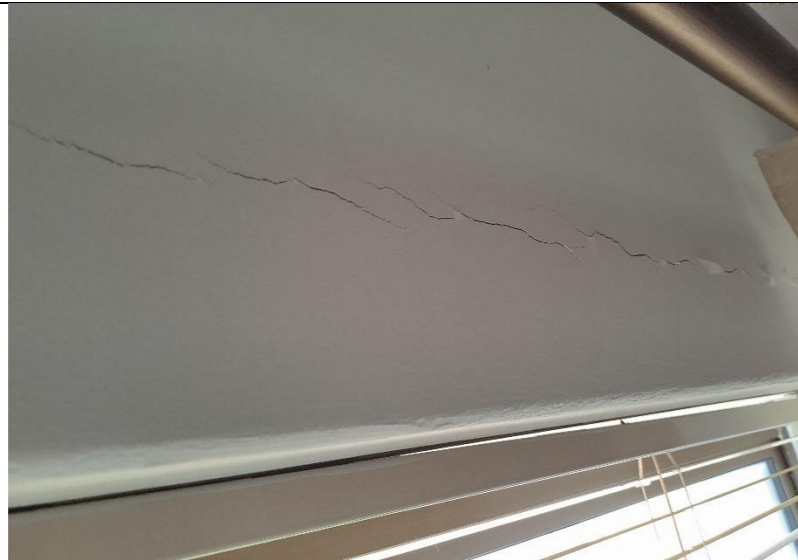
Photo 13: Horizontal crack above window.

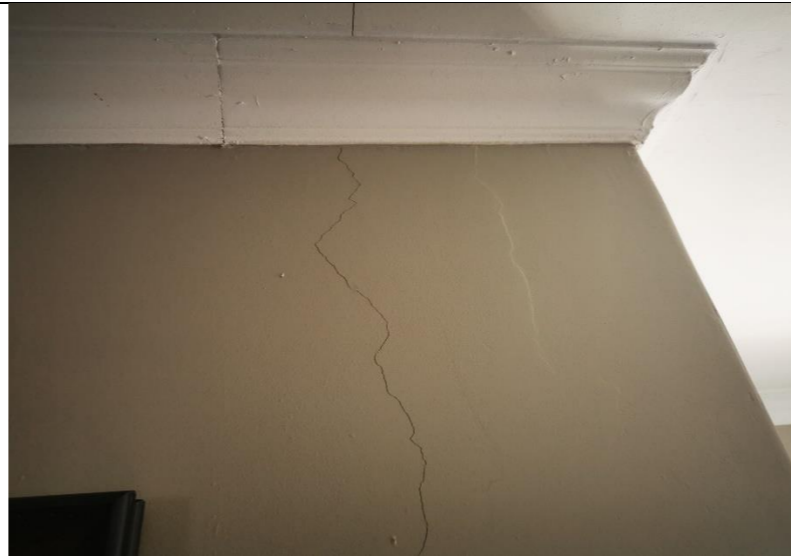
Photo 14: Vertical crack on internal wall.

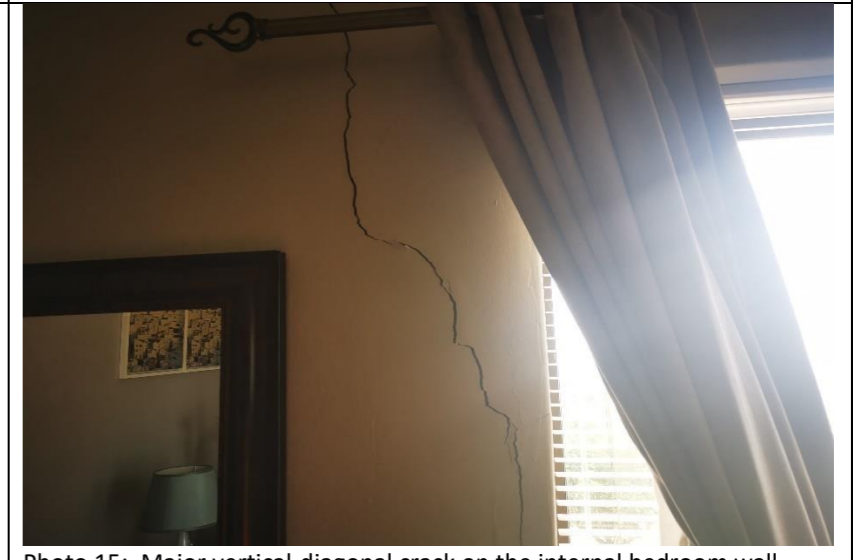
Photo 15: Major vertical-diagonal crack on the internal bedroom wall.

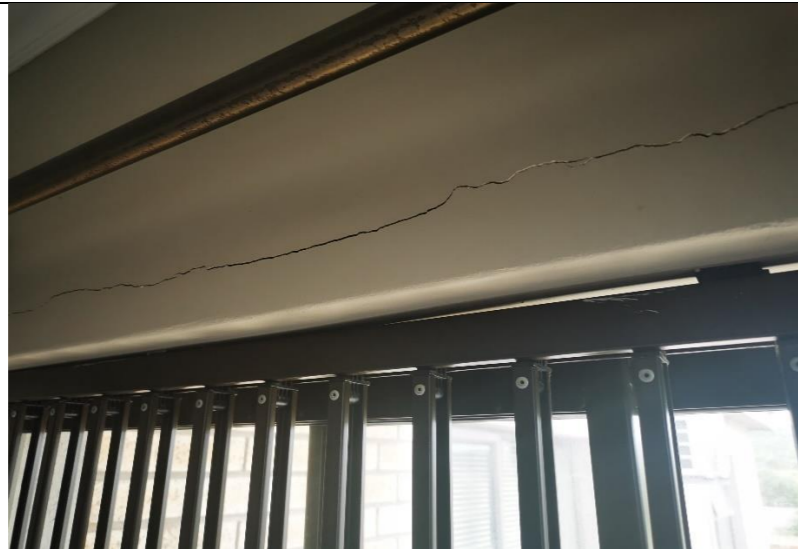
Photo 16: Horizontal crack above window.

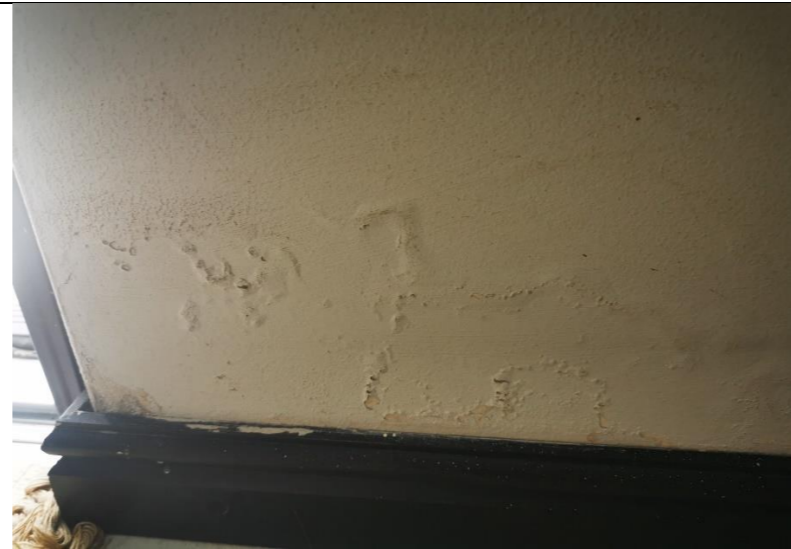
Photo 17: Dampness on internal brick wall.

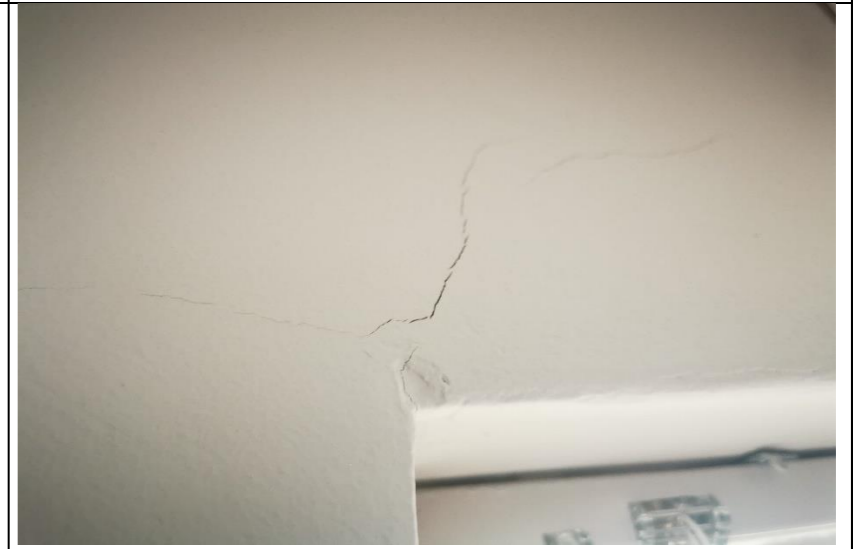
Photo 18: Diagonal crack on the internal bedroom wall above window.

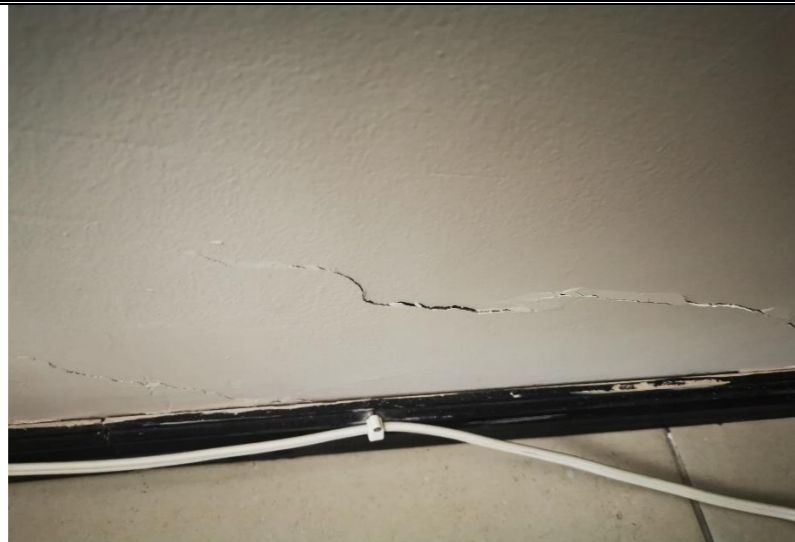
Photo 1: Vertical crack on internal wall.

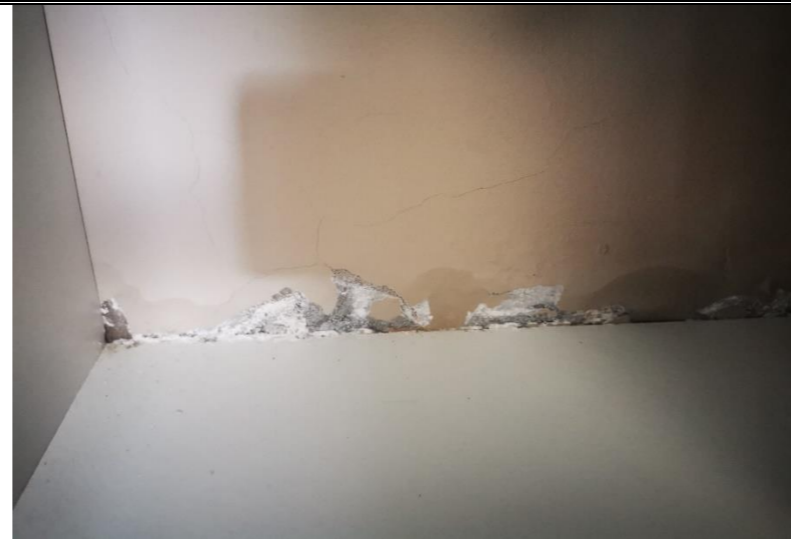
Photo 2: Dampness on internal brick wall.

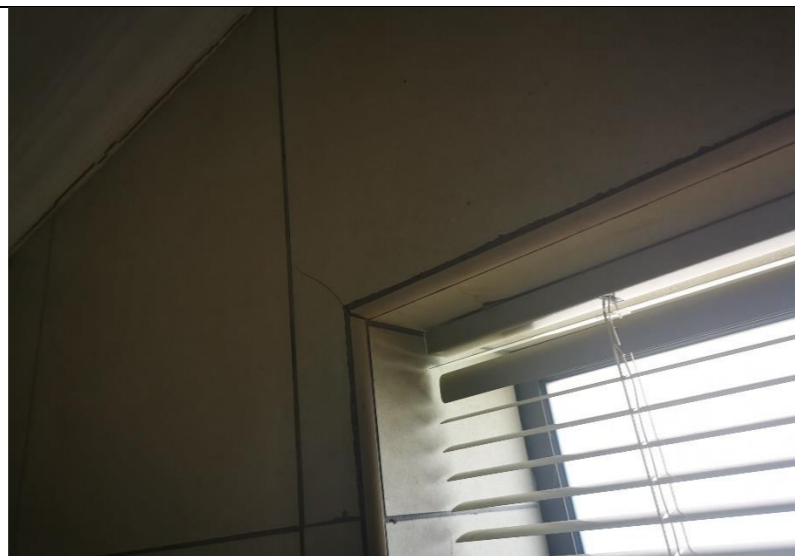
Photo 4: Diagonal crack on the internal bedroom wall above window.

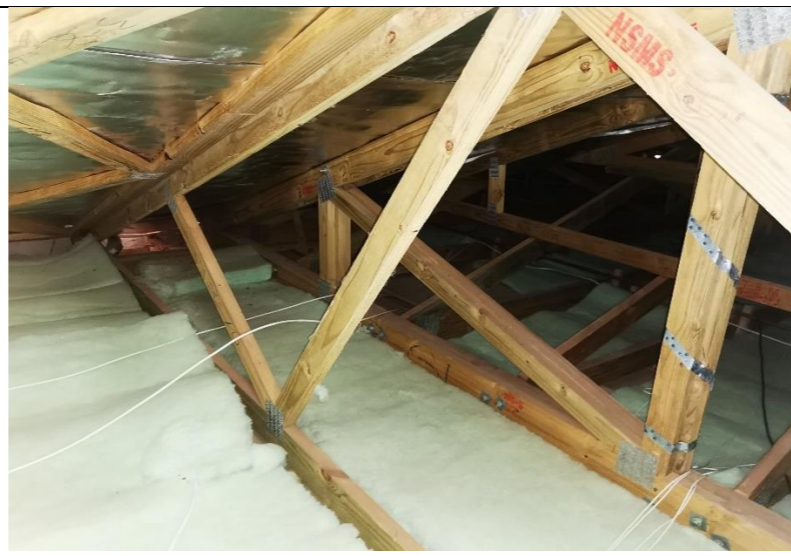
Photo 5: Timber roof trusses

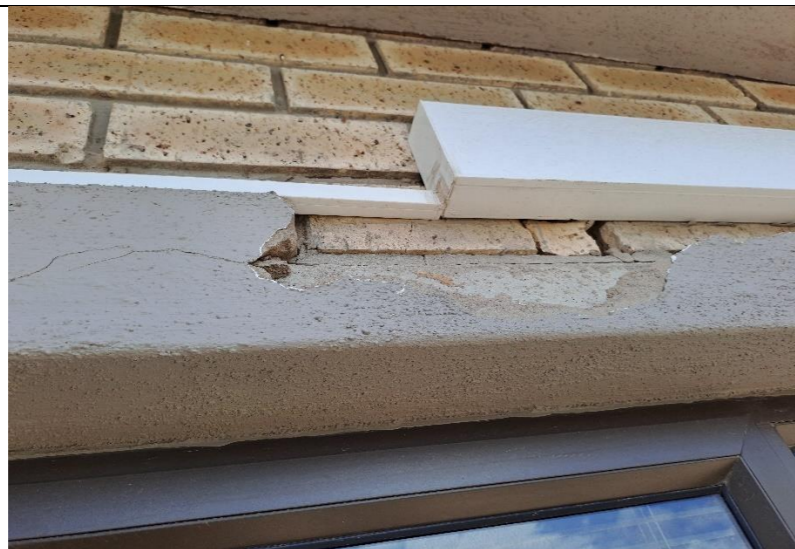
Photo 7: Cracks on external brick wall above window.

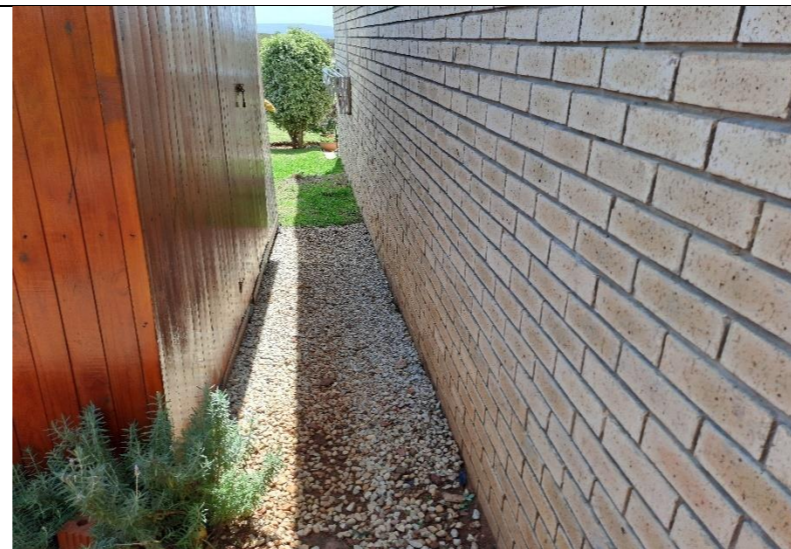
Photo 8: No aprons or stormwater around the building.

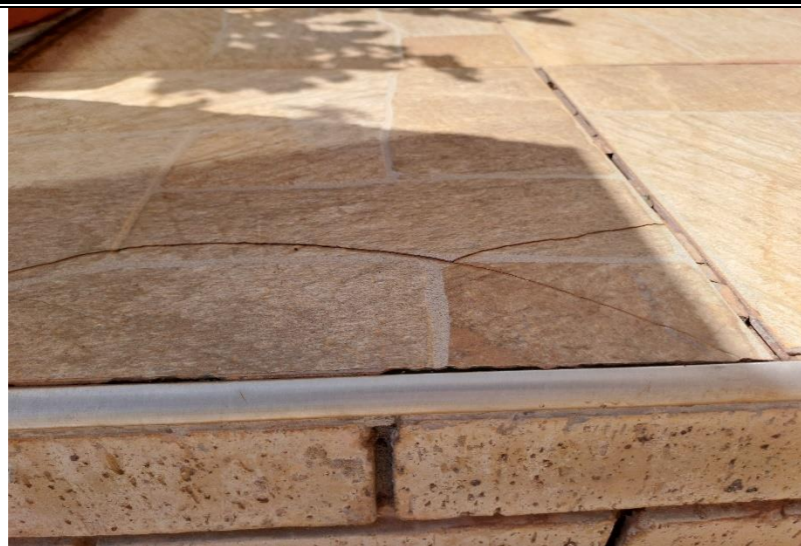
Photo 1: Cracks on floor tiles.

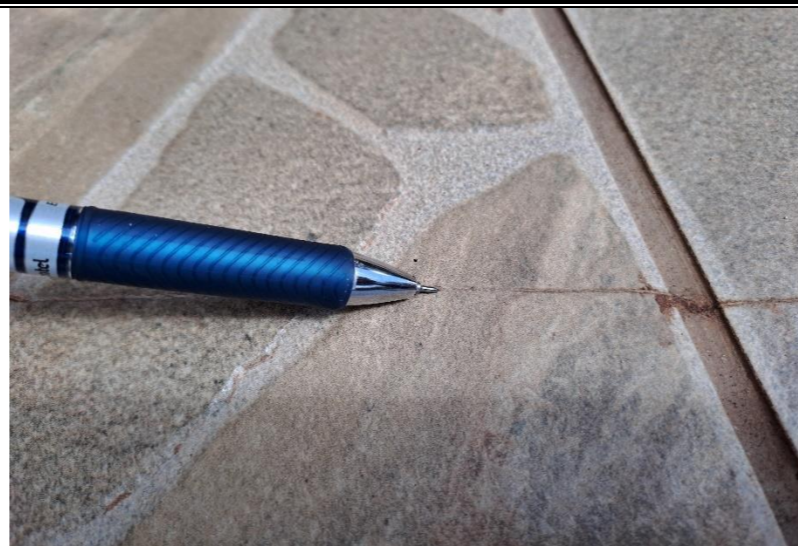
Photo 2: Cracks on floor tiles.

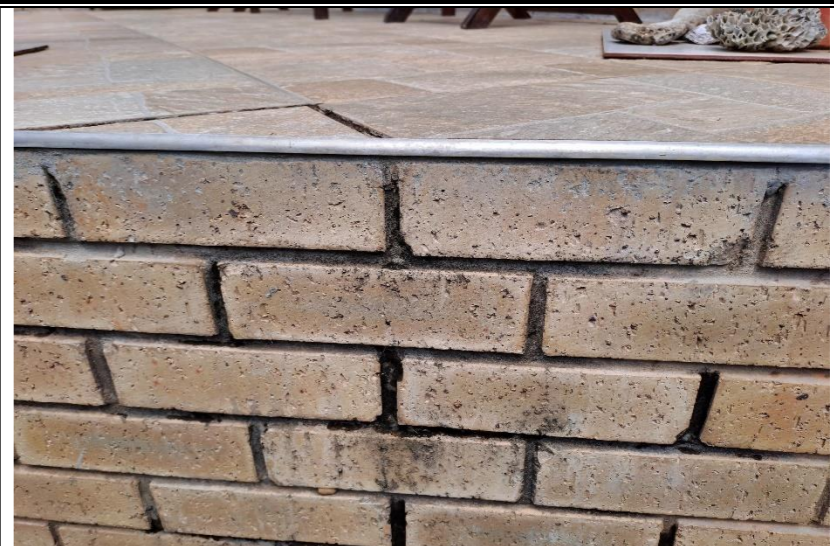
Photo 3: Algae and moulds has developed on the surface of the brick walls.

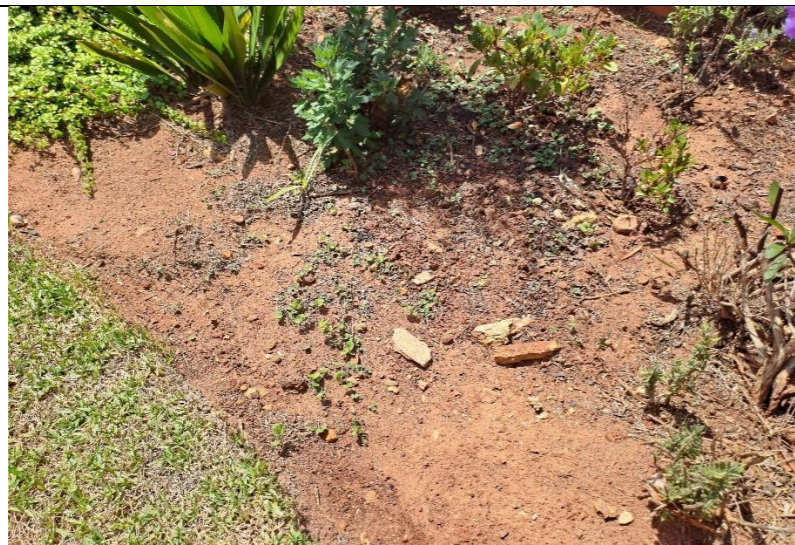
Photo 7: Typical site soil material. It appears the founding material has clay content.

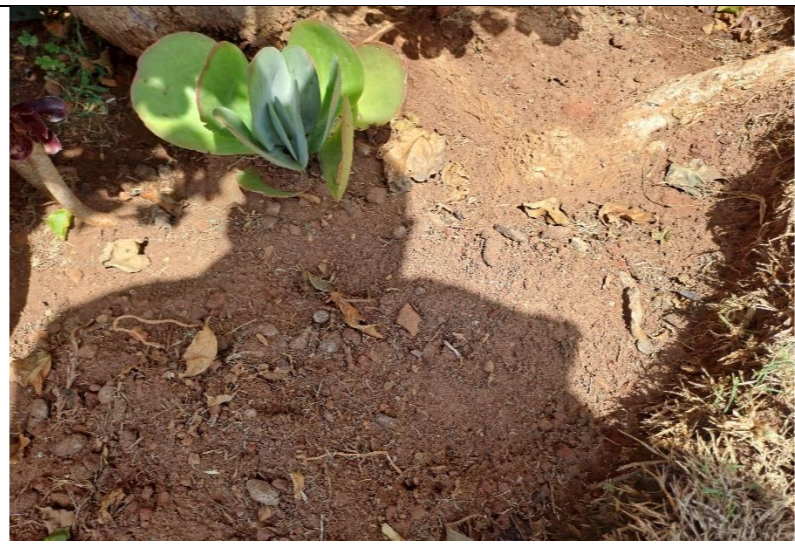
Photo 8: Typical site soil material. It appears the founding material has clay content.

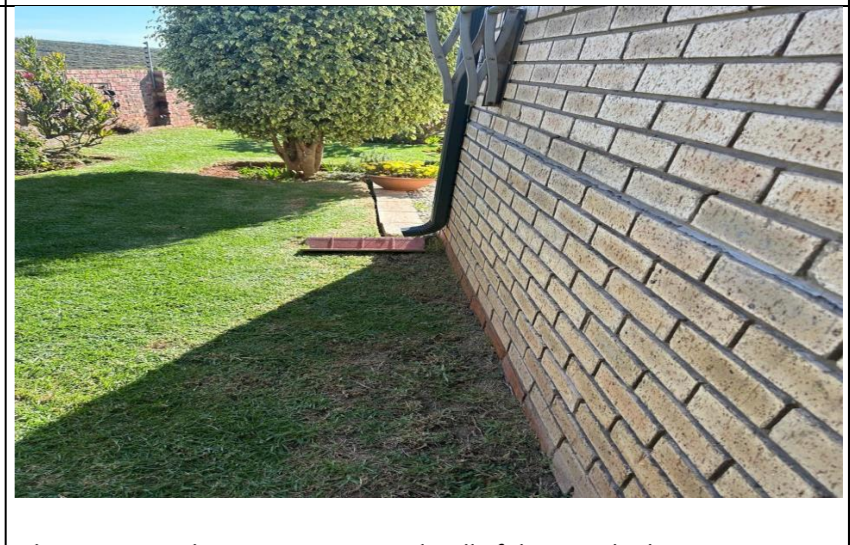
Photo 9: Lateral Movement. External wall of the main bedroom

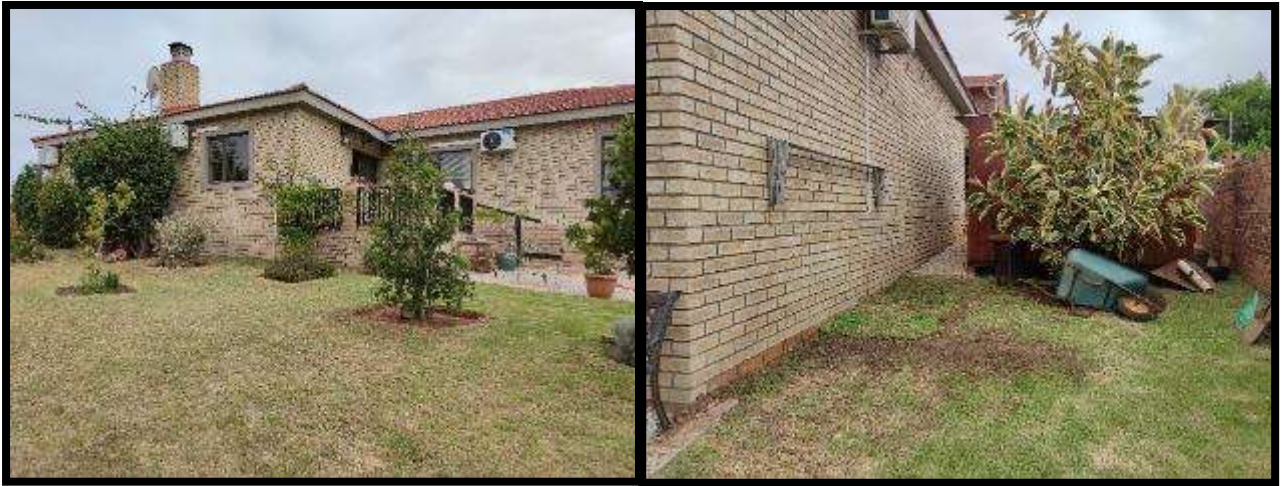
Figure 5: Showing the absence of a concrete apron on the north and the portion on the west side of the investigated house.

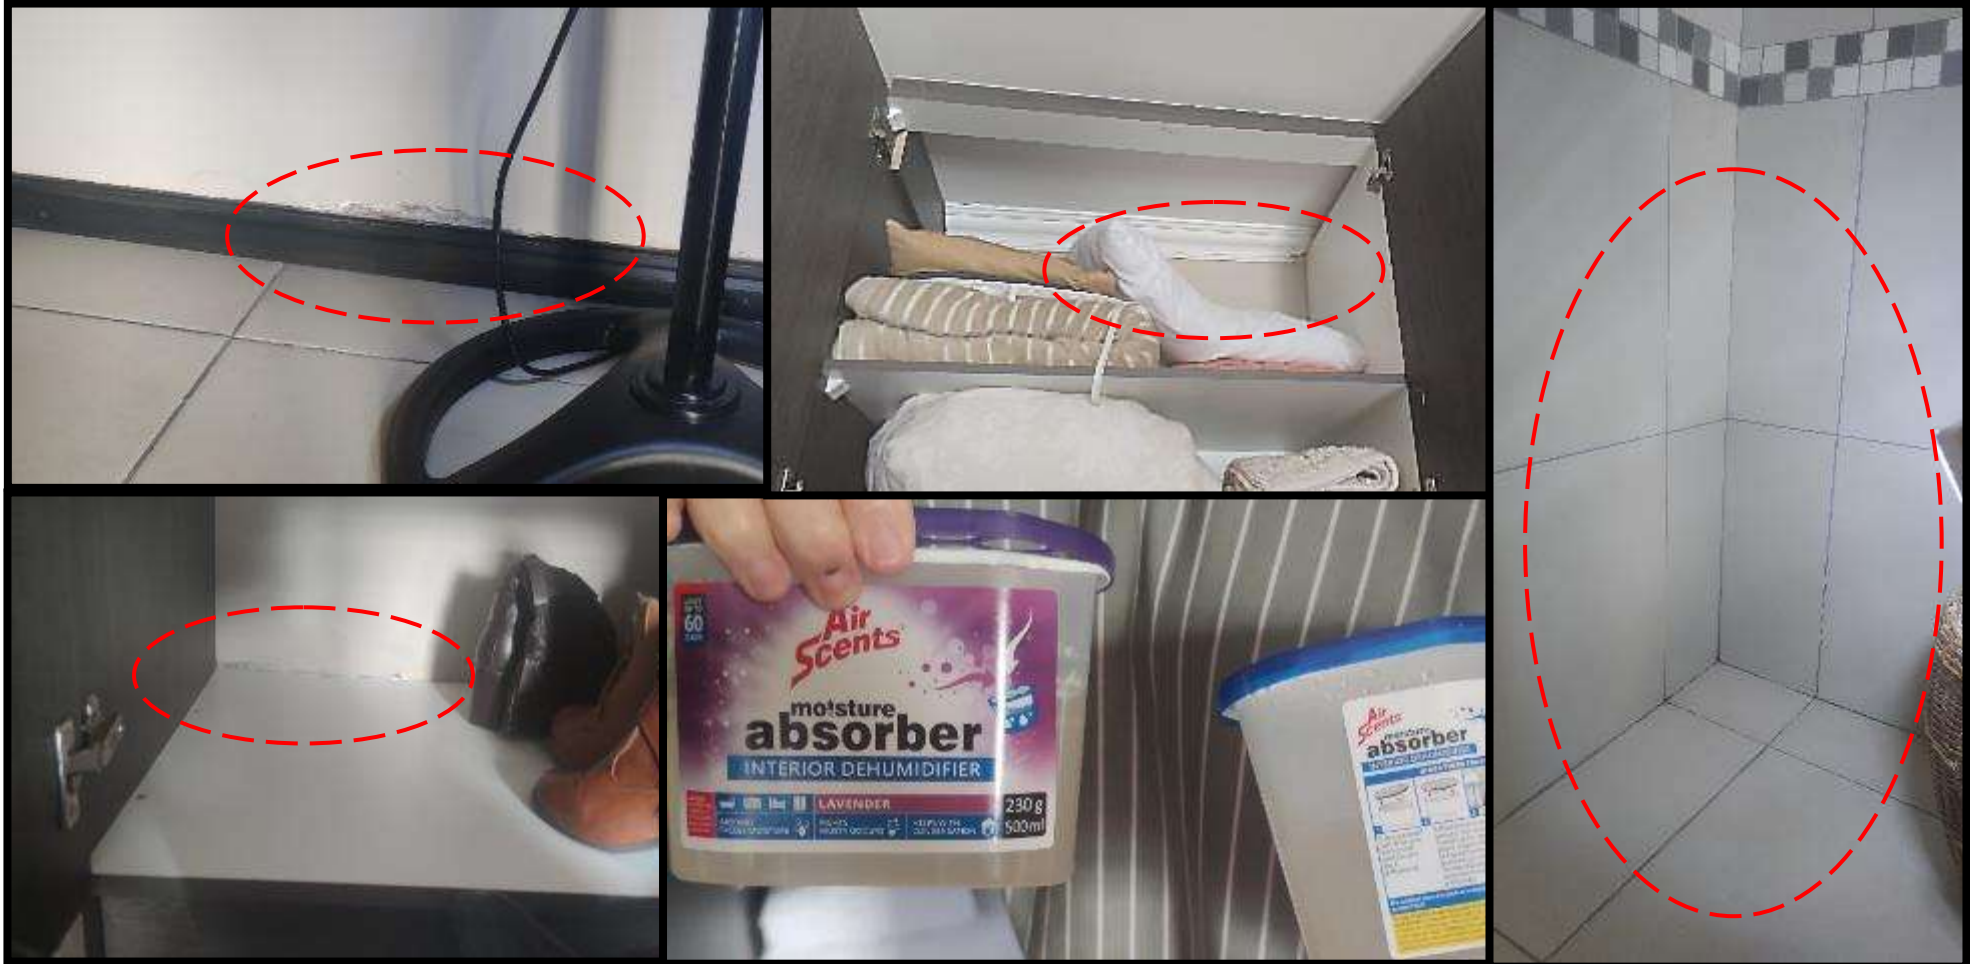
Figure 6: Showing the water damage on the bedroom walls, wardrobe and damp bathroom walls.

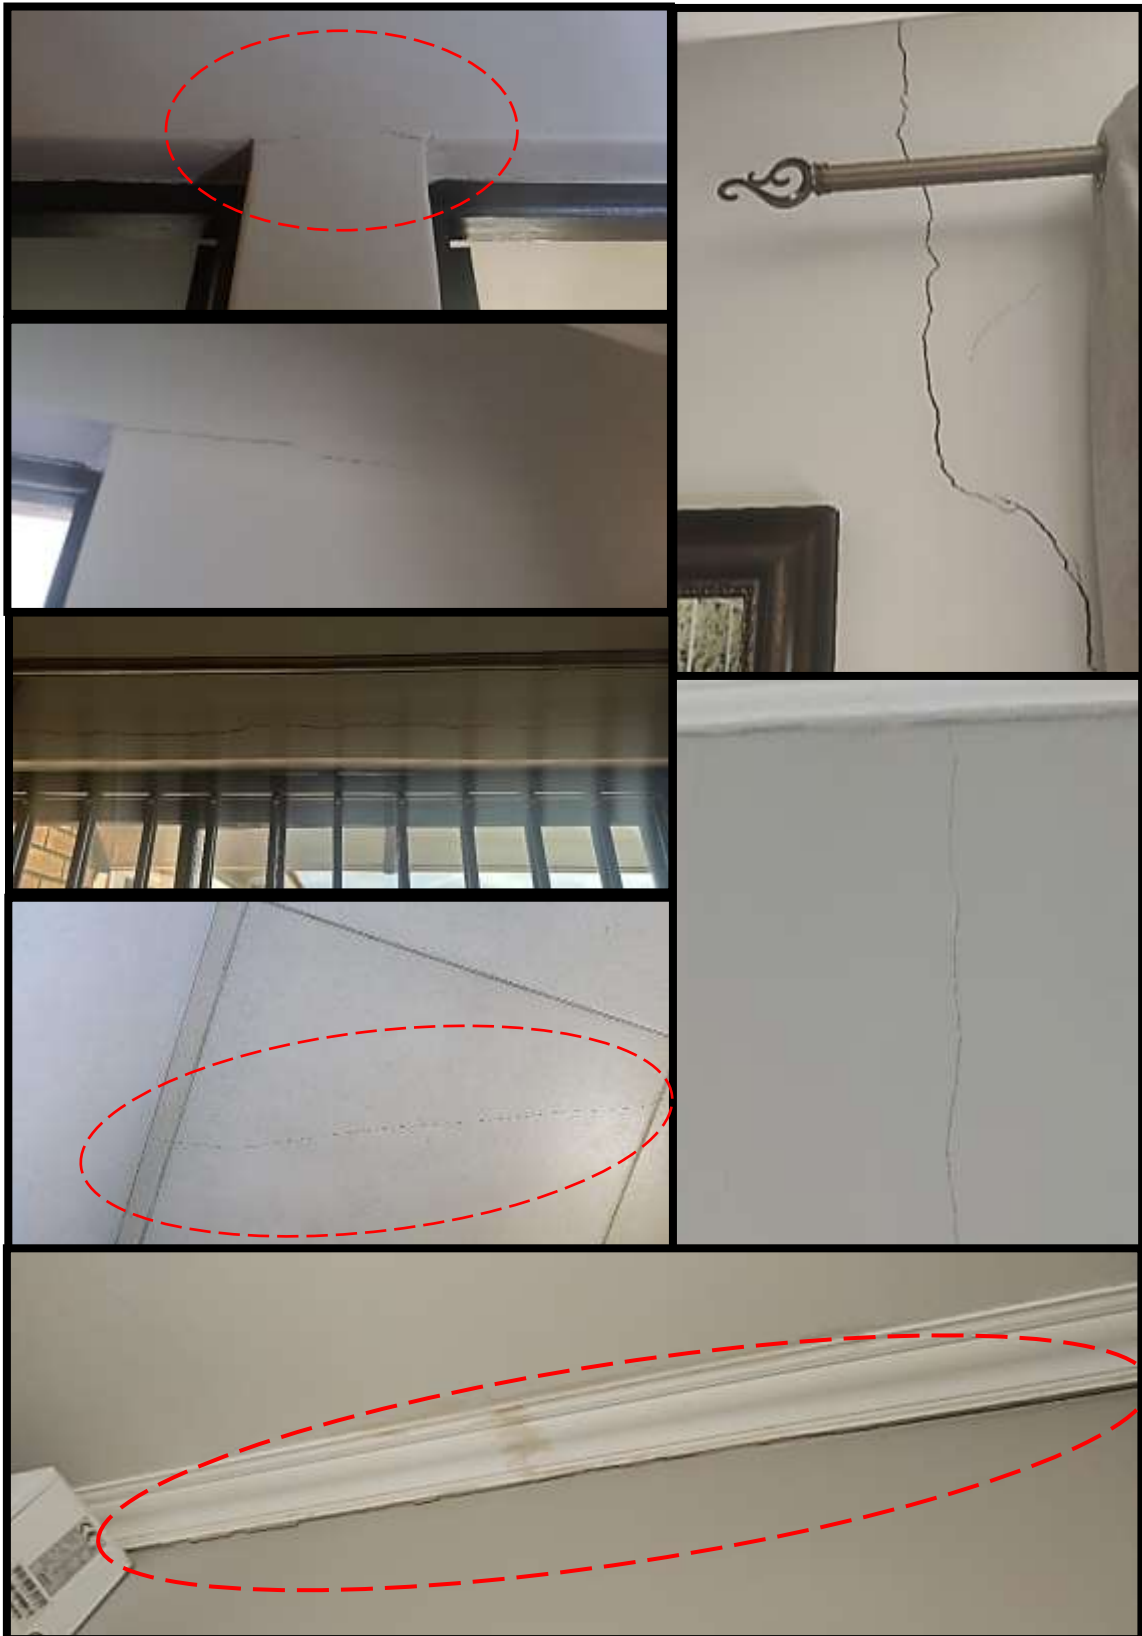
Figure 7: Showing the horizontal, vertical and diagonal cracks on the interior walls, floor and ceiling skirt around the investigated house.

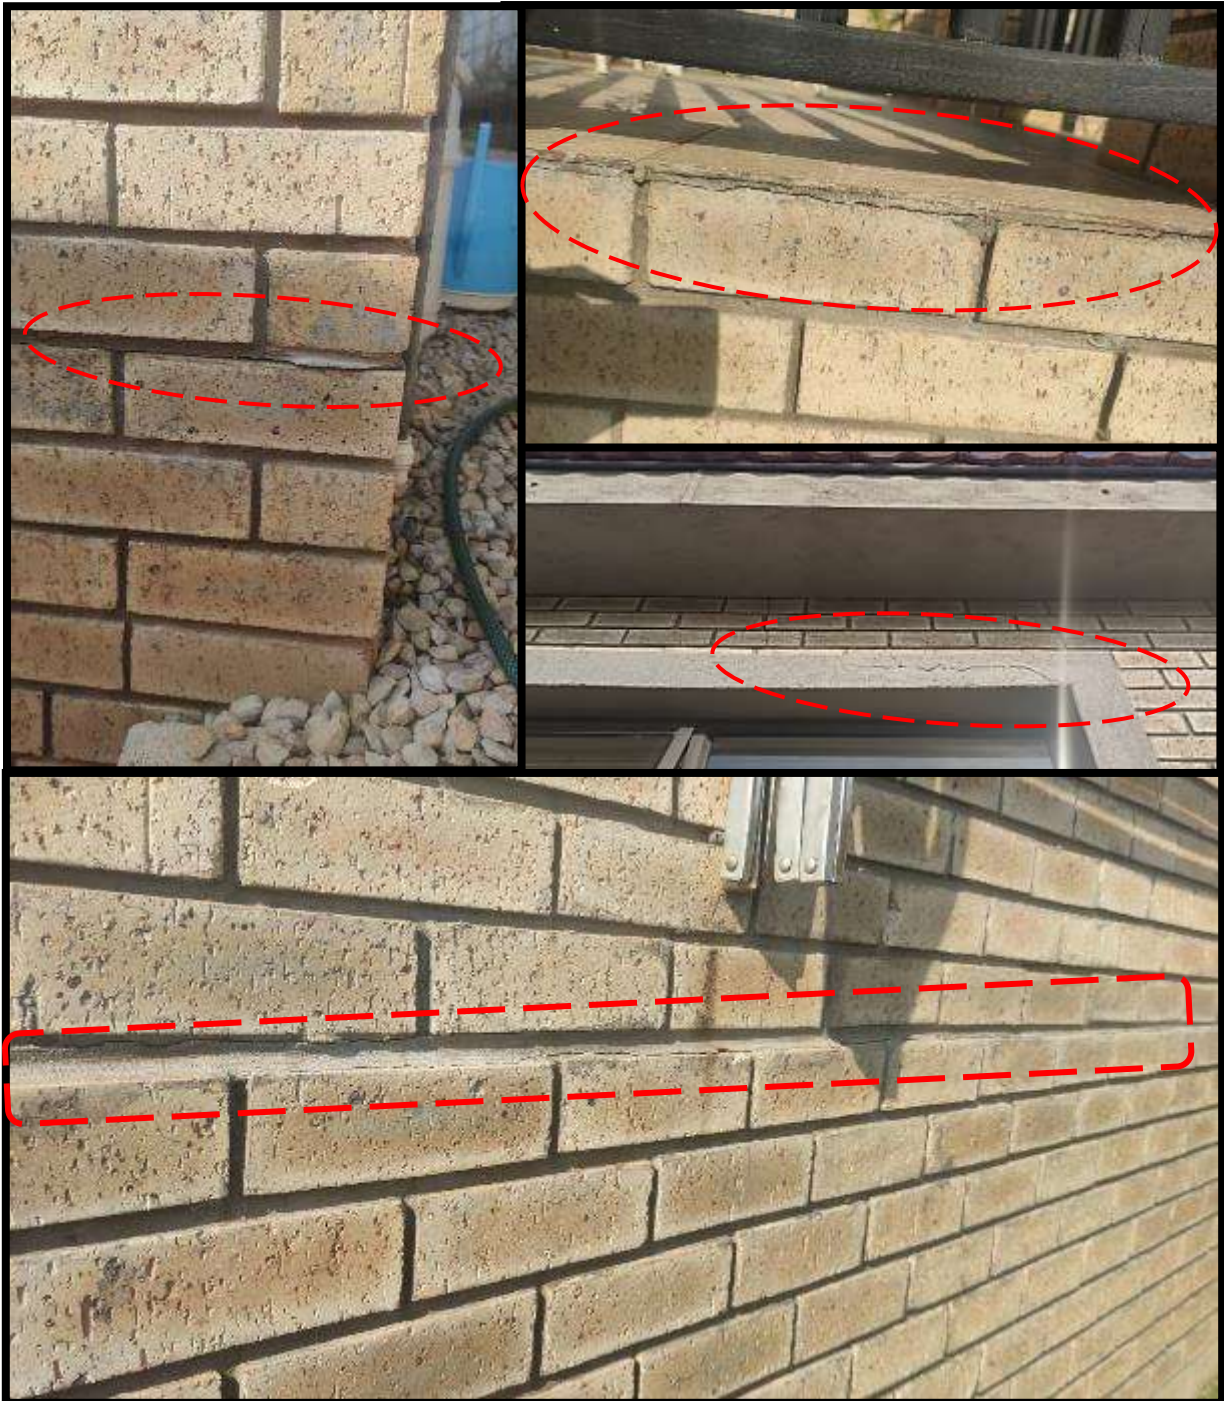
Figure 8: Showing the cracks on the exterior walls around the investigated house.

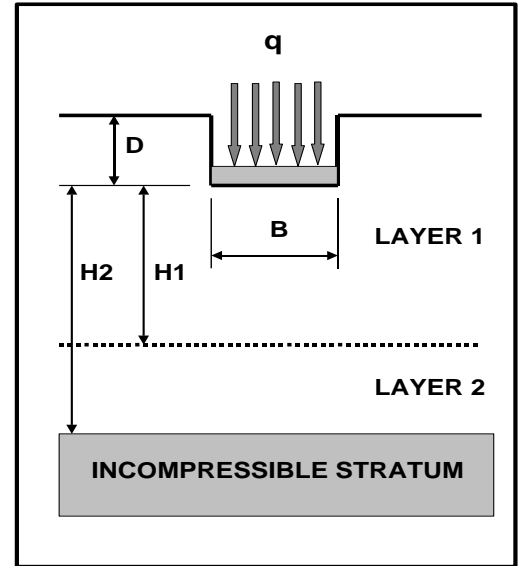
*** - After Janbu, Bjerrum and Kjaernsli

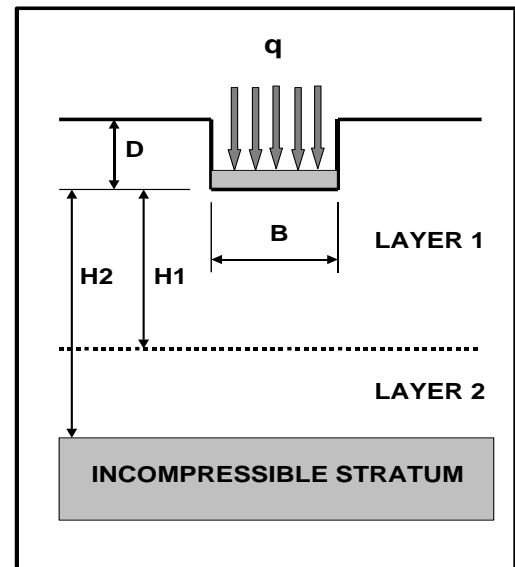
*** - After Janbu, Bjerrum and Kjaernsli
