Ref: 2024 – WC – SE - 039

Structural Engineering Investigation and Remedial Concepts
to Erf 19018, Seeumeu Park, Mossel bay
House Curtain

Report – Rev 02

27 May 2025 Contact Person: **Melt Badenhorst** (Pr.Tech.Eng)(Pr.CPM)

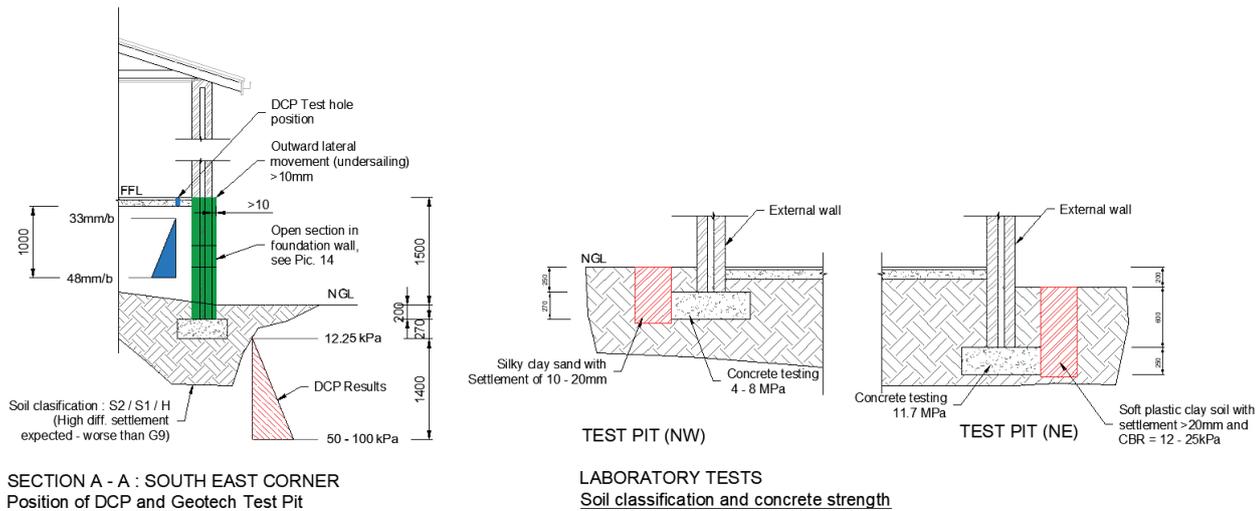
- Soil classification is S2/S1/H1 with potential settlement between 10mm to 20mm
- CBR indicators of fill under surface beds range from 12 to 25 kPa
- Average concrete strength of external strip foundations is 8,1 MPa
- Fill below surface beds has inconsistent compaction (DCP's - 35 mm per blow to more than 80mm per blow)
- Sufficient soil bearing capacity is approximately 1,0m below existing strip foundations.

The images below is a summary of the geotechnical investigation test results and engineering interpretation of the DCP and CBR results, with graphical illustrations for clarity.

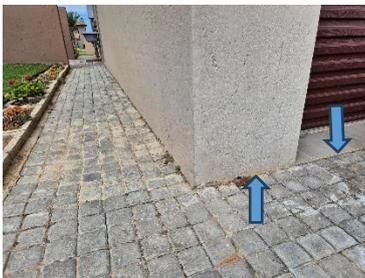
Most obvious observation is the level difference in the slope of the site and the high foundation walls on the southern façade of the structure. Concern is also the finished floor levels of the north and north-east elevations of the building in comparison the naturel ground level, which should be a minimum of 150mm.

Pic 01: Paving level same as Garage FFL with no weepholes in walls.

Concrete aprons, min 75mm thick of Class 15/19 concrete is recommended to the above-mentioned sections of the building to be the finishing works to the concrete underpinning.

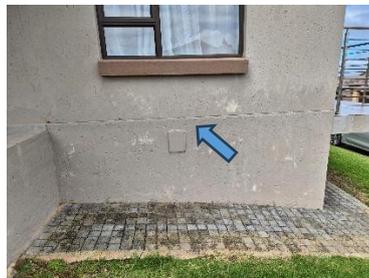
Pic 02: Settlement cracks above and below V-joint

It is clear from the geotechnical test pit investigation and observations towards the structural cracks and defects that the root cause of structural cracks and settlement can be related to the existing underlain soil substructure which requires improved foundation conditions and suitable engineering fill.

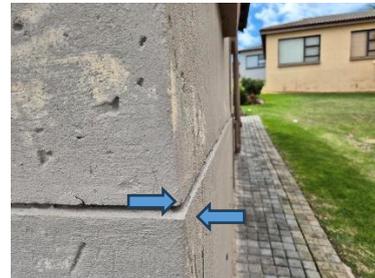
Pic 03: Outwards movement of foundation walls with cracks

Lateral support and strengthening of the eastern foundation walls are recommended as per **Detail 1** of the drawing attached in **Annexure A**.

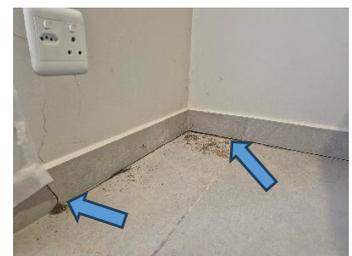
The photos below give evidence of large cracks (>5mm) in the internal walls and settlement of the surface beds (>10mm), all due to poor foundation design and construction and unsuitable fill material below the surface beds, as outlined in the independent reports attached as **Annexures E and F**.

Pic 07: Settlement (>10mm) of surface bed and crack in wall.

We concur with the recommendation as per **Item 3 of the URBAN Engineering report** (22 October 2024) to demolish the existing surface beds of the eastern side of the building including removal of unsuitable filling material up to a minimum depth of 1,0m, or as deep as instructed by the Engineer on site.

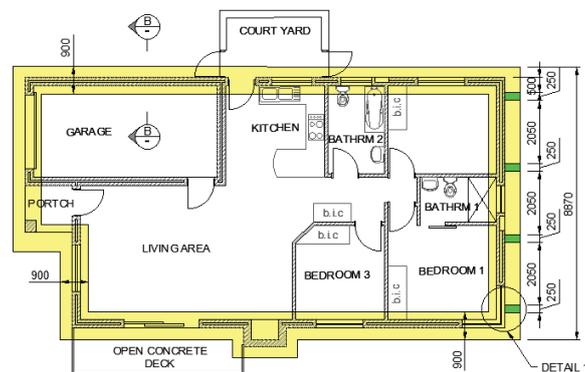
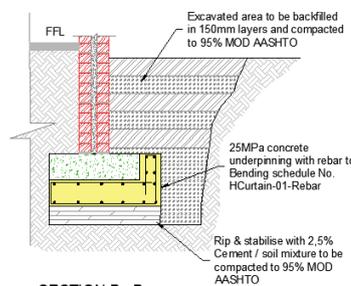
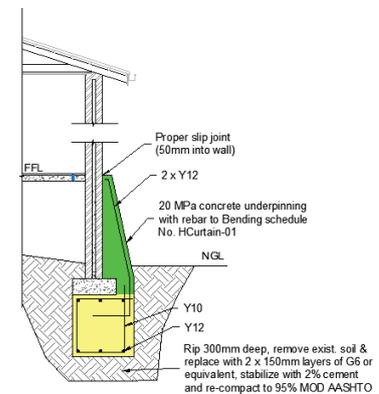
The geotechnical investigation conducted by **Terra Geotechnical (October 2024)** as per the report attached as **Annexure F**, revealed unsuitable soil conditions for erection of a structure with **classification S2/S1/H**. Poor concrete strength results of the external strip footings is an alarming factor to possible future severe structural defects and failure.

Concrete underpinning to the existing poor quality strip foundations on the exterior of the structure, with stabilisation of the sub-strata earthworks are recommended, however, the internal wall foundation pose to be problematic in the future where settlement and cracks will occur.

Detailed concept remedial methodologies are provided on the drawing attached as **Annexure A** with graphic images given below.

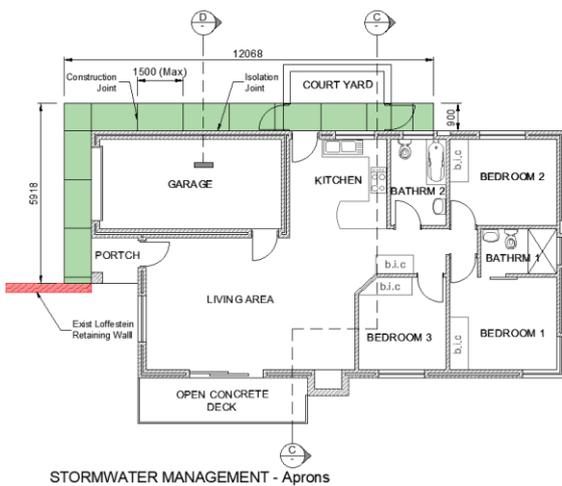
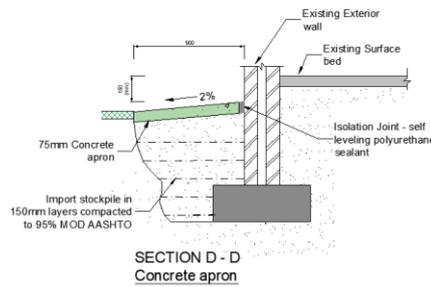
The property site slopes naturally from north to south adequately so to ensure good run-off of stormwater from the structure walls and prevent standing of rain water. However, SANS 10400 – K, clause 4.5.3.7 requires that at least 150mm be maintained between NGL and FFL of a structure, which is not evident on the north and north-east facades of the structure.

The images below provide information towards the above methodology with full details on the drawing attached as **Annexure A**.

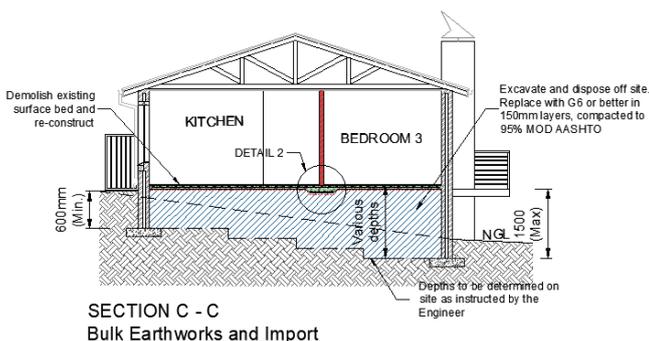
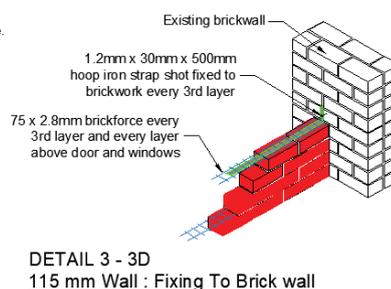
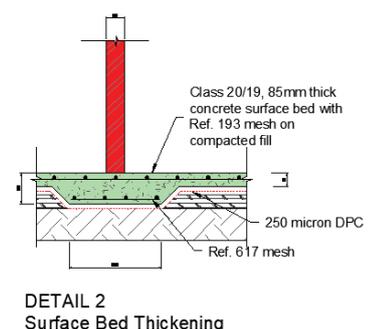
No definite detail exists if the internal walls were constructed on strip foundations or thickened sections of the surface bed – see Section 2.1 (b) above. Large settlement (>10mm) of the surface bed in the eastern side of the building will continue if the supporting earthworks are not improved.

The above will result in the associated internal walls to be demolished and re-constructed to proper engineering design and specifications on suitable fill material, adequate thick surface beds and correct masonry wall construction.

The graphic images below provide description to the above methodology with details on the drawing attached in **Annexure A**.
