PROJECT SCOPE and INVESTIGATIVE NOTES

PROJECT TITLE  
Structural Engineering Investigation Services for  
Erf 2044, 38R Ocean View Drive, Greenpoint  
(House Noth)

DRAWING TITLE  
Investigation Notes and Concept Proposed  
Remedial Detail

Drawing number: HNoth - Struct 01  
Drawing size: A1  
Rev: 00

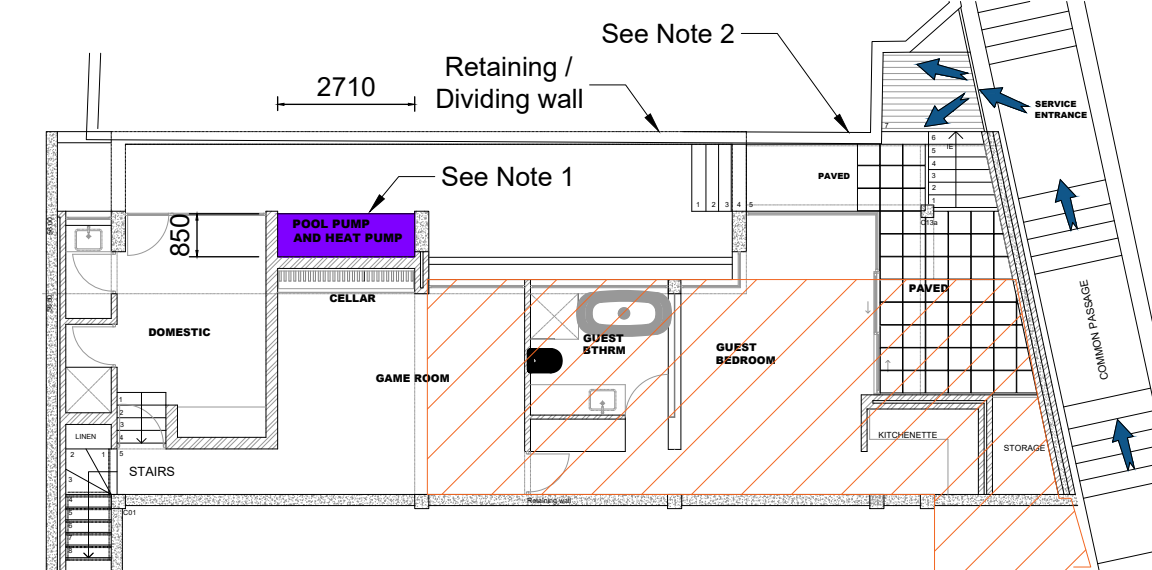
GROUND FLOOR

- Cast 75mm thick Class 15/19 concrete floor with Ref 395 mesh to slope to passage
- Water damp to Retaining / Division wall with neighbour emanating from standing water on neighbour's adjoining building roof. This issue to be deliberated between Homeowners, building roof brought to spec and wall re-plastered and painted thereafter.

ACTIVITY C: Stormwater management - Ground Floor
