PROJECT SCOPE and INVESTIGATIVE NOTES

Structural Engineering Investigation Services for  
Erf 4114, Arum Road, Table View, Cape Town  
(House Barnard)

Investigation Notes and Concept Proposed  
Remedial Detail

| HBAR - Struct 01 | A1 | 01 |

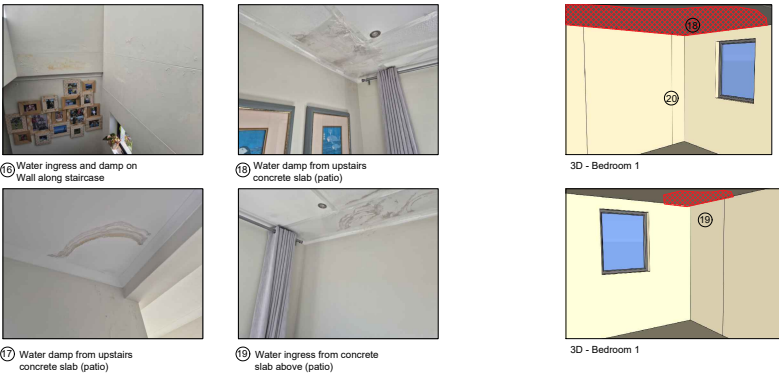
WATER DAMP REPAIRS

- Identify and Address the Source:  
**Leaks:** Check for any roof leaks, plumbing leaks, or condensation issues causing the dampness.  
**Rising Damp:** If the dampness is coming from the walls below, it could be rising damp, which requires a different treatment approach.

**Condensation:** Poor ventilation can lead to condensation, especially in bathrooms and kitchens. Ensure proper airflow/Water ingress from concrete slab above (patio).

- Remove Damaged Materials:  
**Mold and Deteriorated Plaster:** If mold is present or the plaster is damaged, remove the affected areas.  
**Prepare the Surface:** Clean the exposed concrete thoroughly and ensure it's dry before applying any new materials.

- Improve Ventilation:  
**Dehumidifier:** Use a dehumidifier to draw out moisture from the air and help dry the concrete.  
**Fans:** Fans can help circulate air and speed up the drying process.

**Ventilation:** Ensure proper ventilation in the room, especially in areas prone to dampness like bathrooms.
- Apply Waterproofing:  
**Damp Proof Membrane:** For persistent dampness, consider installing a damp-proof membrane on the ceiling.

**Cementitious Crystalline Render:** This render forms a waterproof barrier and can be effective in holding back moisture.  
**Elastomeric Coatings:** These coatings are flexible and can help prevent cracks and water penetration.

**Liquid Membrane:** A liquid membrane can be applied to create a seamless waterproof barrier.
- Other Tips:  
**Anti-Mold Paint:** If mold is a recurring problem, use anti-mold damp seal paint that contains fungicidal chemicals.

**Sealants:** Use sealants to fill cracks and holes in the concrete, preventing water from entering.  
**Regular Maintenance:** Regularly inspect your ceiling for signs of dampness and address them promptly.
