Our ref: P 2433-02-01 Forensic Engineering Assessment Report 02

FORENSIC ENGINEERING ASSESSMENT REPORT

**HOUSE MOCHOARI
ERF 40416, WILD OLIVE
BLOEMFONTEIN**

Date: December 2025

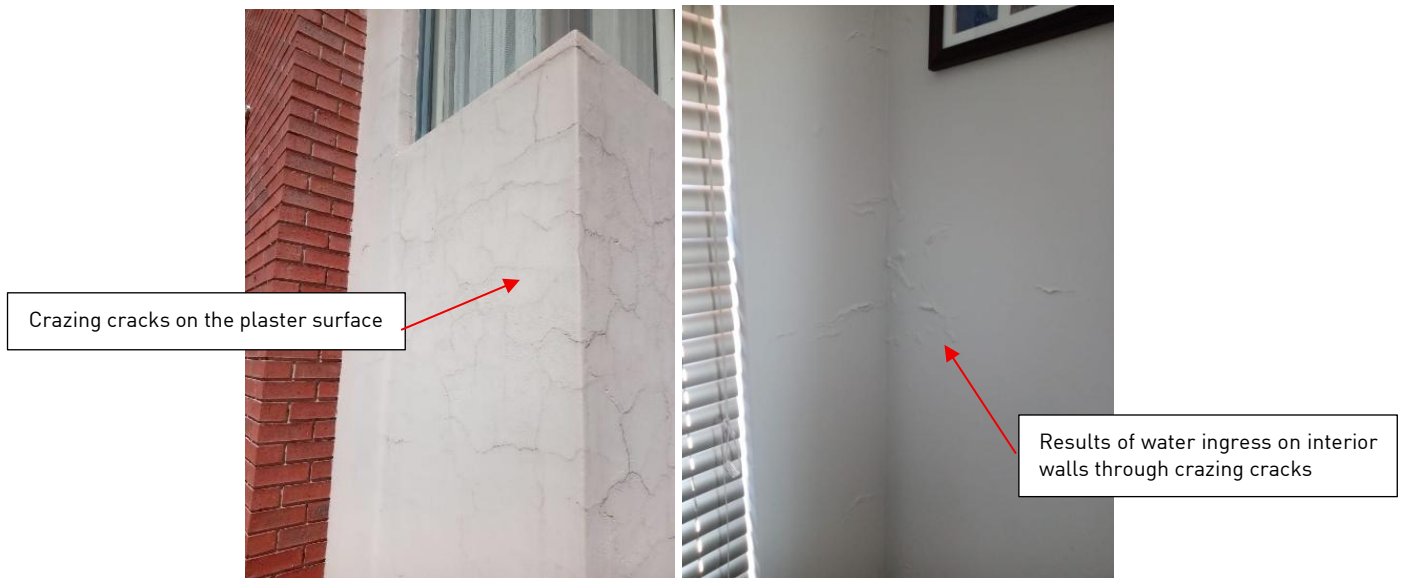
Figure 4: Exterior Plaster Cracks

Hairline cracks can be observed on all exterior plastered surfaces and are consistent with crazing cracks. Shrinkage is attributed to the mixing ratios of plaster or the quality sand used during construction.

The hairline cracks allow water seepage into the masonry resulting in excessive cracking on exterior walls and damp accumulation on the interior walls as seen below in Figure 4.

Exterior wall cracks	Serviceability Defect	The plaster strength will need to be confirmed prior to a recommendation on a suitable product to bond the cracks. The product will depend on the current strength of the plaster
2

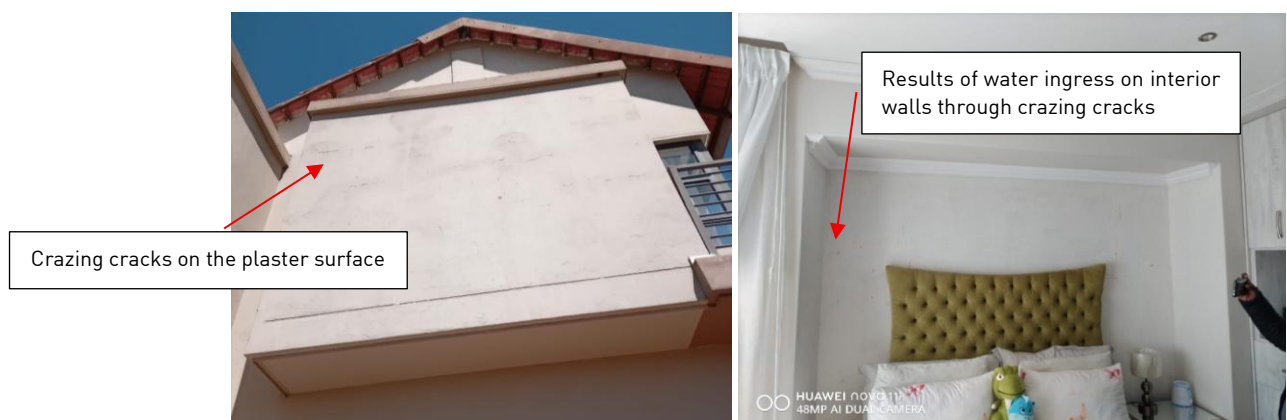
FIGURE 5: PLASTER CRACKS ON BEDROOM WALL

The bedroom wall in Figure 5 below show signs of water ingress. Upon inspection of the exterior wall, excessive hairline cracks are observed on the exterior plaster surface that are consistent with crazing cracks.

Exterior wall cracks	Serviceability Defect	The plaster strength will need to be confirmed prior to a recommendation on a suitable product to bond the cracks. The product will depend on the current strength of the plaster

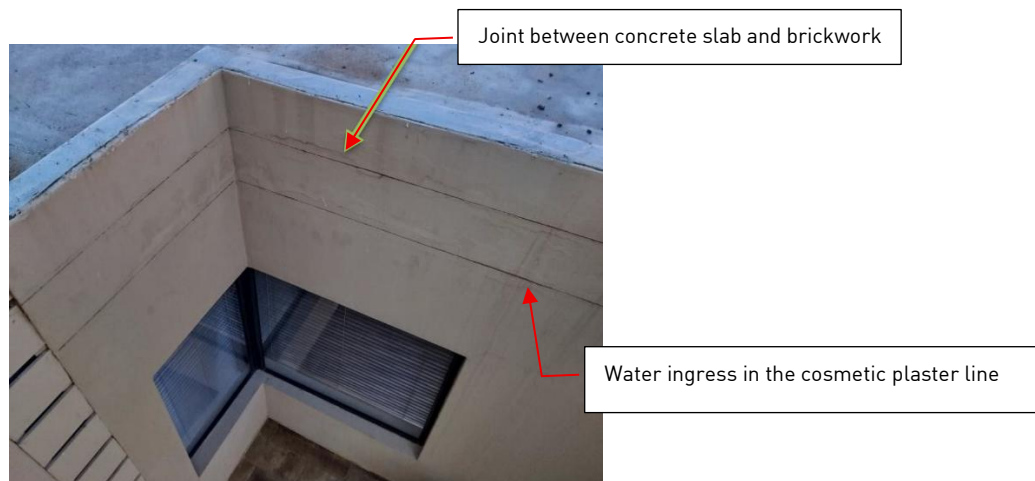
FIGURE 6: AESTETIC PLASTER LINES AND DECORATIVE LINES

Aesthetic plaster lines (also known as plaster movement joints) are located near the roof slab as shown in Figure 6 below. Aesthetic plaster lines are found between the interface of the concrete slab and supporting masonry. It is common practice to install such joints where movement is expected between different building materials in order to eliminate random cracking during thermal expansion. The second line below is decorative.

Development of hairline cracks along these lines are expected due to thermal expansion and water ingress between the plaster and brickwork is the result. Good practice is to seal these joints on external surfaces to prevent penetrating damp.

<p>Water ingress and cracking</p>	<p>Does not conform to the serviceability limit state requirements of the building regulations- Serviceability Defect</p> <p>A cause for water ingress into the building</p>	<p>All plaster with cracks at the movement joint to be removed.</p> <p>The decorative line to have all plaster with cracks removed.</p> <p>Replaster the above surfaces in accordance with Method Statement 2 in Annexure B</p>
4

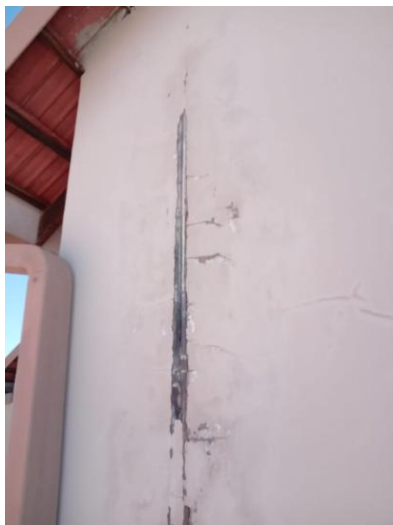
Figure 7: Water Pipes Inadequately Installed

Water pipes from the first floor are chased too shallow into the wall as shown in the figure below. Insufficient coverage to the pipes creates a weak spot in the plaster attracting cracks and delamination shortly after construction. Water penetrates through the crack and causes damp build up in the walls.

<p>Incorrect placement depth of water pipes</p>	<p>Delamination of exterior plaster. Serviceability Defect</p>	<p>A certified plumber is to remove the water pipes and re-chase the pipe to an adequate depth</p> <p>Replaster in accordance with Method Statement 1 in Annexure B</p>
5		<p>Incorrect sloped surface</p>	<p>Does not conform to the serviceability limit state requirements of the building regulations Serviceability Defect</p>	<p>Tiles to be removed. Re-screed the surface in order to allow for a 2% slope away from the door.</p> <p>Waterproofing to be installed by a waterproofing specialist.</p>

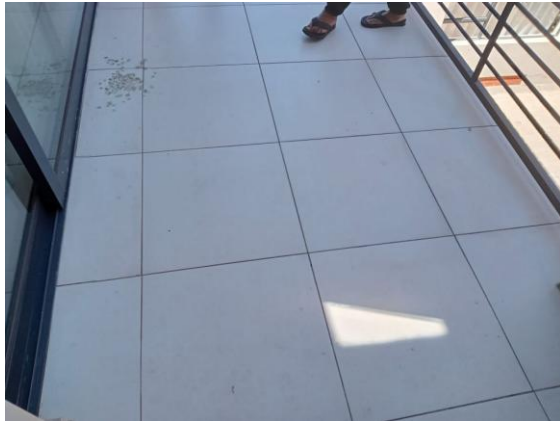
Figure 8: Balcony 1 with Insufficient Slope

Balcony 1 is located above the side entrance. The balcony was constructed without a weather step at the sliding door which allows free movement of water into the room. This is a construction error and not good practice.

The only way to manage the water flow on the balconies without reconstruction is re-screeding the balcony with a steep slope to ensure water run-off or add an upstand beam at the door which could be a tripping hazard.

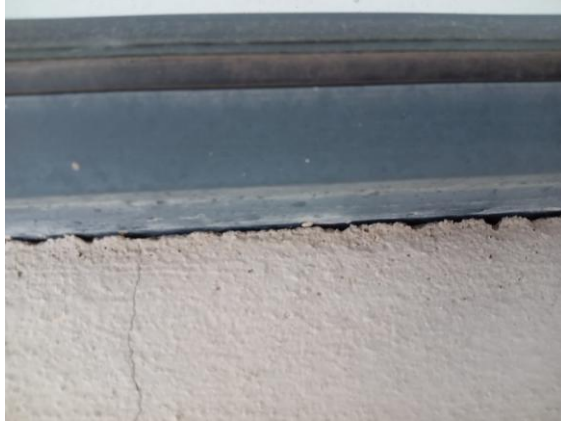
Figure 10: Aluminium Window and Plaster Separation

Figure 8 shows a separation between the window frame and the plaster. The plaster and aluminium window frame have different coefficient of expansions resulting in the separation observed. This is a point of water ingress causing major damp to build up in the masonry.

<p>Separation of aluminium window and plaster</p>	<p>Does not conform to the serviceability limit state requirements of the building regulations – Serviceability Defect</p> <p>A cause for water ingress into the building</p>	<p>The gap to be filled with a polyurethane sealant approved by the engineer.</p>
8

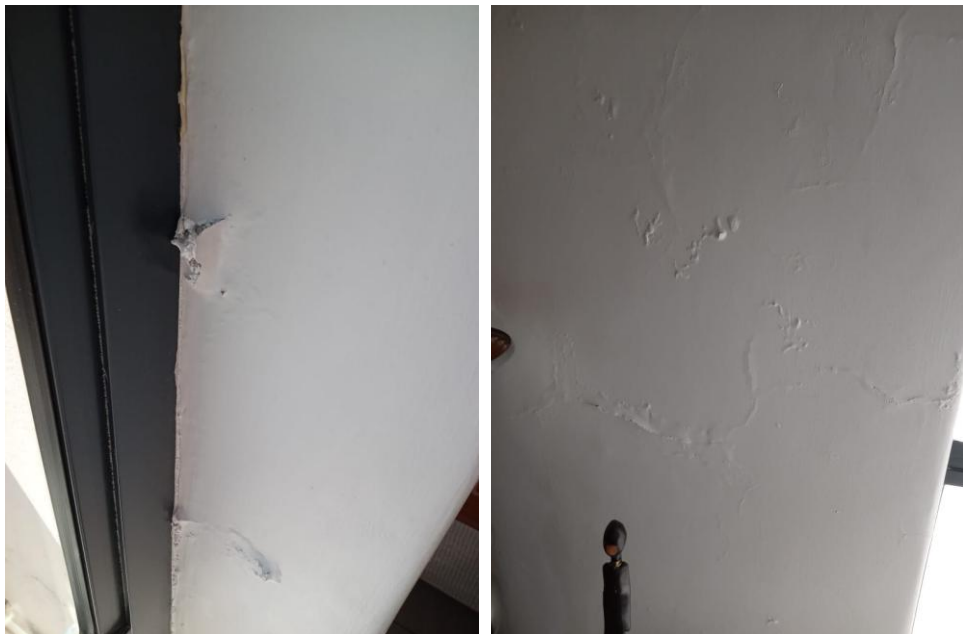
Figure 11: Interior Plaster Damp and Calcium Build Up Due to Water Ingress

Water ingress occurs through crazing cracks on the external walls and from the roof slab. To prevent damp build up in the wall, the external defects need to be addressed.

<p>Water ingress into interior walls</p>	<p>Calcium build-up on the interior wall. Serviceability Defect</p>	<p>Exterior cracks to be remedied prior to remedial work.</p> <p>The extent of the damage to the plaster will need to be evaluated:</p> <ul style="list-style-type: none"> (i) A plaster surface that has delaminated, will require re-plastering. (ii) A plaster surface that no signs of delamination as shown in the figure to the left. The surface should be smoothed by sanding, damp proof sealant applied and paint to match existing

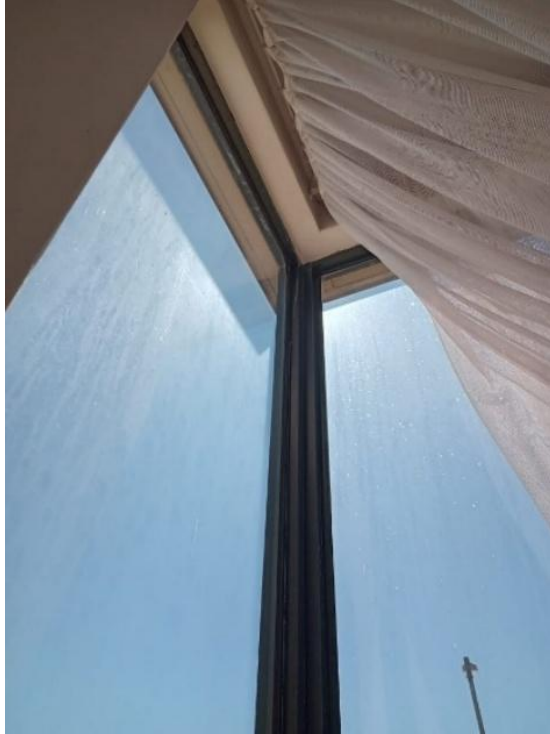
Figure 12: Leaking Aluminium Windows

The homeowner noted water ingress through the large window above the stair landing during rain events. The aluminium window in figure 10 below is to be inspected by an aluminium specialist. Windows to be checked for water tightness and sealed if required.

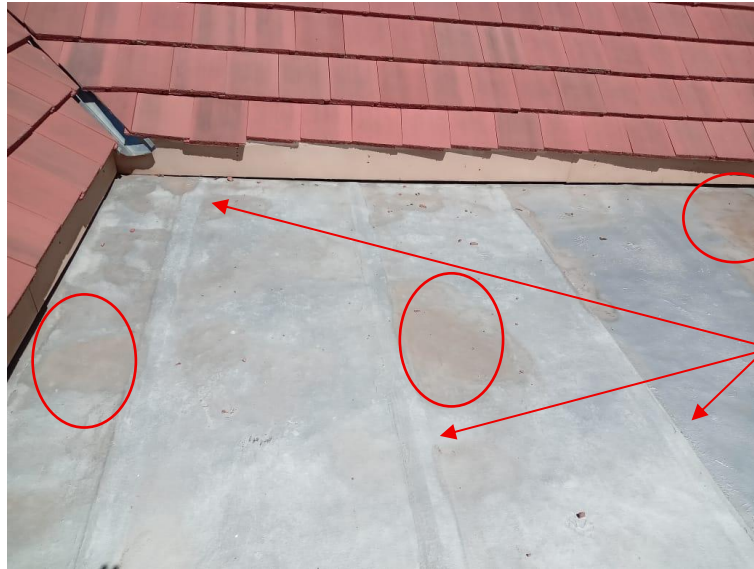
Figure 13: Concrete Slab Surface

A concrete roof slab is situated above the dining area, lounge and kitchen area. The slab has been constructed with protruding grooves on the surface which extend the full length of the slab. The grooves prevent smooth water flow to the discharge points and result in water pooling behind the groove as shown in the figure below. No signs of water ingress or stained ceilings were noted below the slab during the inspection. The slab parapet walls were inspected; however, the depth could not be measured due to accessibility. A design evaluation is required to determine the minimum depth required to prevent overtopping. The design evaluation in section 7 below indicates the minimum values that need to be present to avoid water overtopping. The roof clay tiles are to be removed, and the parapet wall height measured against the minimum values calculated.

Grooves on the screeded surface of the slab. The grooves cause water to pool behind it as seen in the circles marked in red.

<p>Grooves on screeded surface of concrete slab.</p>	<p>Does not conform to the serviceability limit state requirements of the building regulations – Serviceability Defect</p> <p>A cause for water ingress Into the building due to Uneven runoff flow</p>	<p>Waterproofing and screed on concrete slab to be removed.</p> <p>New screed to slope as per engineering drawing in Annexure A.</p> <p>Waterproofing done by a specialist.</p>
<p>10</p>

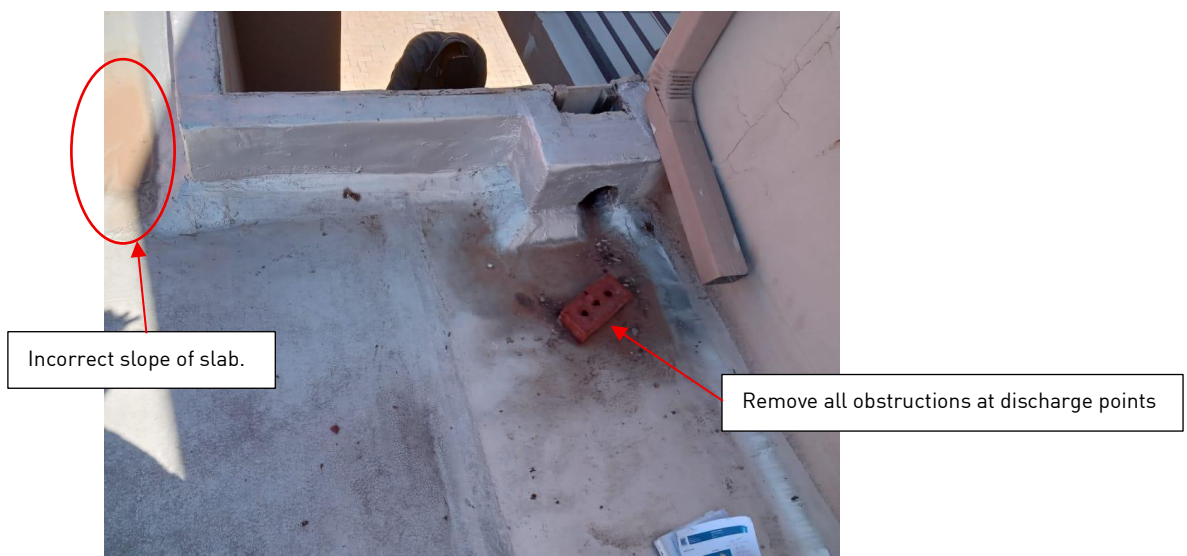
Figure 14: Incorrect Slope at DP 1

It was observed that the sloped screed at the entrance of the discharge point 1 (DP1) directs water runoff inefficiently. The slope directs water to the side of DP1 instead of the invert of the pipe which results in water pooling around DP1 as shown in figure 12 below. It should be noted that any debris on the slab aggravates the inefficiency of diverting water to the outlets. The incorrectly sloped surface of the slab contributes to insufficient drainage, as pooling water builds up behind the grooves until it overtops the current heights

Incorrect slope of slab.

Remove all obstructions at discharge points

<p>Entrance slopes into downpipes inefficient</p>	<p>Serviceability Defect</p>	<p>Waterproofing and screed on concrete slab to be removed.</p> <p>New screed to slope as per Annexure A.</p> <p>Waterproofing done by a specialist.</p>

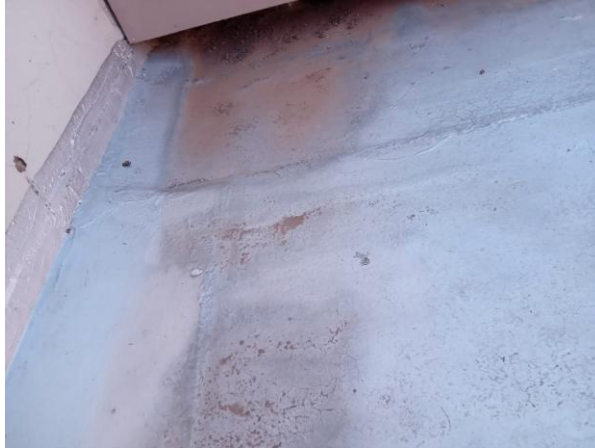
Figure 15: Incorrectly Sloped Screed at DP 2

The incorrectly sloped screed also applies to DP2 and DP3 as shown in figures 13 to 15 respectively.

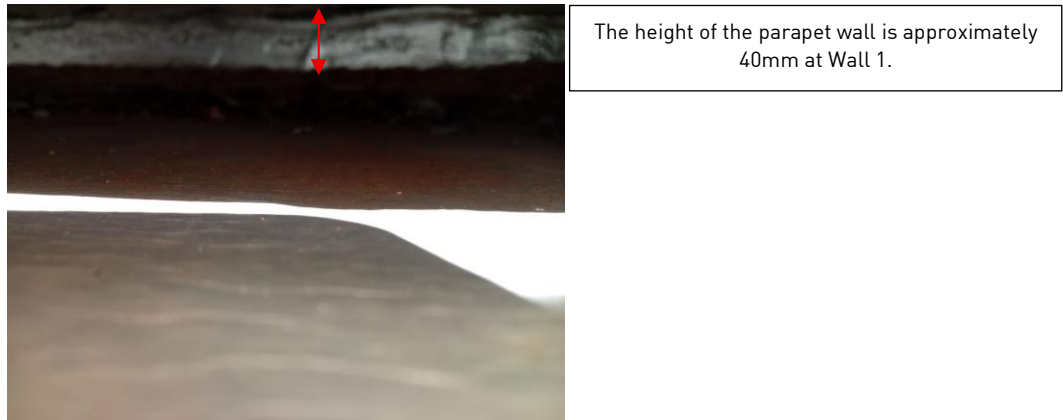
Figure 18:W1 Parapet Inspection

Upon inspection of W1, W2 and W4 it was noted that there is a parapet on the slab. Due to the inaccessibility of the parapet the depth of W1 could not be accurately measured but is visually estimated to be 40mm as shown in figure 16 below. The presence of waterproofing has been confirmed on the parapet. The quality of the waterproofing cannot be evaluated due to access constraints, and we recommend that a contractor open a

The height of the parapet wall is approximately 40mm at Wall 1.

From the visual inspection of the height of the parapet, it is rational to conclude that the depth of W1 is inadequate and contributes to the water ingress into the walls.

Wall height above slab not sufficient	Water flows over the wall And into the home. Serviceability Defect	Increase parapet heights as per Table 1. Waterproofing to be redone by specialist.

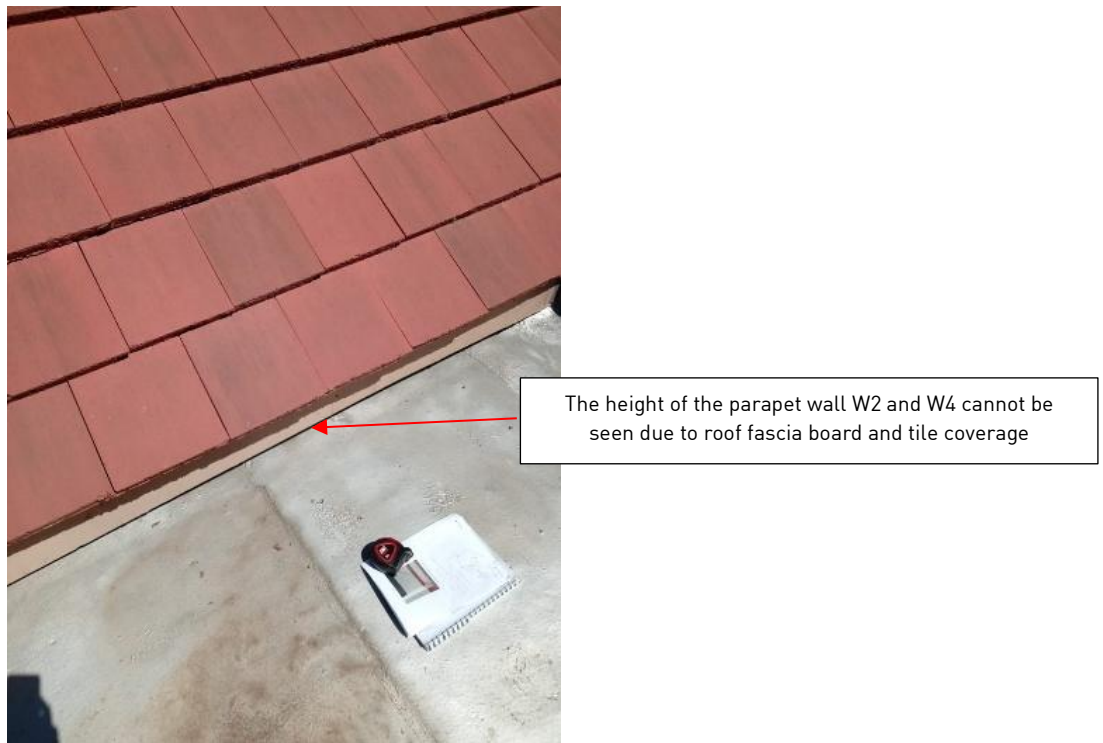
Figure 19:Inspection of Parapet Height Under Roof

small area to confirm that the water proofing is not damaged. W2 and W4 could not be visually assessed as shown in figure 17 below.

The height of the parapet wall W2 and W4 cannot be seen due to roof fascia board and tile coverage

Once the facia boards and clay tiles have been removed on site, the results in Table 1 can be compared to the actual measurements taken for W2 and W4 to confirm our findings. Insufficient parapet heights should be increased to accommodate the design rainfall without over topping. UB 1 and UB 2 are found to have sufficient depth.

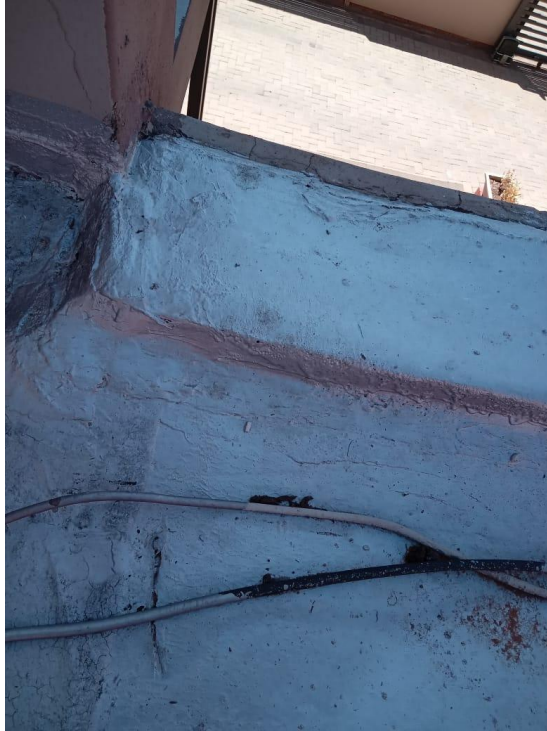
Figure 20:UB 3 Depth

The height of UB 3 is inconsistent along the length of the beam as shown in the figure below. The height of upstand ranges from 30mm to 100mm. These depths will be evaluated in section 7 below to confirm their adequacy in preventing overtopping of the slab.

UB 3 has a varying depth. The minimum depth required is 100mm therefore, the lower sections should be increased to prevent overtopping.

Upstand beam depth not sufficient	Water flows over the upstand. Serviceability Defect	Increase depth of upstand to 100mm throughout the length. Waterproofing to be redone by specialist.
12
