- 📍 Office Corner  
Block C, 184 Lancaster Road,  
Gordon's Bay,  
7140
- ☎ 066 105 1226
- ✉ techq.development@outlook.com
- 📞 086 474 1937
- 🌐 www.techq-development.com

## Professional Engineering Services

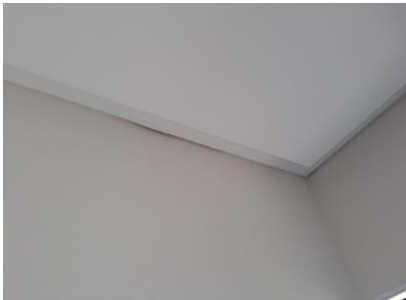
**Pic 01:** Water ingress from the 1<sup>st</sup> floor roof

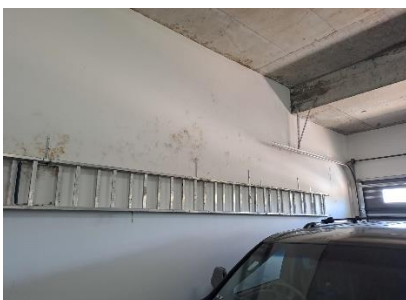
**Pic 04:** Water damp on the garage wall

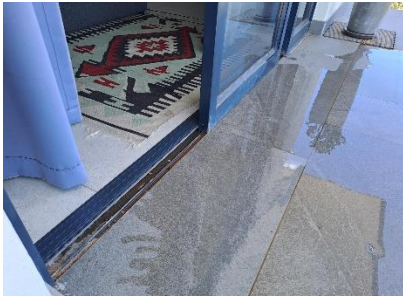
**Pic 05:** Standing water on the 1<sup>st</sup> floor patio

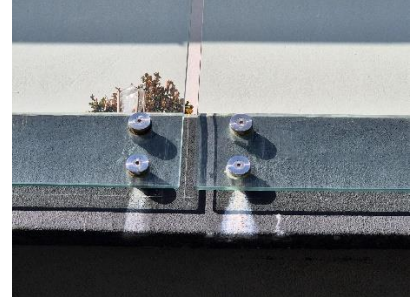
**Pic 07:** Water seepage - balustrade fixing bolts

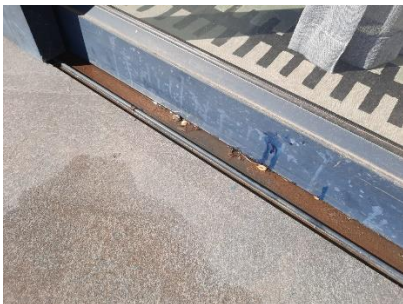
**Pic 08:** Water ingress into gaps between the sliding door rails and patio tiles

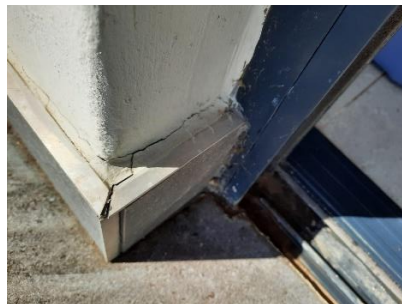
**Pic 09:** Blue coloured water seeping into cracks in walls and patio tiling

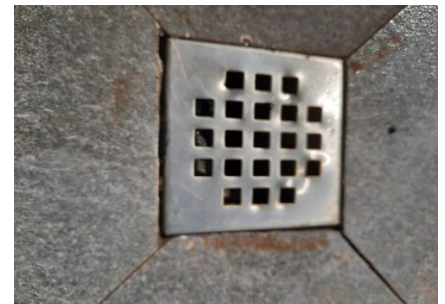
**Pic 10:** Poor waterproofing of the full-bore trap on the patio results in leaks to the living room

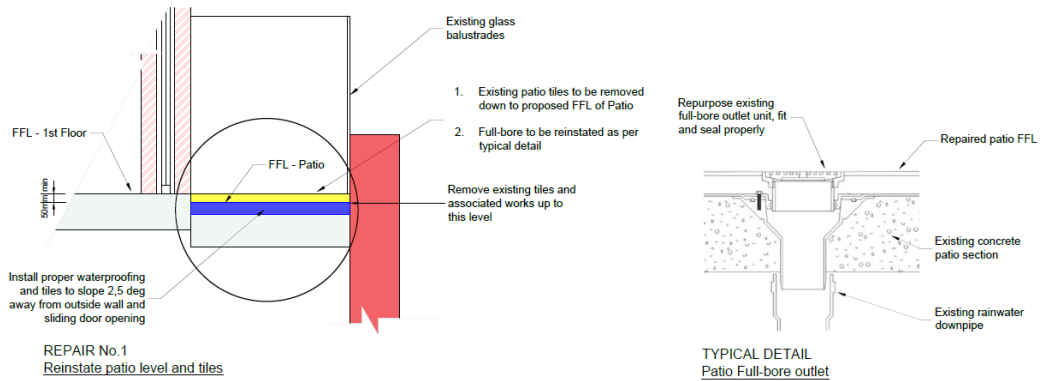
### 3.2 Remedial works B: Waterproofing to external sliding door railings

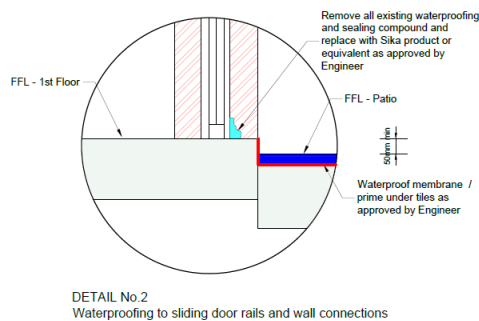
### 3.3 Remedial works C: Refit glass balustrades

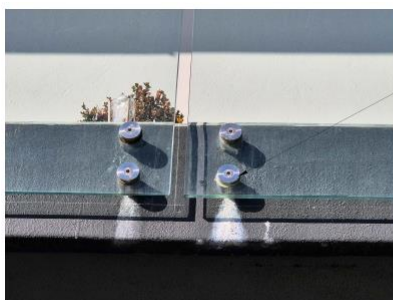
Remove all glass balustrades, anchors and existing epoxy sealant, clean out and seal holes, then refit glass balustrades to supplier's specifications, after patio tiling and waterproofing has been redone

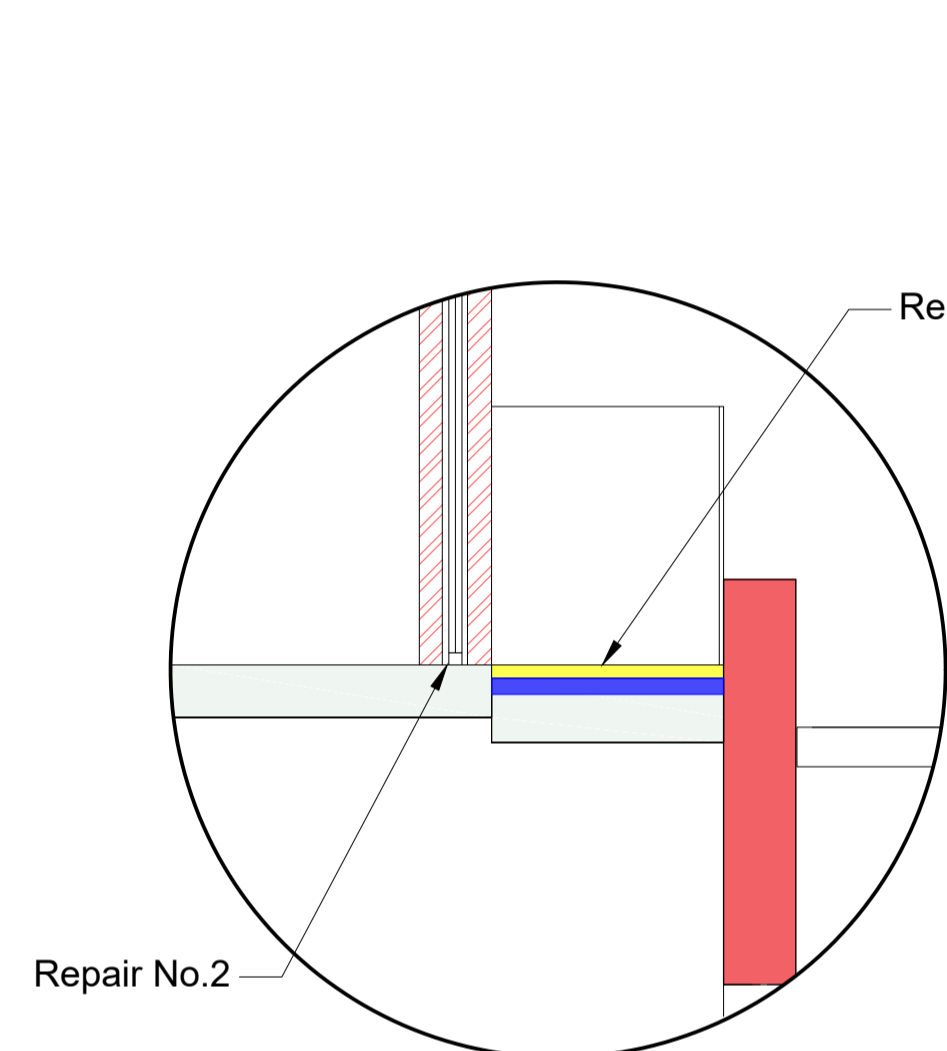
DETAIL No. 1  
Repairs to Patio walkway

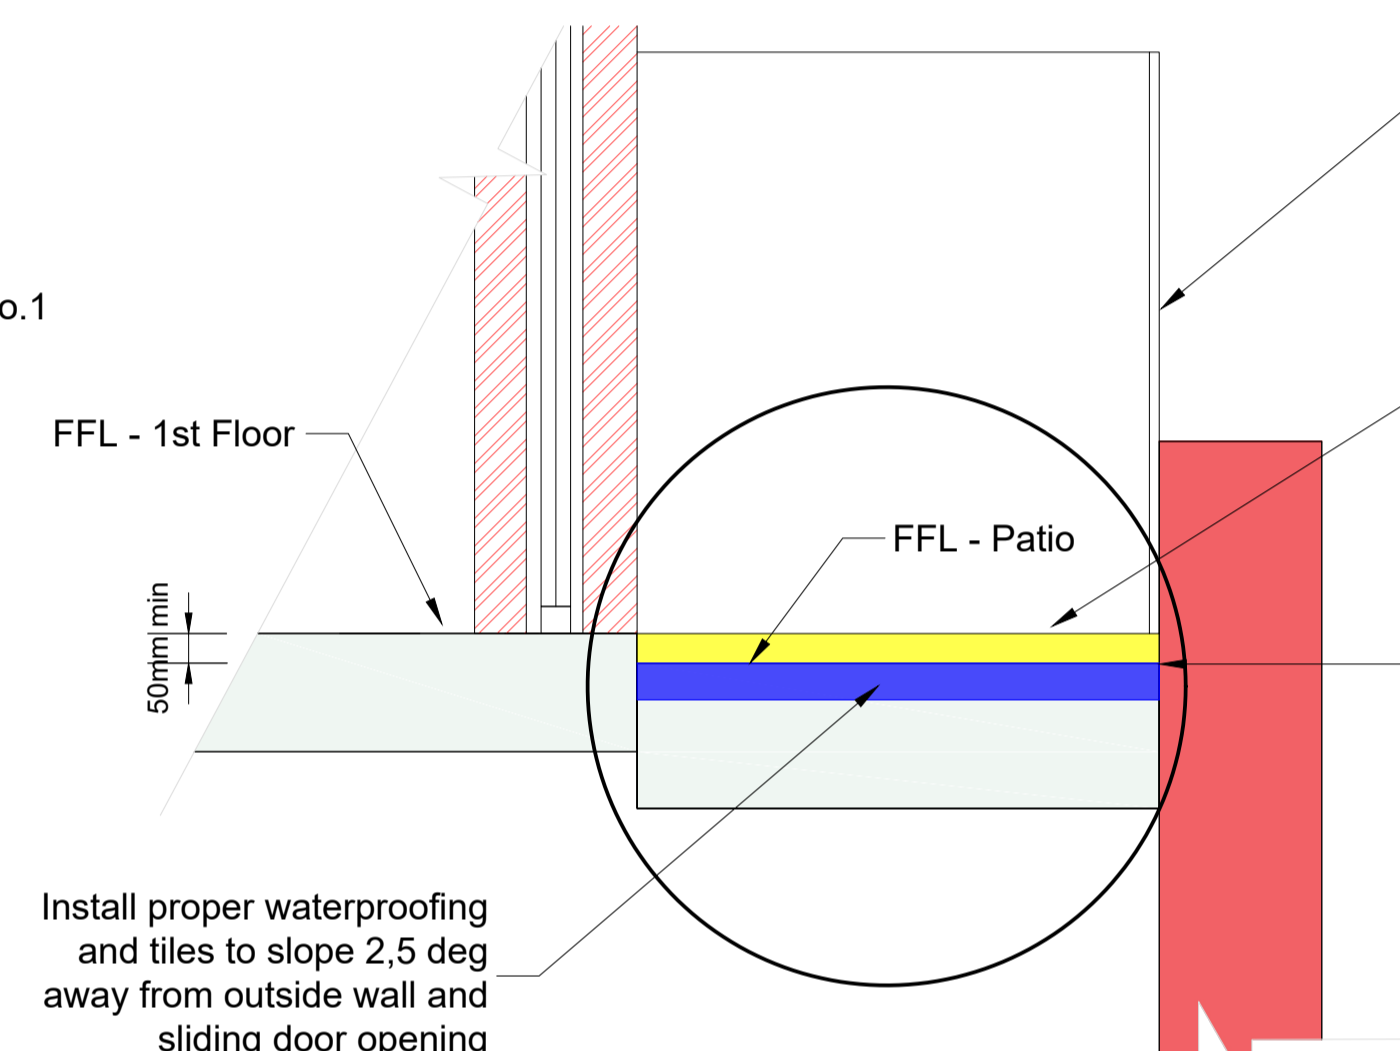
REPAIR No. 1  
Reinstate patio level and tiles

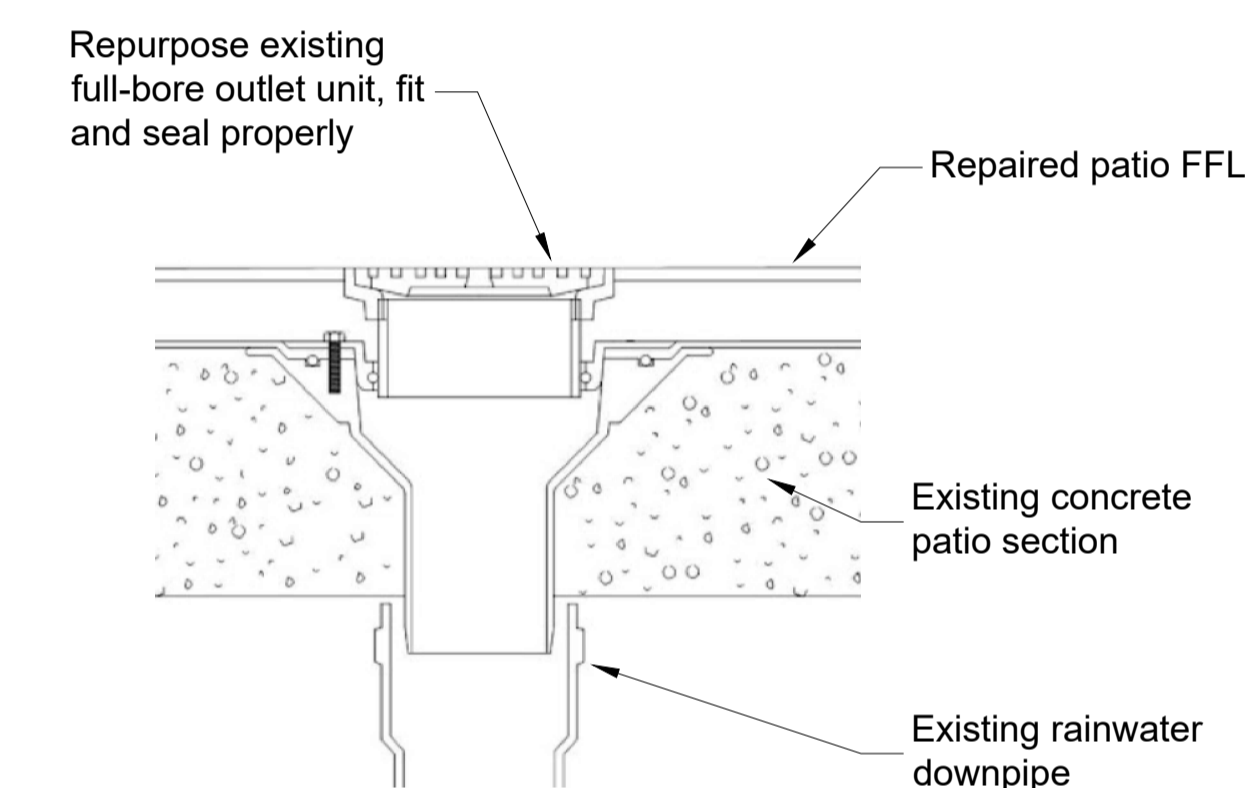
TYPICAL DETAIL  
Patio Full-bore outlet

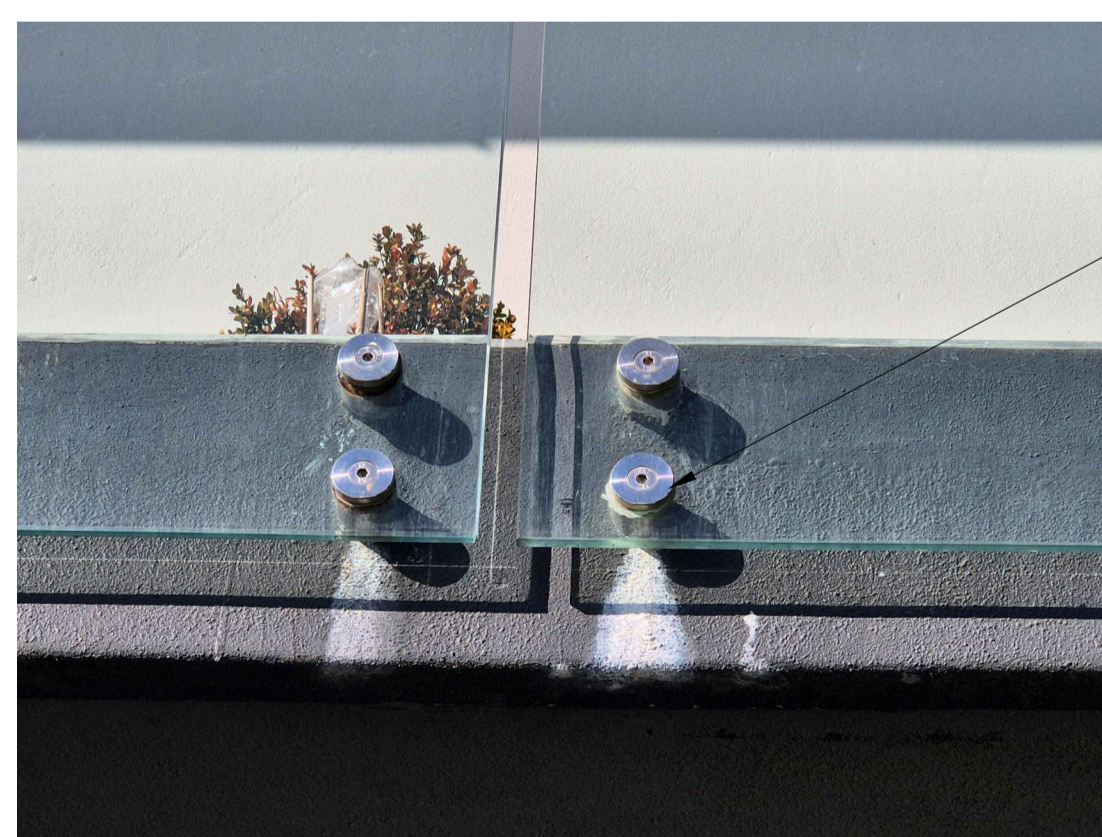
DETAIL No. 3  
"Cement rust" on balustrade fixing anchors

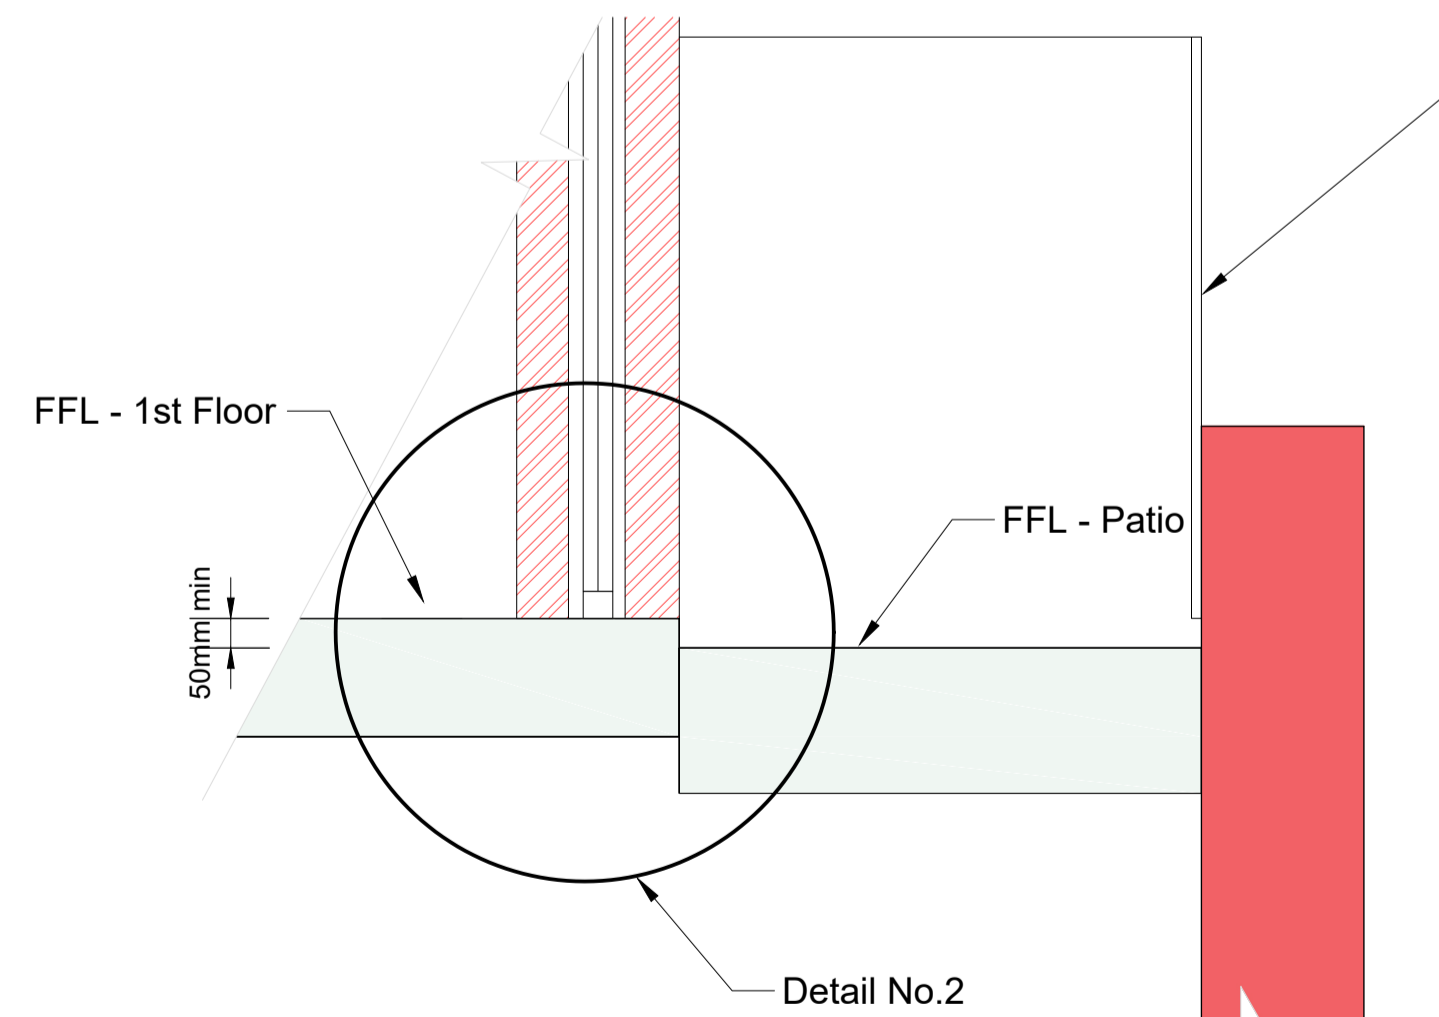
REPAIR No. 2  
Waterproofing to sliding door rails and wall connections

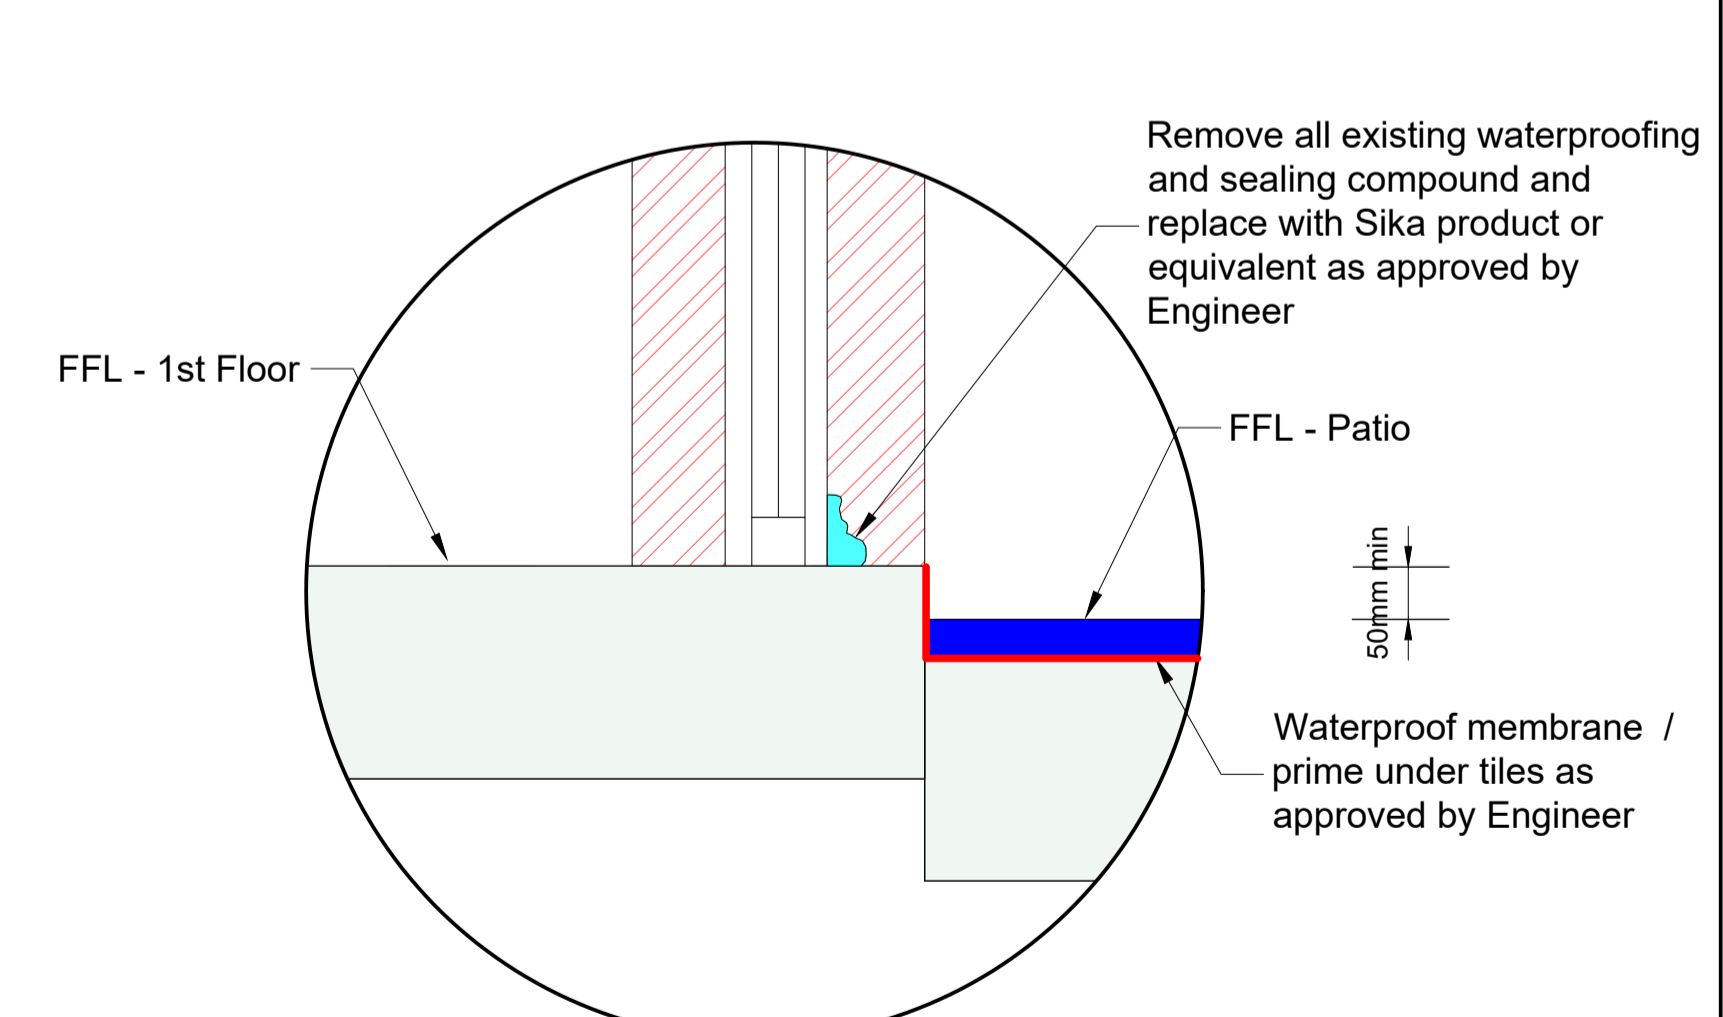
DETAIL No. 2  
Waterproofing to sliding door rails and wall connections

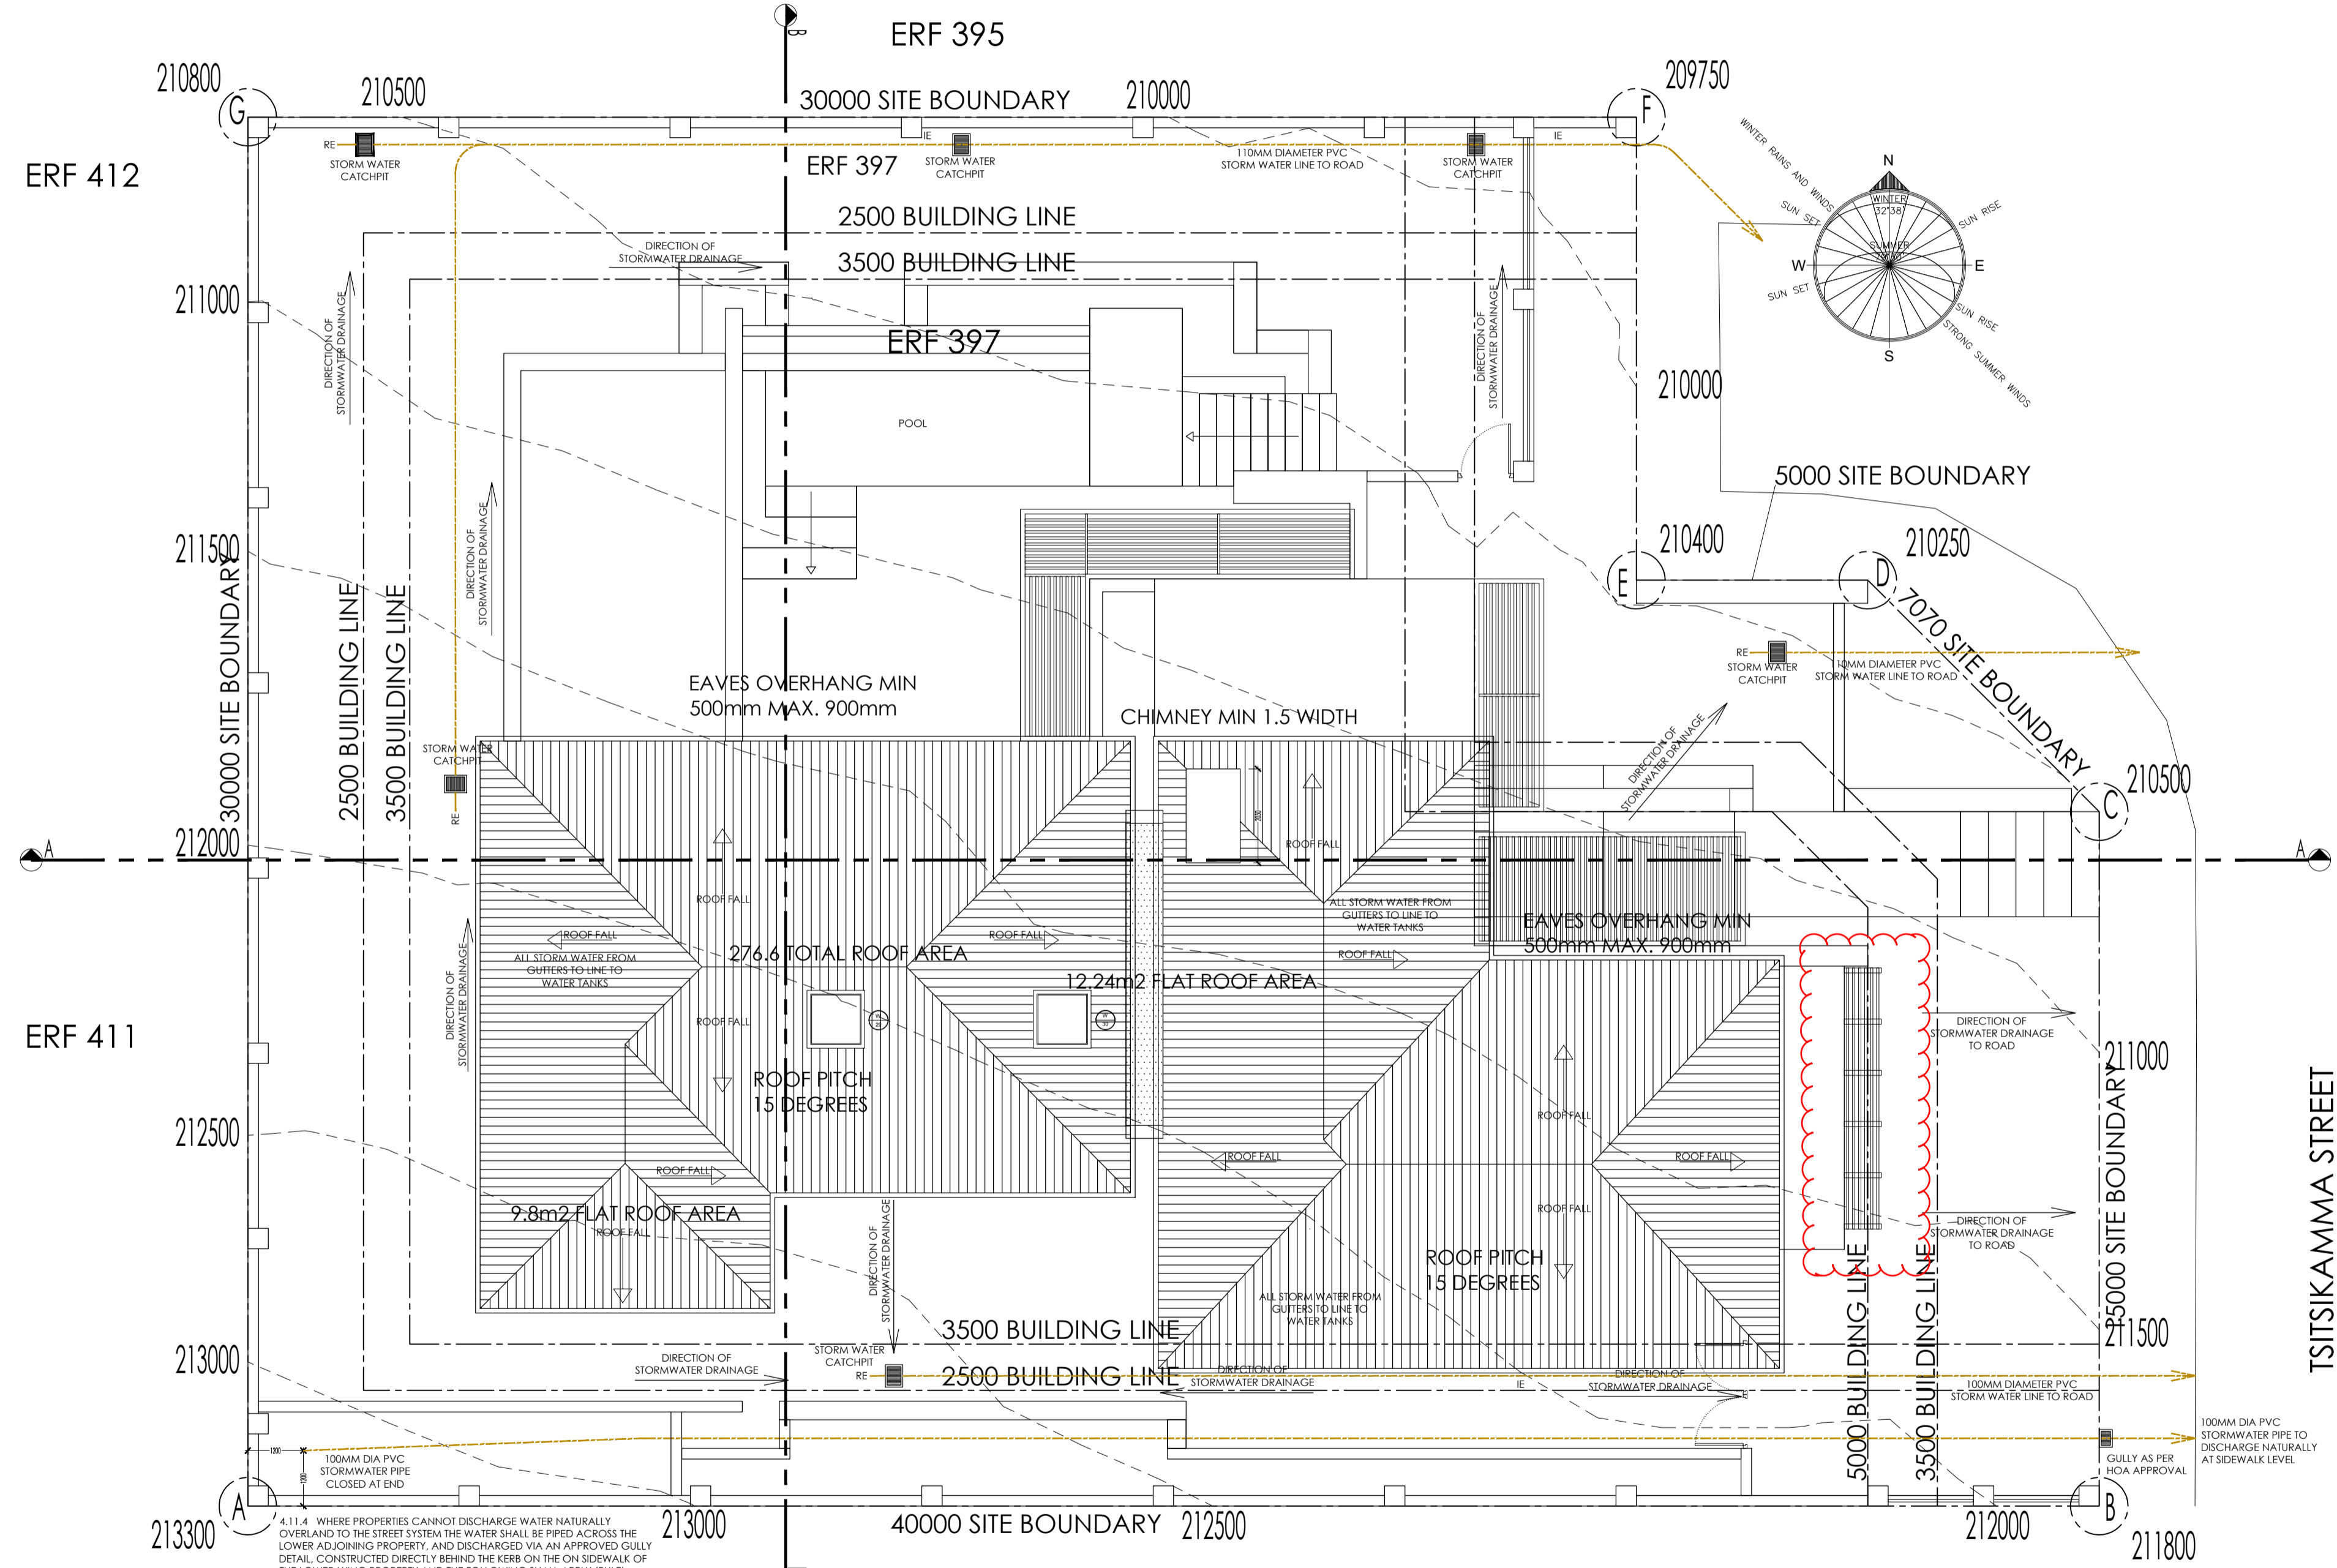
SITE, ROOF & STORMWATER PLAN  
 SCALE 1:100

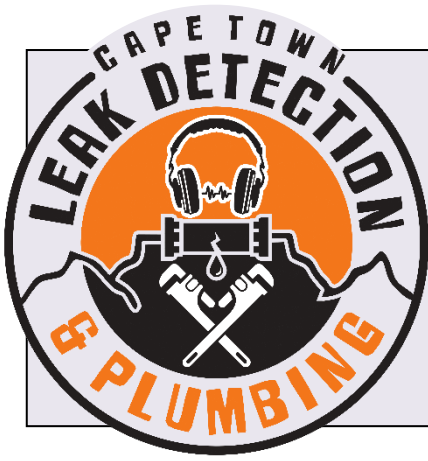
# CAPE TOWN LEAK DETECTION
