STRUCTURAL REPORT FOR ERF 5245 THE ORCHARDS.

Background: A single-storey house at 5245, The Orchards Ext 56 in the City of Tshwane built year 2019 showed some structural defects on the walls and roof. An investigation was then requested to determine the cause and possible remedial works to these defects. In this report are the findings and recommended remedial works found after the two site inspections dated (23 June and 02 July 2022).

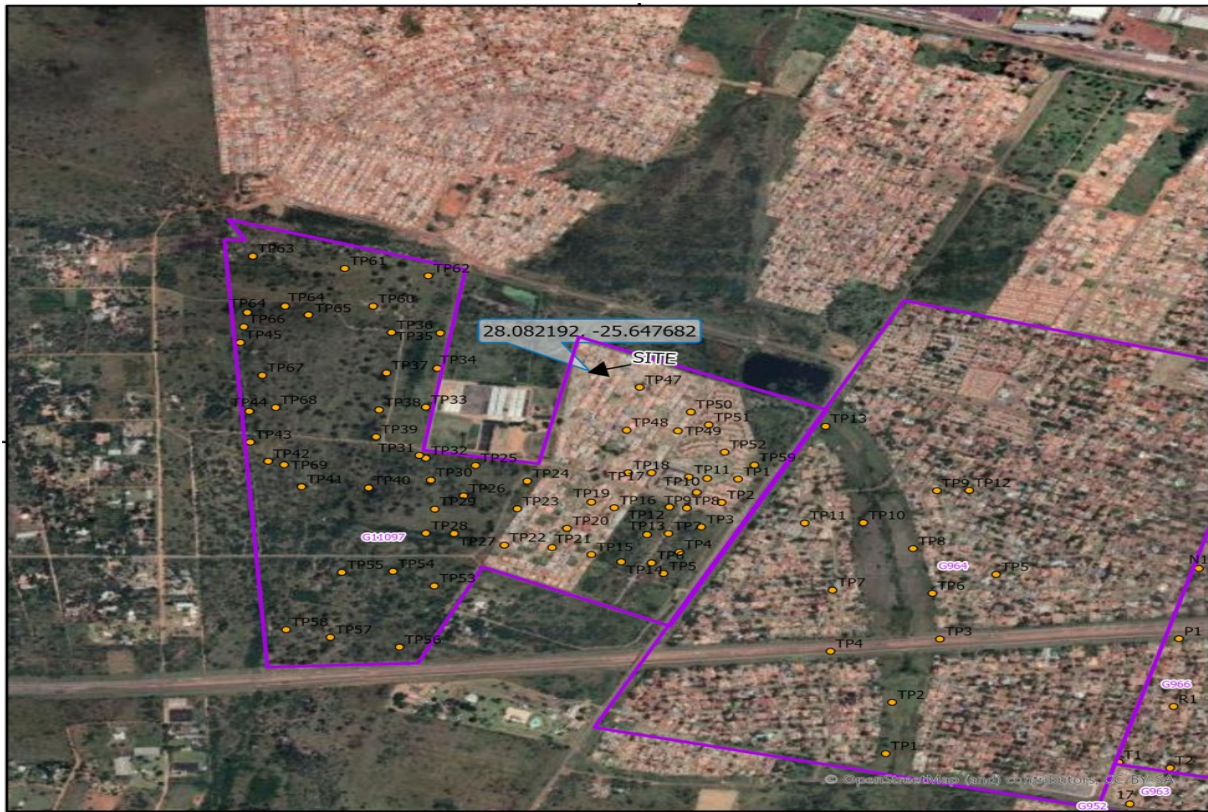
Fig 13- Site Area

There is an existing geotechnical report of the area Prepared by SOILKRAFT CC titled "Geotechnical conditions on Portion 1 of The farm Plantland 644-JR (3497/1995). A Report for the Establishment of a proposed new residential development." This report dated 4th August 2005 covers Lavender estate where the above-mentioned property is positioned.

- The estate is underlaid by Fine Colluvium.
- Settlement is up to 37.5mm under strip footing for single-storey buildings.
- Property falls under geotechnical Zone II.
- Area Zoned as (S2-C2)/H1.
- Foundation design options are : Reinforced strip footings, reinforced raft and soil replacement.
- Construction must include articulation joints at some internal and external doors.
- Preferred foundation be Reinforced Raft (8.2)

Due to the above-mentioned highlights from the Geotechnical report, it is clear that although a reinforced strip foundation is an option, the preferred foundation was the Reinforced foundation raft to accommodate settlements determined in the design parameters.
