Our ref: P 2433-02-01 Forensic Engineering Assessment Report 02

FORENSIC ENGINEERING ASSESSMENT REPORT

**HOUSE MOCHOARI
ERF 40416, WILD OLIVE
BLOEMFONTEIN**

Date: December 2025

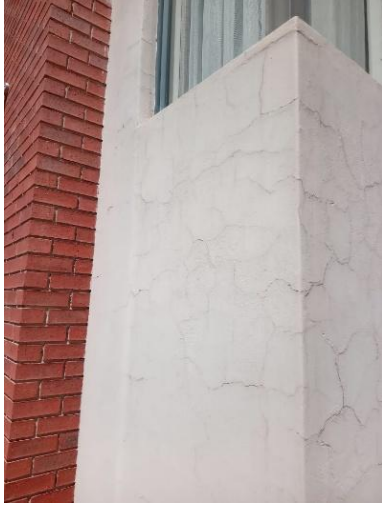
Exterior wall cracks	Serviceability Defect	The plaster strength will need to be confirmed prior to a recommendation on a suitable product to bond the cracks. The product will depend on the current strength of the plaster
2

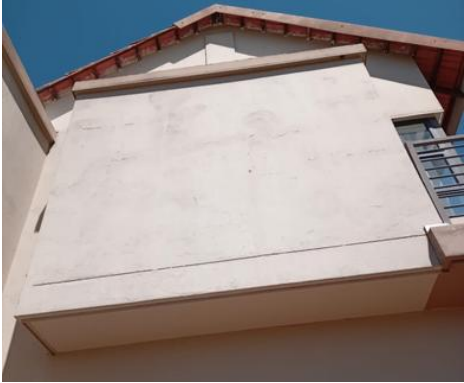
Exterior wall cracks	Serviceability Defect	The plaster strength will need to be confirmed prior to a recommendation on a suitable product to bond the cracks. The product will depend on the current strength of the plaster

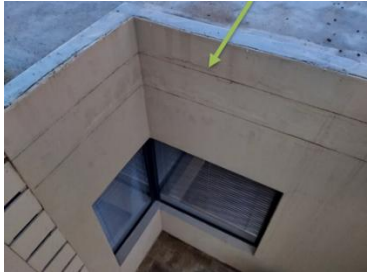
3

Aesthetic plaster lines (also known as plaster movement joints) are located near the roof slab as shown in Figure 6 below. Aesthetic plaster lines are found between the interface of the concrete slab and supporting masonry. It is common practice to install such joints where movement is expected between different building materials in order to eliminate random cracking during thermal expansion. The second line below is decorative.

Development of hairline cracks along these lines are expected due to thermal expansion and water ingress between the plaster and brickwork is the result. Good practice is to seal these joints on external surfaces to prevent penetrating damp.

<p>Water ingress and cracking</p>	<p>Does not conform to the serviceability limit state requirements of the building regulations- Serviceability Defect</p> <p>A cause for water ingress into the building</p>	<p>All plaster with cracks at the movement joint to be removed.</p> <p>The decorative line to have all plaster with cracks removed.</p> <p>Replaster the above surfaces in accordance with Method Statement 2 in Annexure B</p>
4

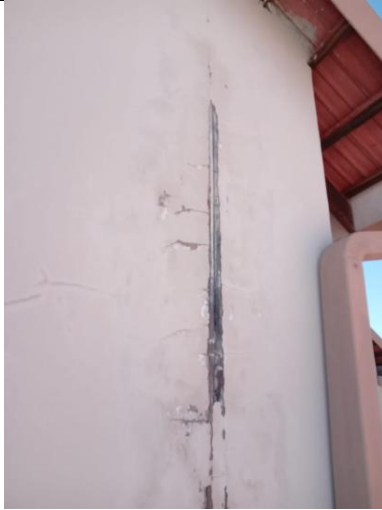
Water pipes from the first floor are chased too shallow into the wall as shown in the figure below. Insufficient coverage to the pipes creates a weak spot in the plaster attracting cracks and delamination shortly after construction. Water penetrates through the crack and causes damp build up in the walls.

<p>Incorrect placement depth of water pipes</p>	<p>Delamination of exterior plaster. Serviceability Defect</p>	<p>A certified plumber is to remove the water pipes and re-chase the pipe to an adequate depth</p> <p>Replaster in accordance with Method Statement 1 in Annexure B</p>
5		<p>Incorrect sloped surface</p>	<p>Does not conform to the serviceability limit state requirements of the building regulations Serviceability Defect</p>	<p>Tiles to be removed. Re-screed the surface in order to allow for a 2% slope away from the door.</p> <p>Waterproofing to be installed by a waterproofing specialist.</p>

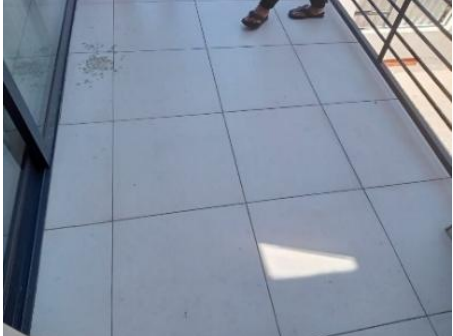
<p>A cause for water ingress into the building</p>	<p>Screed depth to be confirmed with Engineer Prior to construction</p>
<p>6</p>

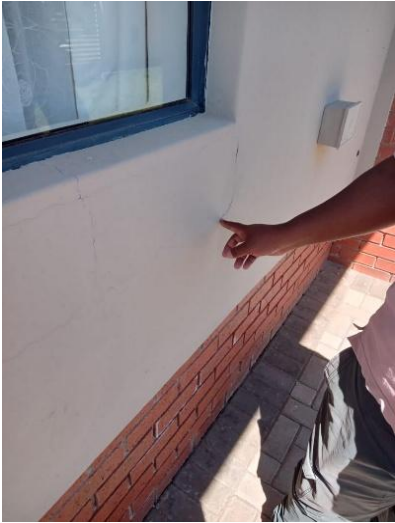
<p>Cracks on plaster</p>	<p>Serviceability Defect</p>	<p>The plaster strength will need to be confirmed prior to a recommendation on a suitable product to bond the cracks. The product will depend on the current strength of the plaster</p>

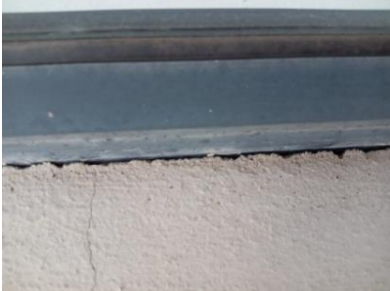
7

Figure 8 shows a separation between the window frame and the plaster. The plaster and aluminium window frame have different coefficient of expansions resulting in the separation observed. This is a point of water ingress causing major damp to build up in the masonry.

<p>Separation of aluminium window and plaster</p>	<p>Does not conform to the serviceability limit state requirements of the building regulations – Serviceability Defect</p> <p>A cause for water ingress into the building</p>	<p>The gap to be filled with a polyurethane sealant approved by the engineer.</p>
8

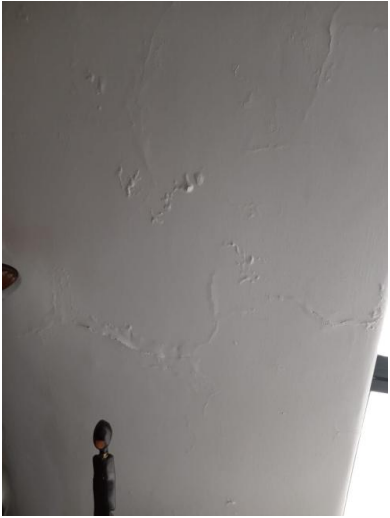
Water ingress occurs through crazing cracks on the external walls and from the roof slab. To prevent damp build up in the wall, the external defects need to be addressed.

<p>Water ingress into interior walls</p>	<p>Calcium build-up on the interior wall. Serviceability Defect</p>	<p>Exterior cracks to be remedied prior to remedial work.</p> <p>The extent of the damage to the plaster will need to be evaluated:</p> <ul style="list-style-type: none"> (i) A plaster surface that has delaminated, will require re-plastering. (ii) A plaster surface that no signs of delamination as shown in the figure to the left. The surface should be smoothed by sanding, damp proof sealant applied and paint to match existing

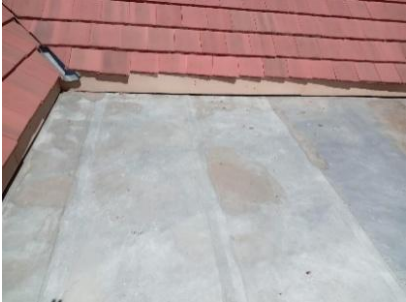
<p>9</p>

Grooves on the screeded surface of the slab. The grooves cause water to pool behind it as seen in the circles marked in red.

<p>Grooves on screeded surface of concrete slab.</p>	<p>Does not conform to the serviceability limit state requirements of the building regulations – Serviceability Defect</p> <p>A cause for water ingress Into the building due to Uneven runoff flow</p>	<p>Waterproofing and screed on concrete slab to be removed.</p> <p>New screed to slope as per engineering drawing in Annexure A.</p> <p>Waterproofing done by a specialist.</p>
<p>10</p>

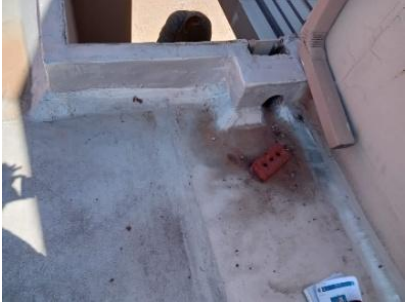
It was observed that the sloped screed at the entrance of the discharge point 1 (DP1) directs water runoff inefficiently. The slope directs water to the side of DP1 instead of the invert of the pipe which results in water pooling around DP1 as shown in figure 12 below. It should be noted that any debris on the slab aggravates the inefficiency of diverting water to the outlets. The incorrectly sloped surface of the slab contributes to insufficient drainage, as pooling water builds up behind the grooves until it overtops the current heights

<p>Entrance slopes into downpipes inefficient</p>	<p>Serviceability Defect</p>	<p>Waterproofing and screed on concrete slab to be removed.</p> <p>New screed to slope as per Annexure A.</p> <p>Waterproofing done by a specialist.</p>

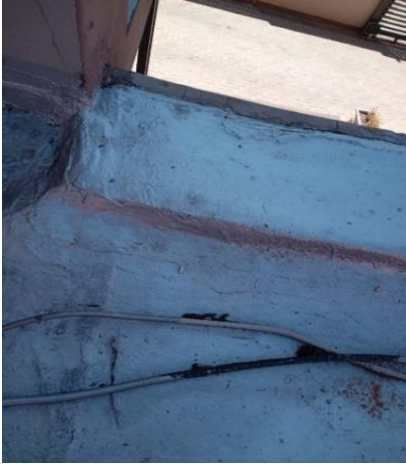
11

Upstand beam depth not sufficient	Water flows over the upstand. Serviceability Defect	Increase depth of upstand to 100mm throughout the length. Waterproofing to be redone by specialist.
12

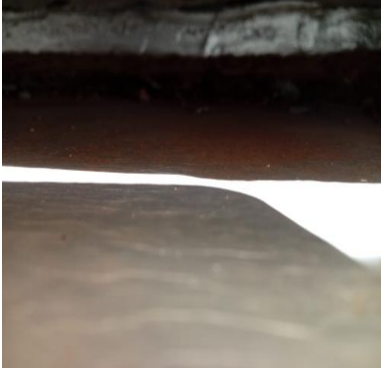
Wall height above slab not sufficient	Water flows over the wall And into the home. Serviceability Defect	Increase parapet heights as per Table 1. Waterproofing to be redone by specialist.
